FAILURE OF SPRINKLER SYSTEM IN HIGH RISE BUILDING

I. INTRODUCTION

We have investigated the cause of **Failure of the gasket** at the bottom flange of a Filter unit located at the 18th floor causing damage to four (4) elevators

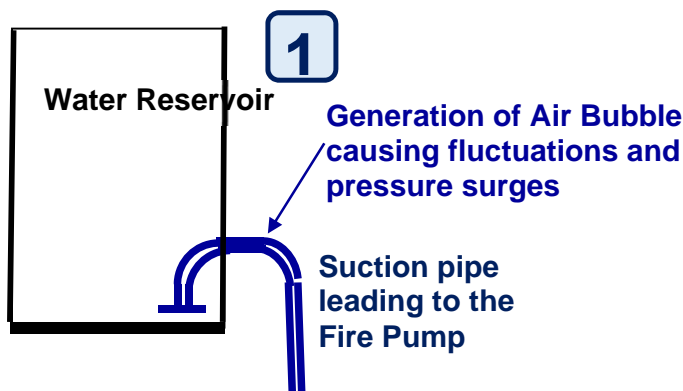
Probable Disturbances in the Pumps operation (Photo 1): The suction pipes arrangement promote the generation of large air bubble not in accord with NFPA 20 (item 4.14.6.1).

4.14.6.1 General. Suction pipe shall be laid carefully to avoid air leaks and **air pockets**, either of which can seriously affect the operation of the pump.

The air bubble may generate pressure surges in the pumps operation.

We mentioned above “Pressure Surges”. The probable cause of it is the way the pumps’ suction pipe connection to the water reservoir is installed. Large “air bubble” are created due to violation of the NFPA-20 instructions (see sketch in Pg. 2). This causes intermittent disturbances in the operation of the fire pump.

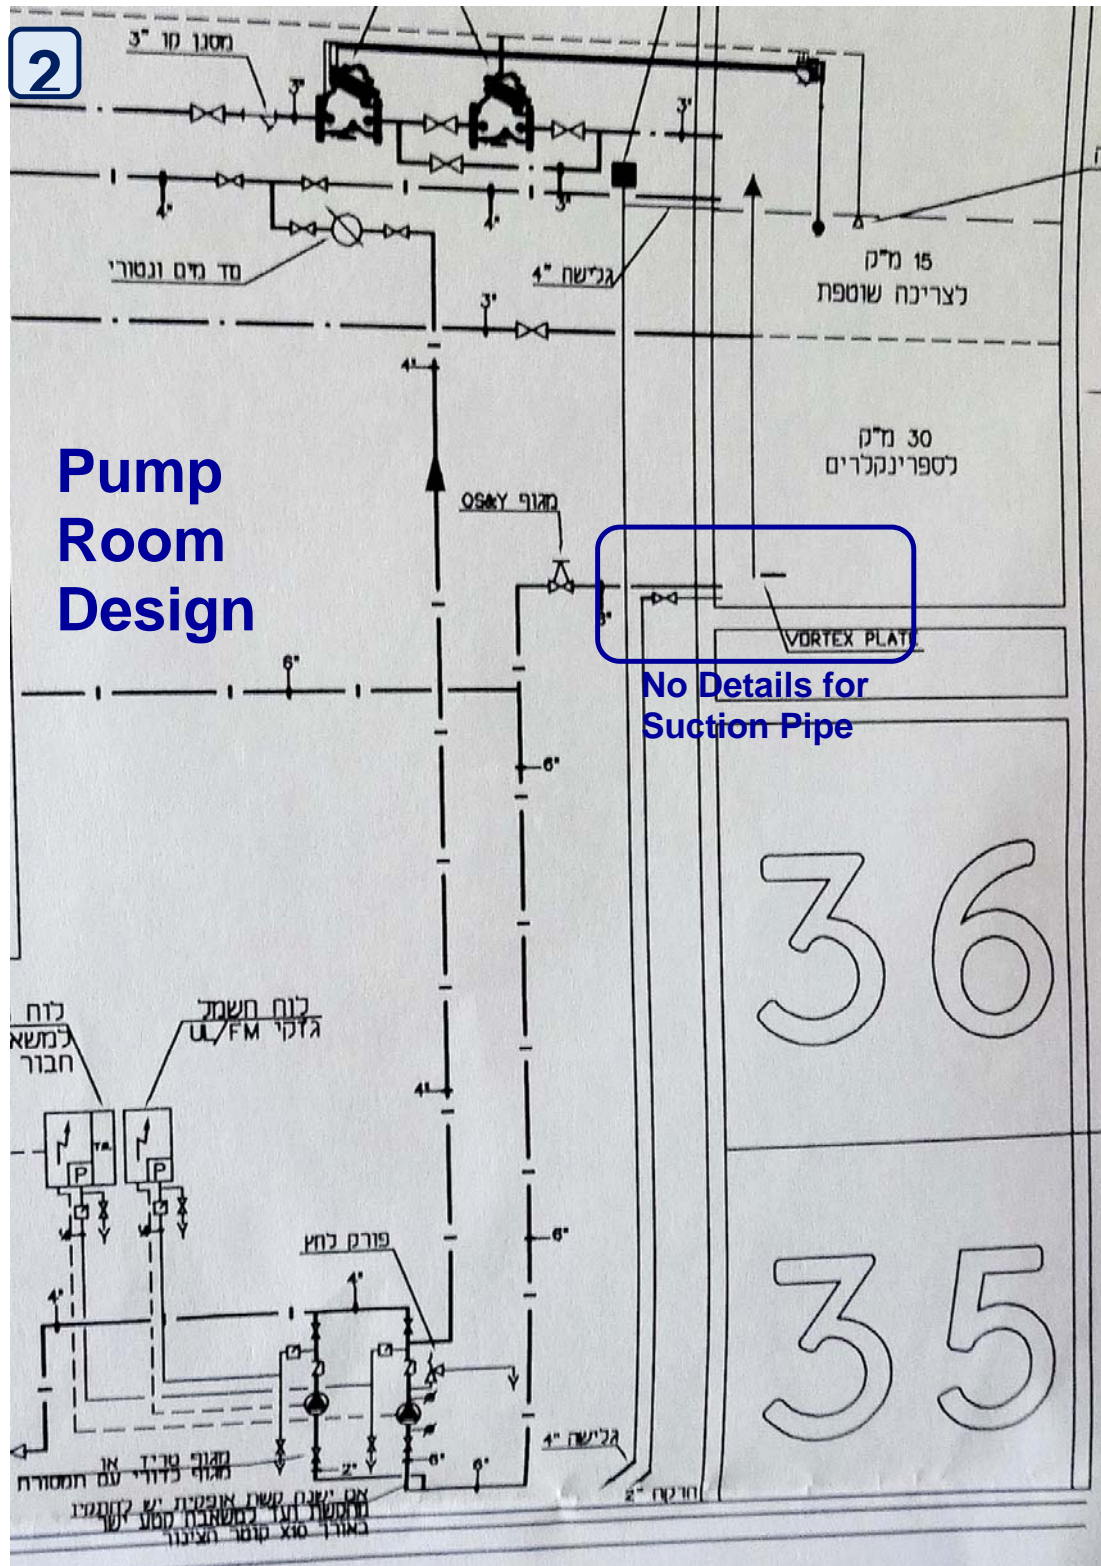
The designer plan of the Pump room and the reservoir is presented in the following page (**Photo 2**). The details of the suction pipe arrangement is poor.

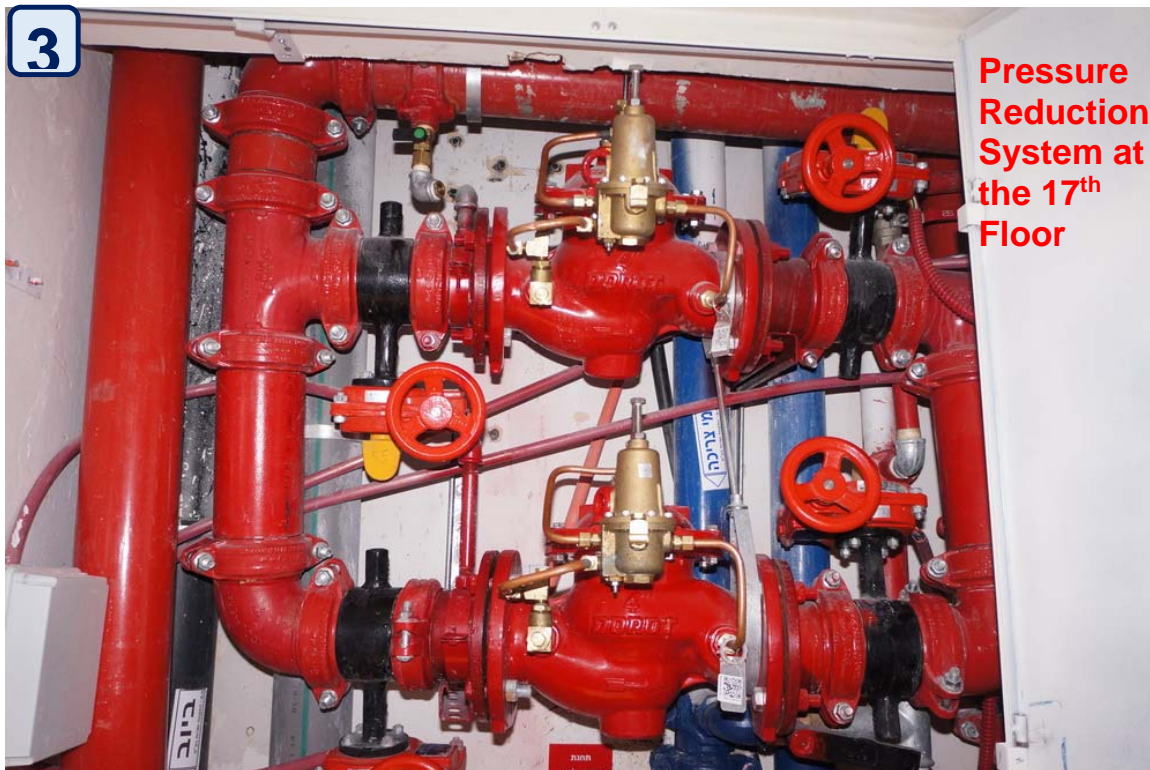
The Pressure Reduction Station (Photo 3, Pg. 4):

It is composed by two (2) parallel 6” pressure reducing valve, and a 2” pressure-releasing valve make “Dorot”. It is located on the 17th floor (Photo 5, Pg. 7).

The “Pressure reduction station” (see photo above) is composed of 2x 6” pressure reducing valves” and a 2” Relief Valve” with 1.5” drain section.

To get a proper operation of the “pressure reduction” station, it is necessary to set the “opening pressure” of the pressure relief valve. It appears that the setting was **125 psi** instead of just **35 psi**.

Following setting of the valve made by the Mfg’s technician, the pressure downstream of the “pressure reduction” station was reduced to 50 psi.

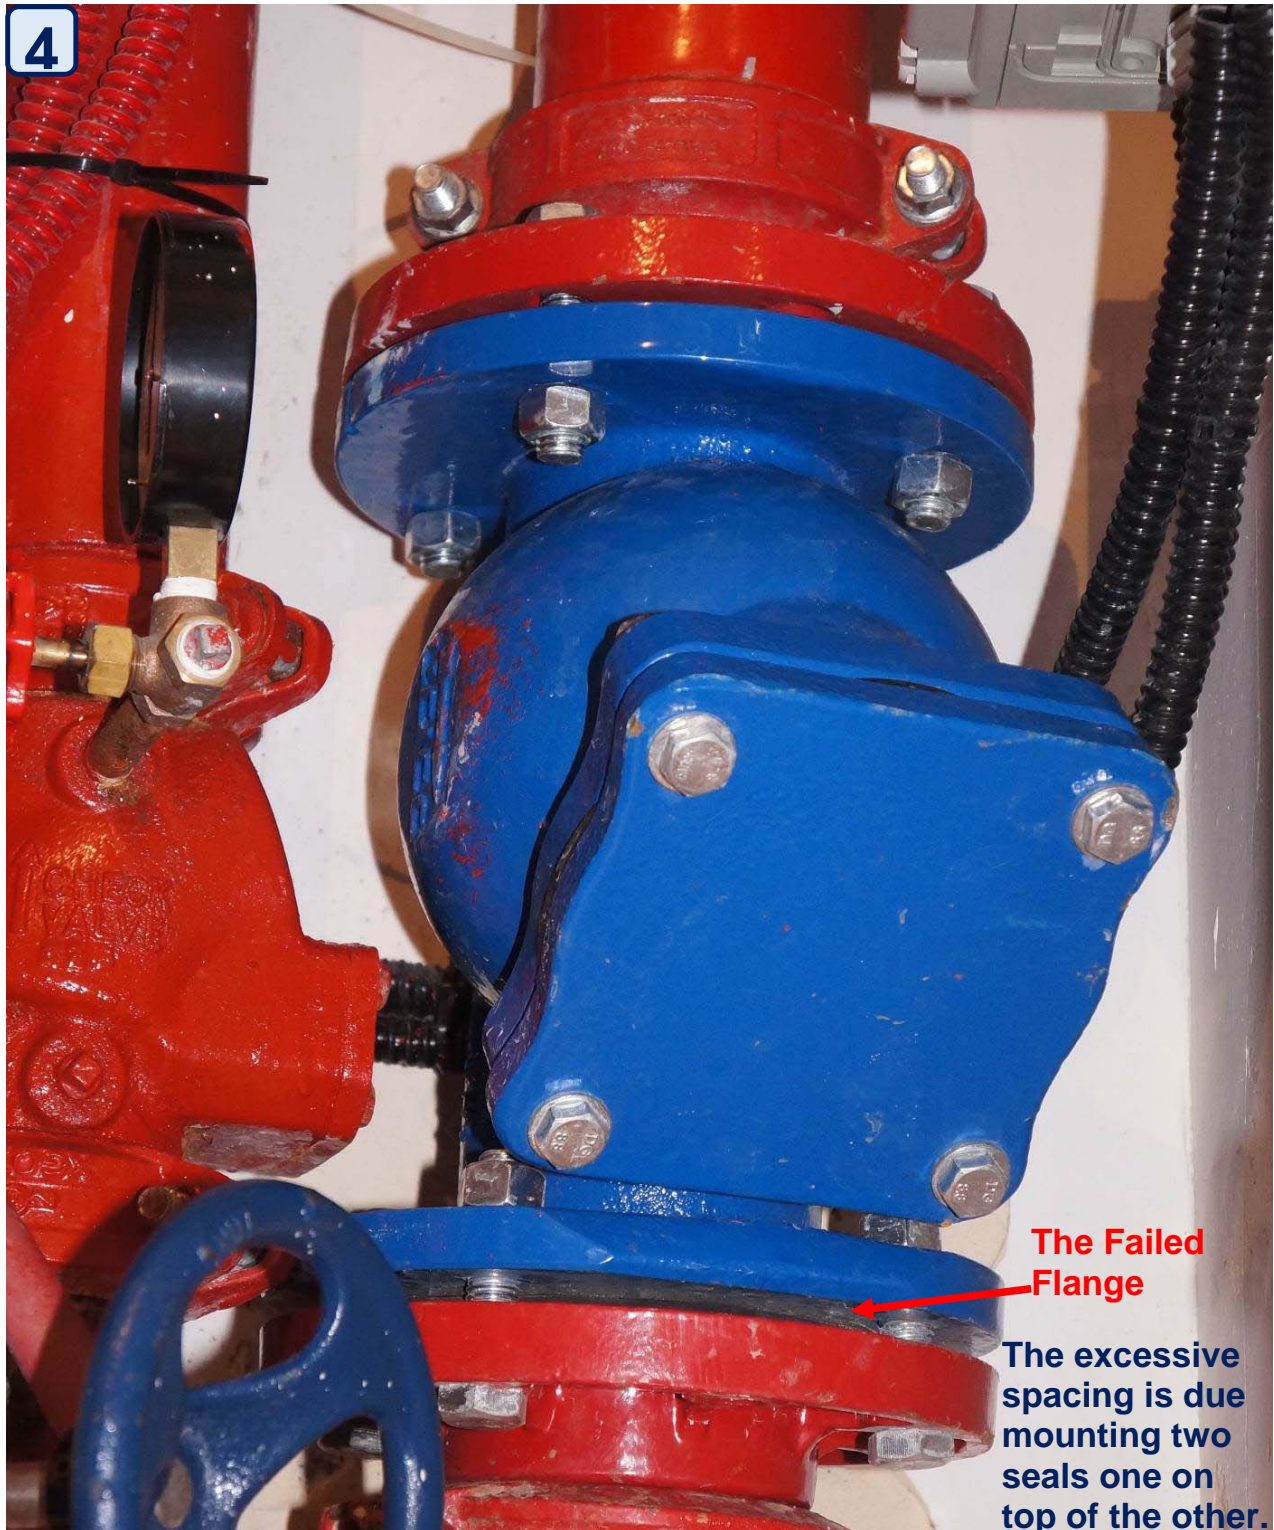
We were informed that it was reinserted with an addition of another gasket and the flanges were re-bolted. This is not the right method. It is necessary to install a good quality gasket suitable for 35 bars service.

We believe the failure of the flange is due to the use of a wrong type of gasket and uneven bolting of the flanges.

Photo 4 below present the flange after the repair.

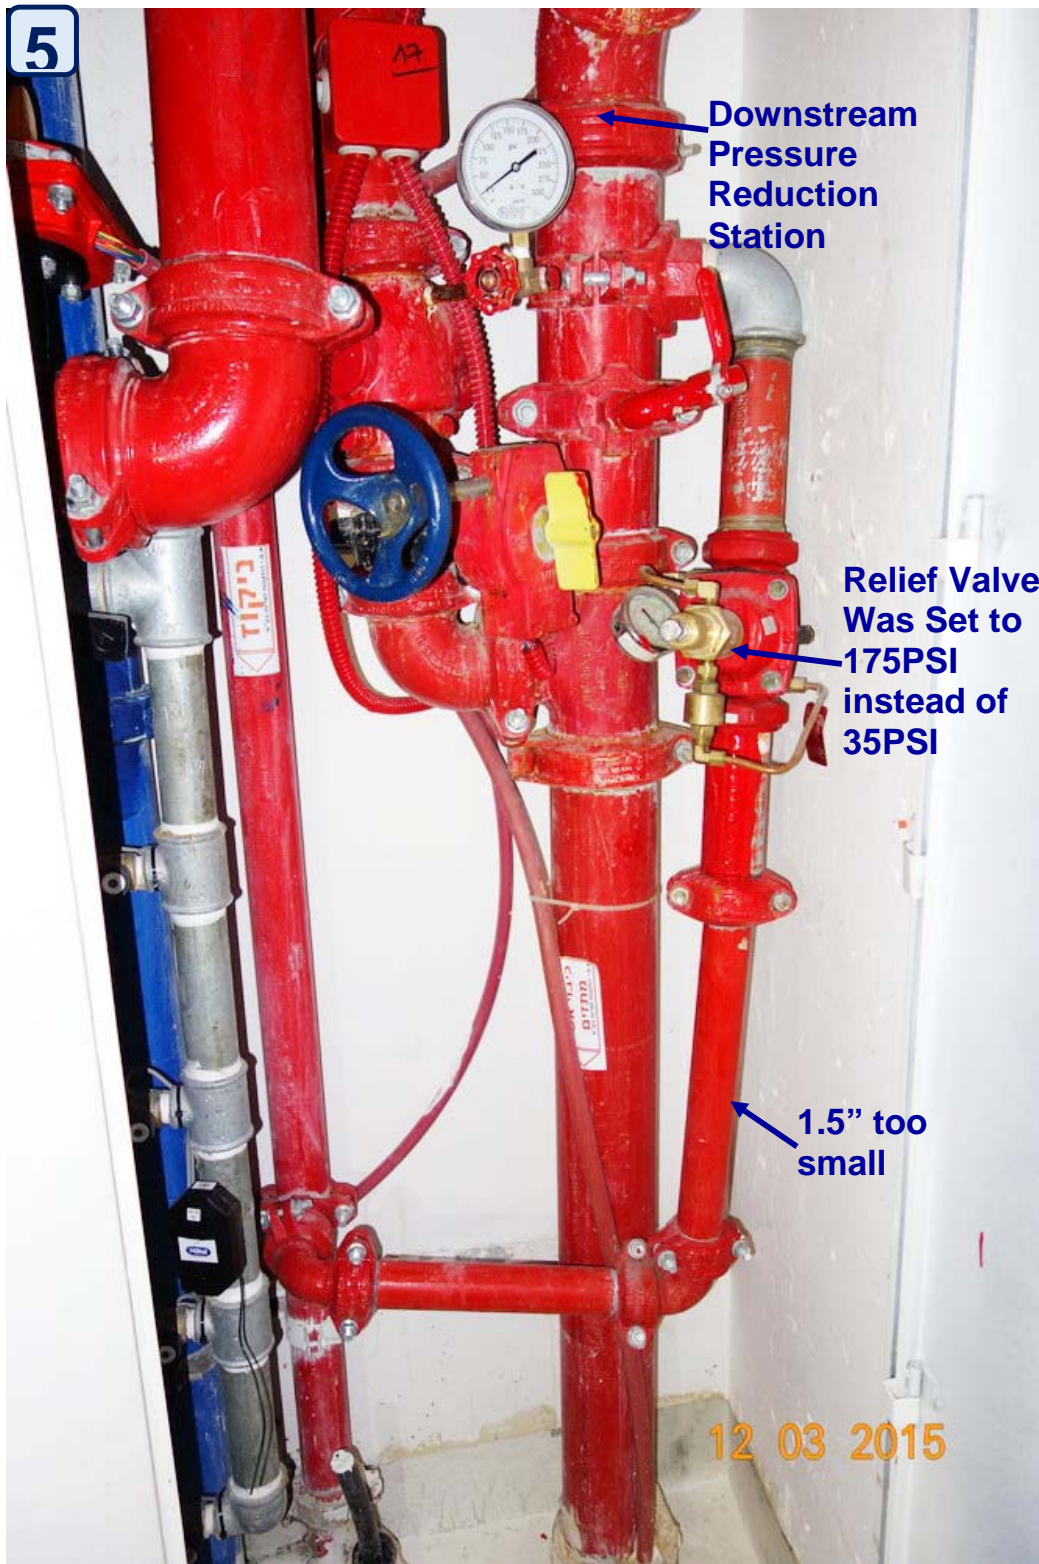
Another problem was the low sizing of the 1.5” pipe downstream of the “pressure relief valve” that connects it to the main drain pipe (Photo 5).

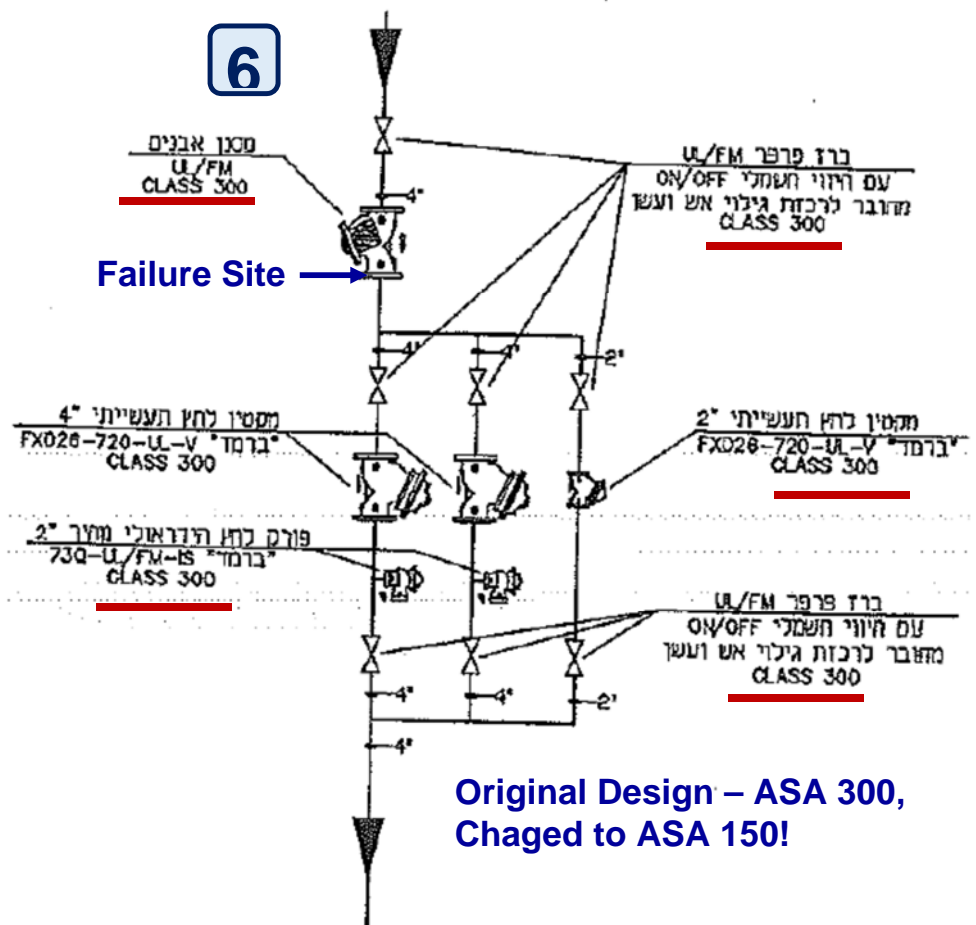
It appears that the Designer specified equipment (valves, pressure reducers and filter) as per ASA Class 300 that is suitable for high-pressure service.

However, the designer accepted lower pressure Class 150 accessories suitable for low-pressure service (**photo 6**).
