Date: 16/05/03  
Ref: ESFR-160503E

## **ESFR FAILURE INVESTIGATION**

A Central's ESFR - 14 1997 lot is subject to significant corrosion.

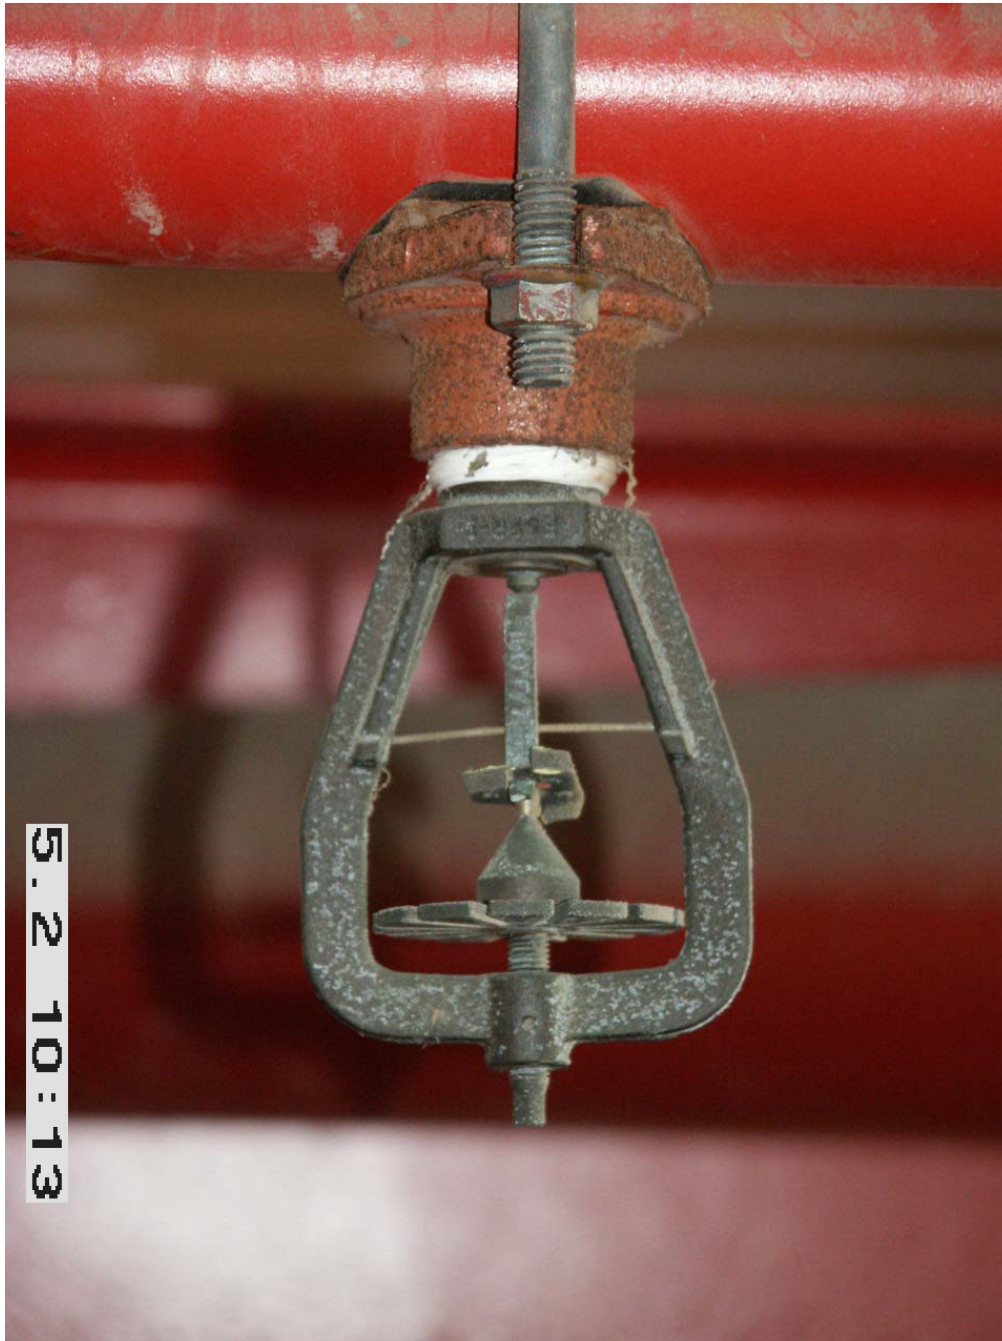
The plant is located about 300m from the Sea Shore.

The building contains chemicals within close containers.

The building is well ventilated

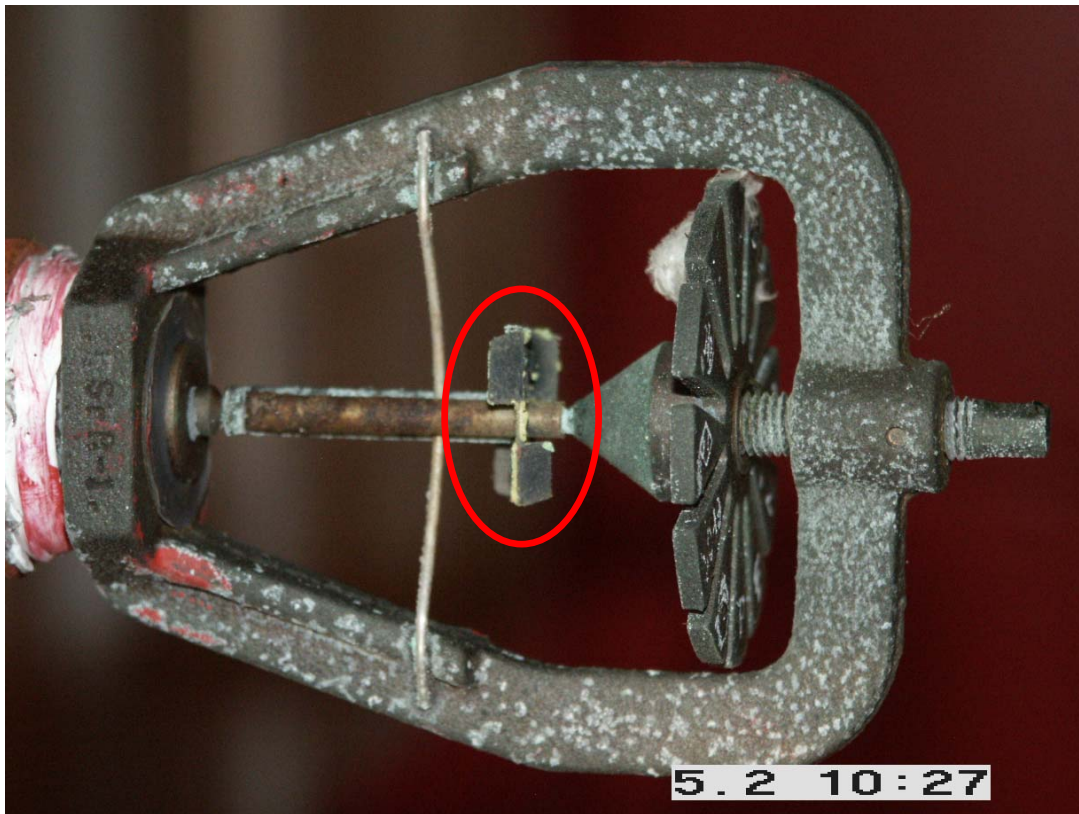
**The Fusible Heating Element is shown within a "red circle"**

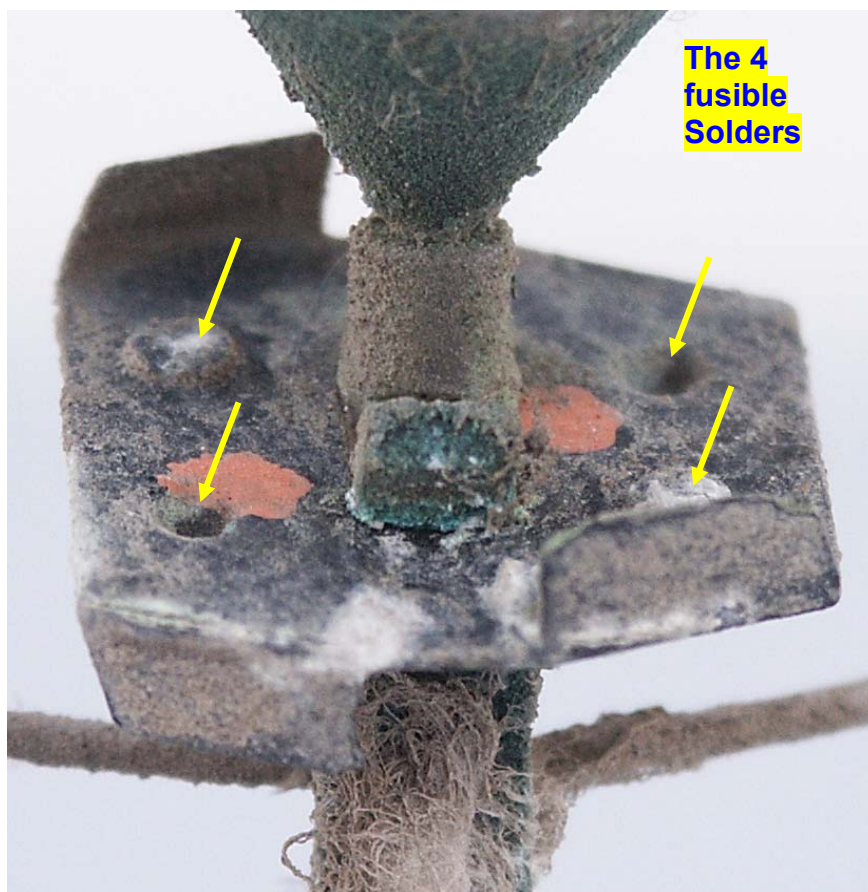
**The heating element is composed from 2 copper made pieces soldered in 4 positions. The Temp. rating is 71°C**

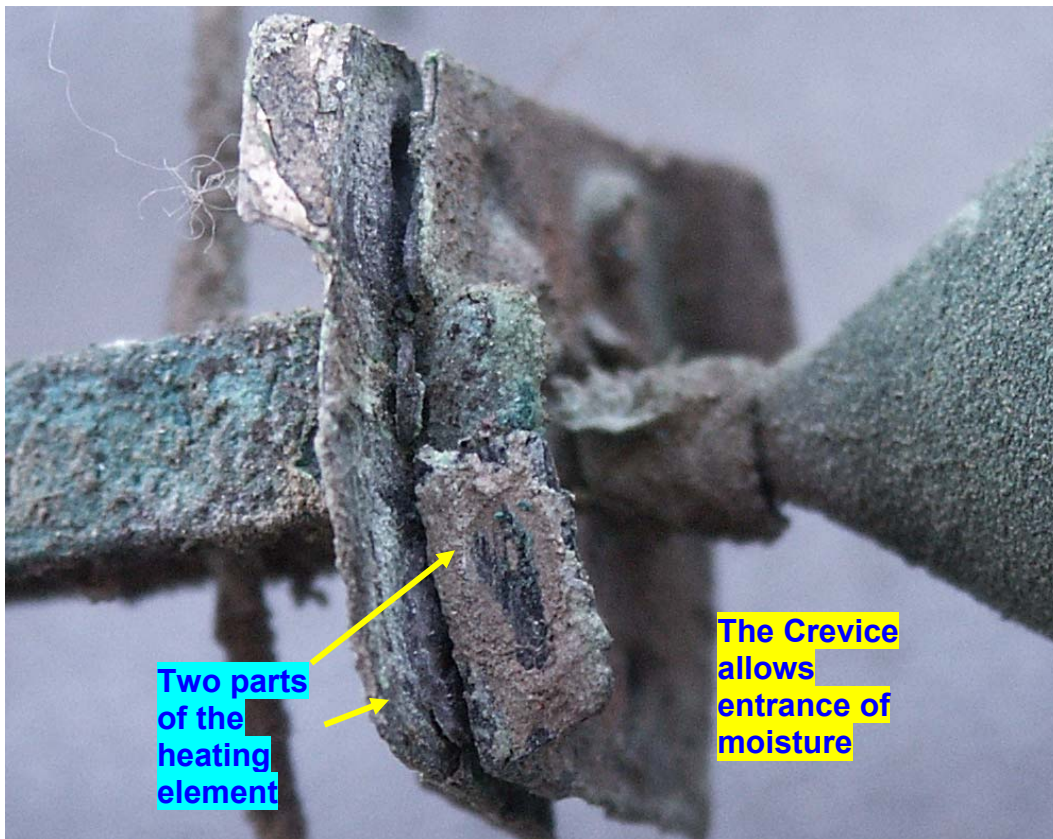
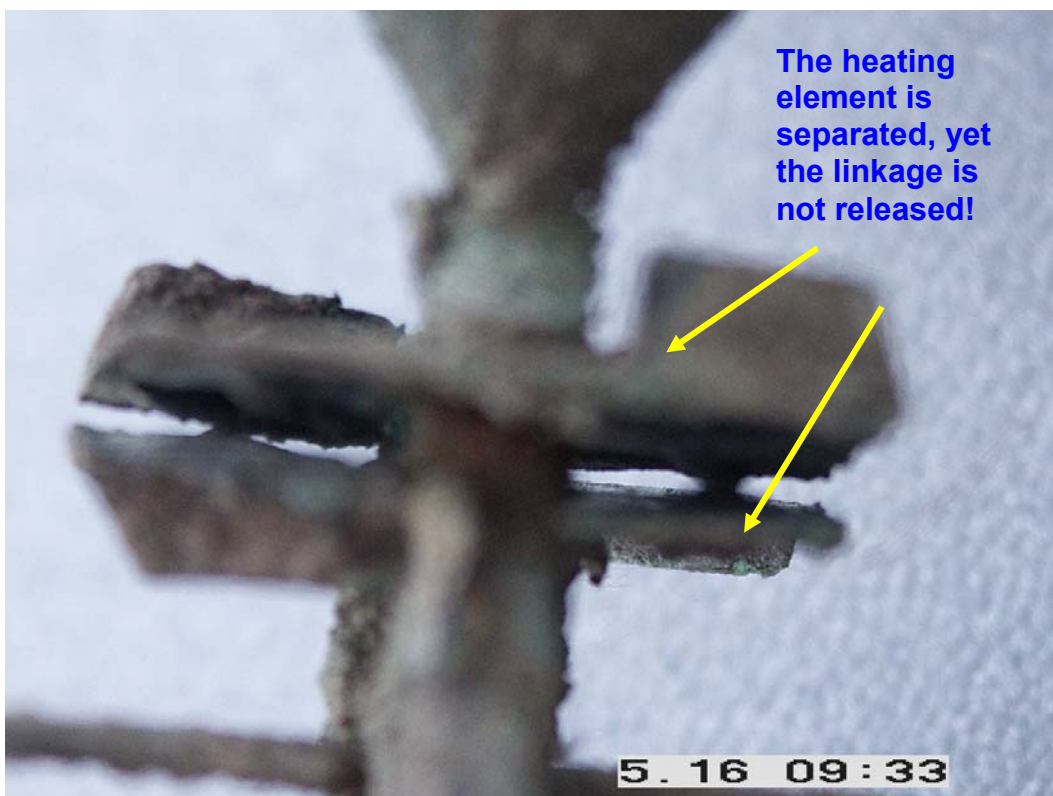
The two parts of the heating elements are easily separated due to failures of the solders. Crevice corrosion is suspected.

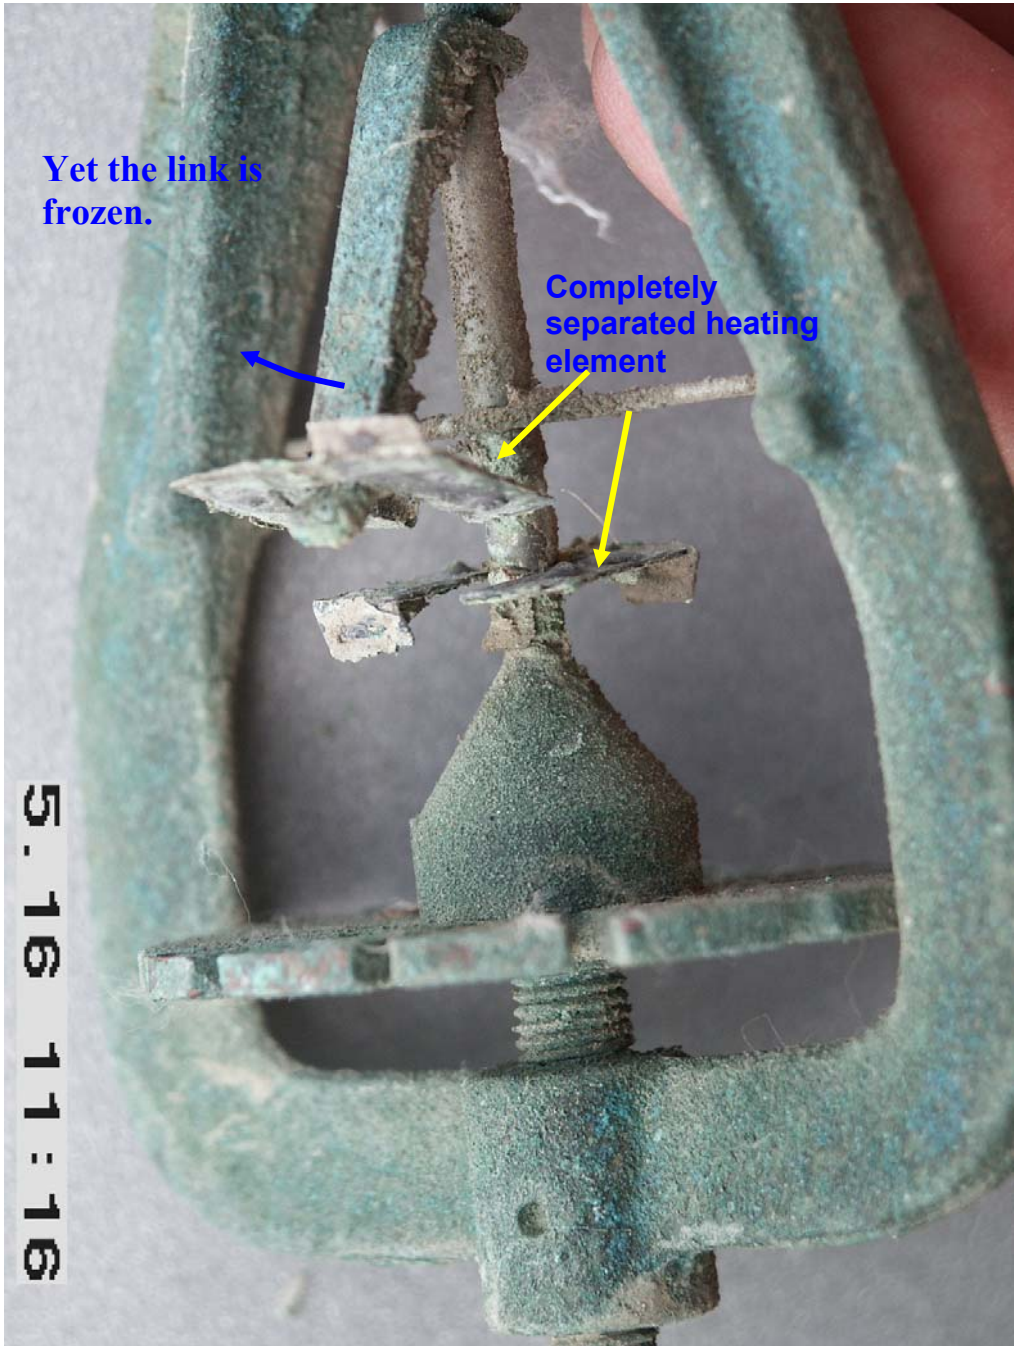
**Not only the heating element disintegrated, the normal operation of the sprinkler is inhibited!**

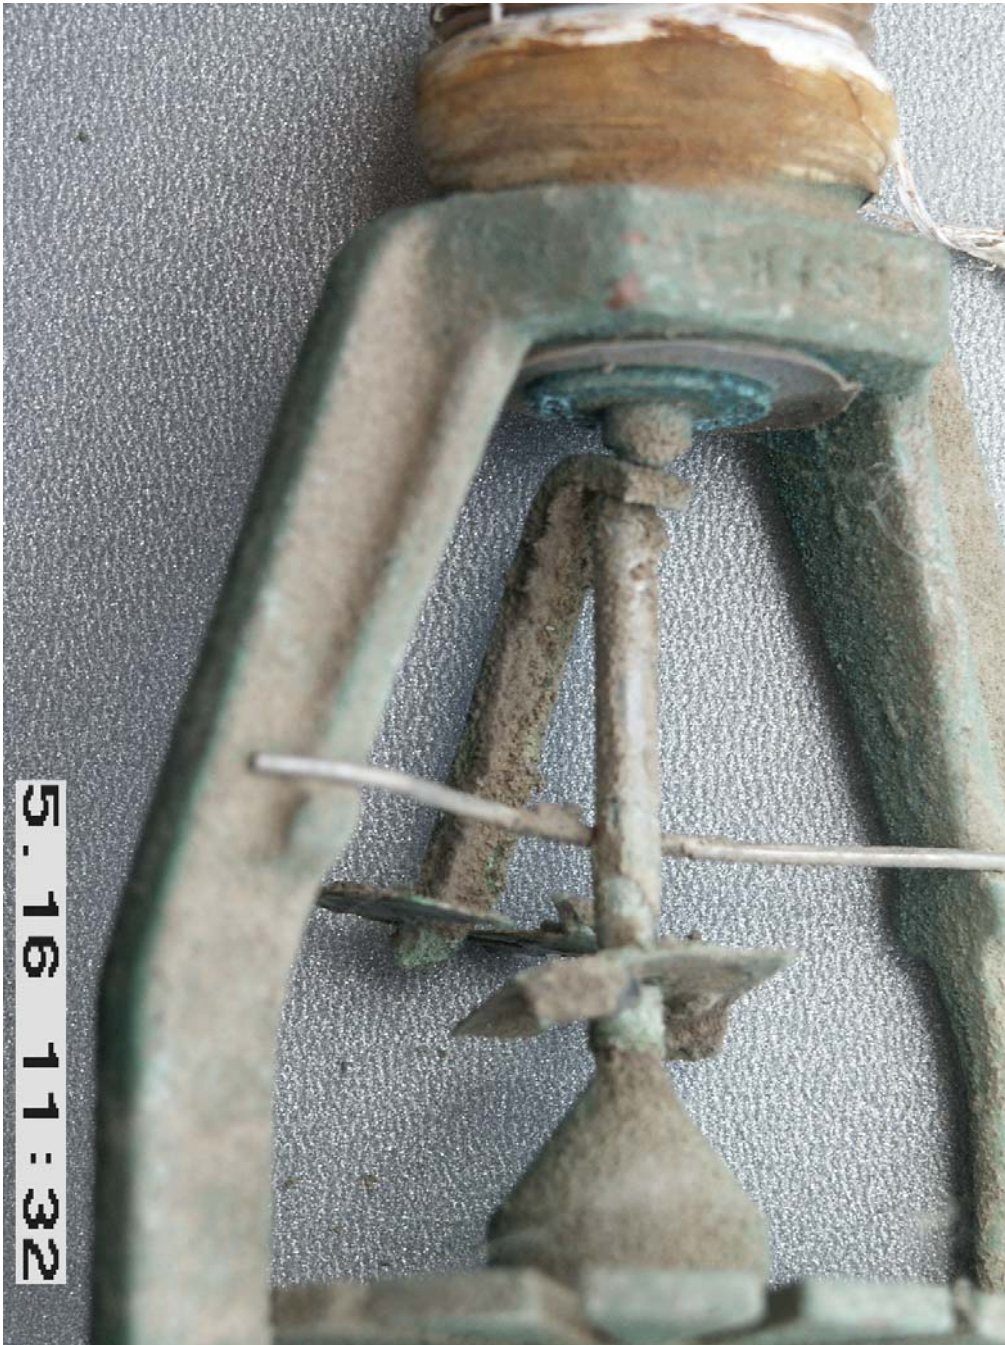
**The sprinkler is shown from a different angle. The link is still frozen.**

**The solders opened due to corrosion attack.**

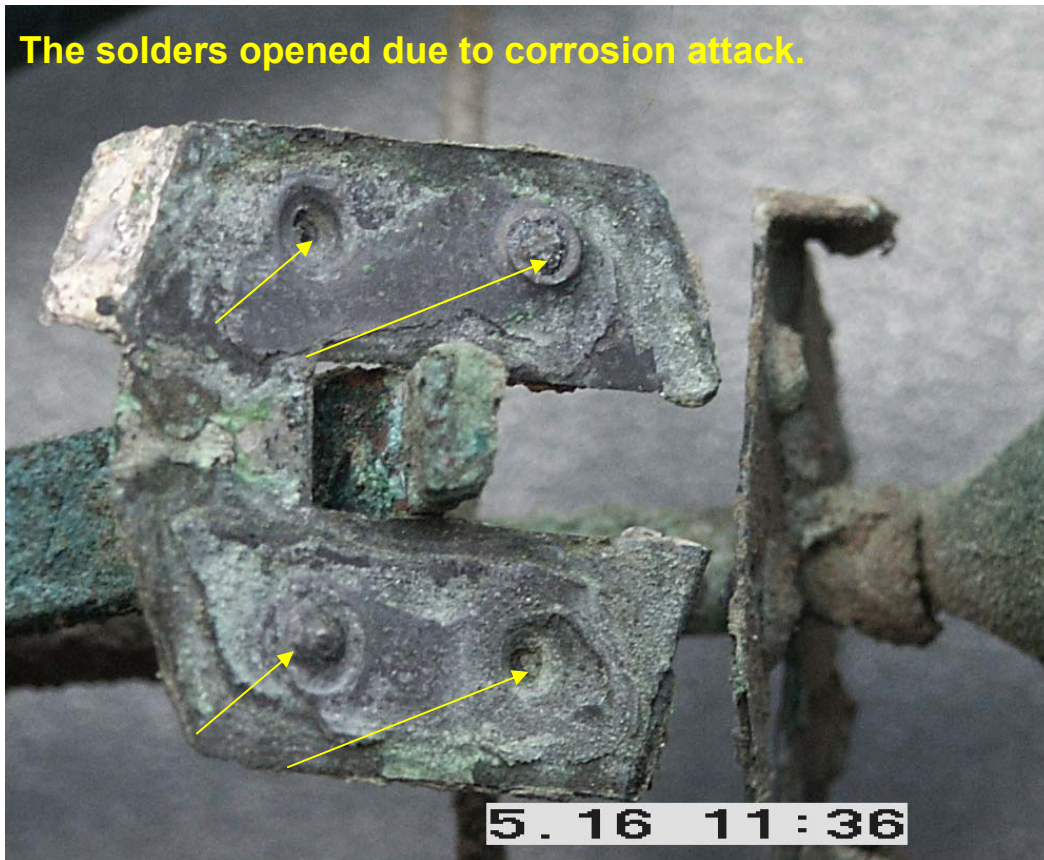
**The Heating Element:**

The location of the solders is towards the center of the plates.

**In the new design** (see photo below) the solders are located toward the edges closing better the gap between the plates.
