Date: 24/10/03
Ref.: PVC - Loss 2003

PVC INSURANCE CLAIM

Explosion and Fire – 13-Oct-2003 Insurance Claim

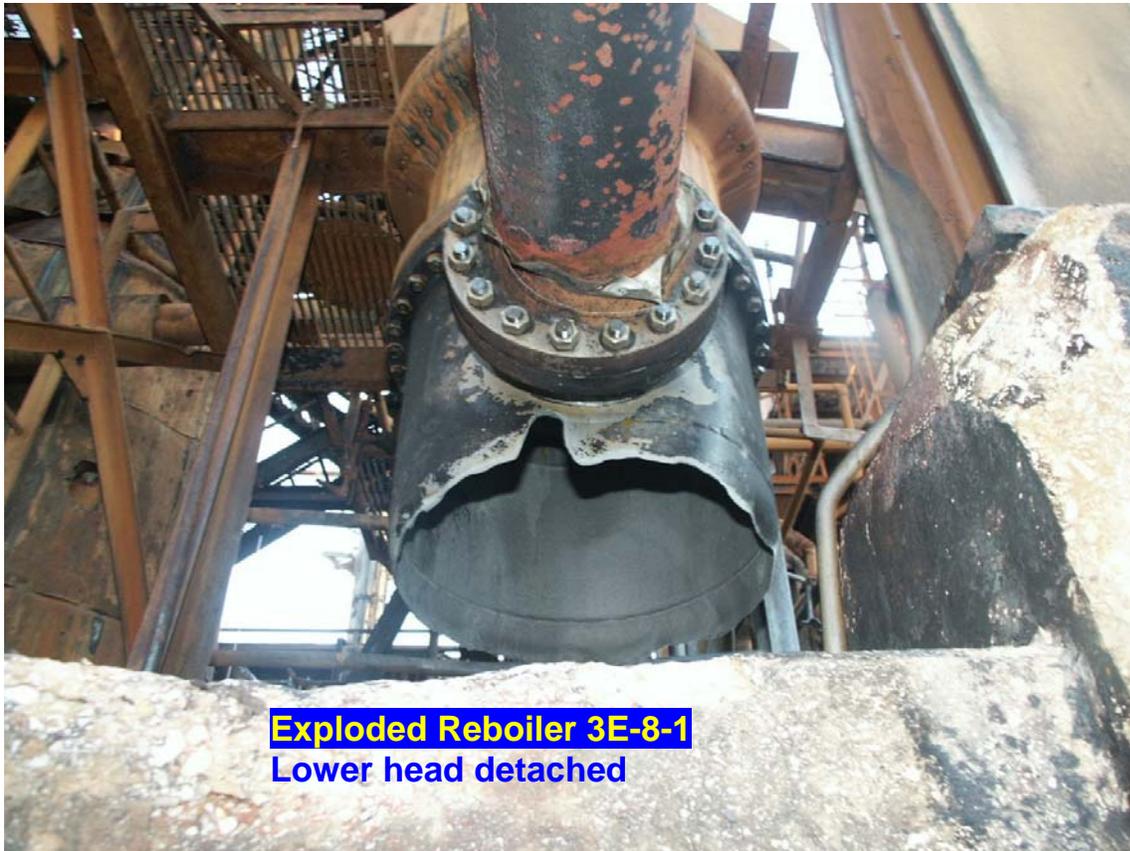
Exploded Reboiler 3E-8-1
Lower head detached

The bottom head thickness in a certain limited area was too thin (down to 1.0-1.5mm) to withstand the pressure of 12 bars.

So the thinning in the exploding unit was extraordinary.

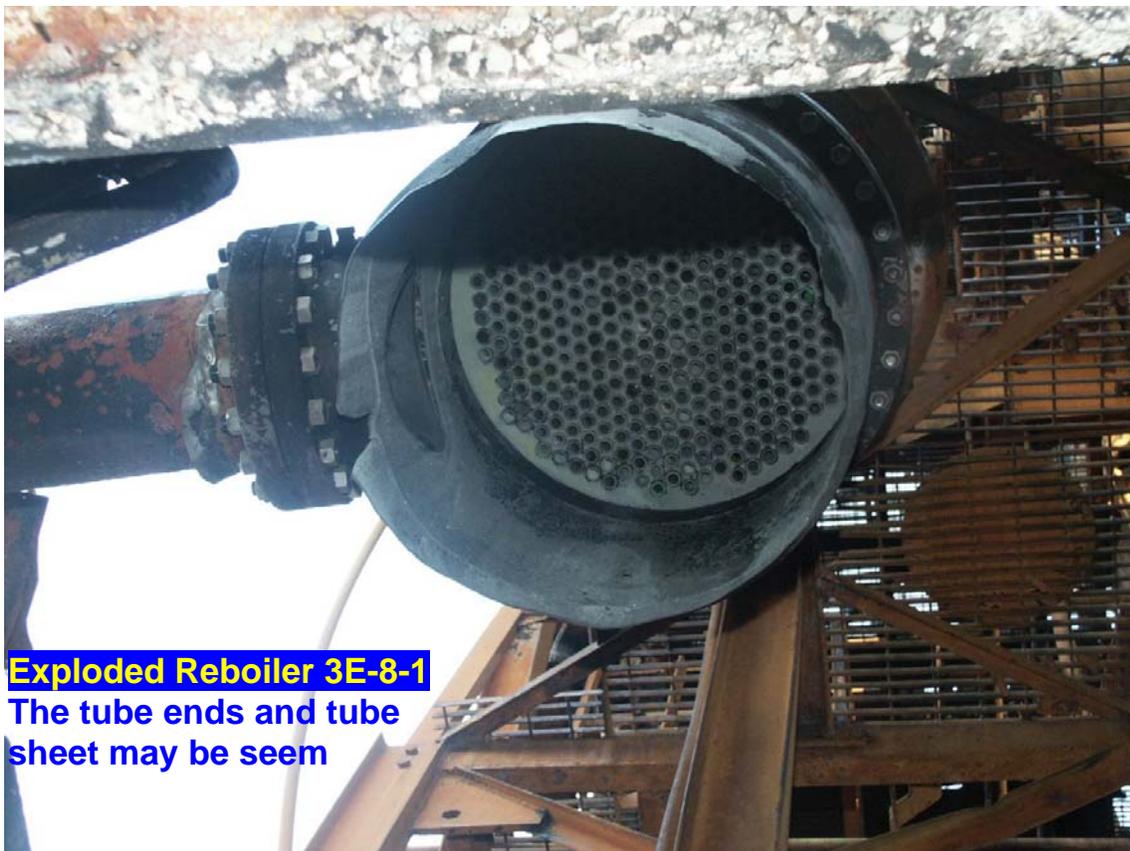
Exploded Reboiler 3E-8-1
The tube ends and tube sheet may be seen

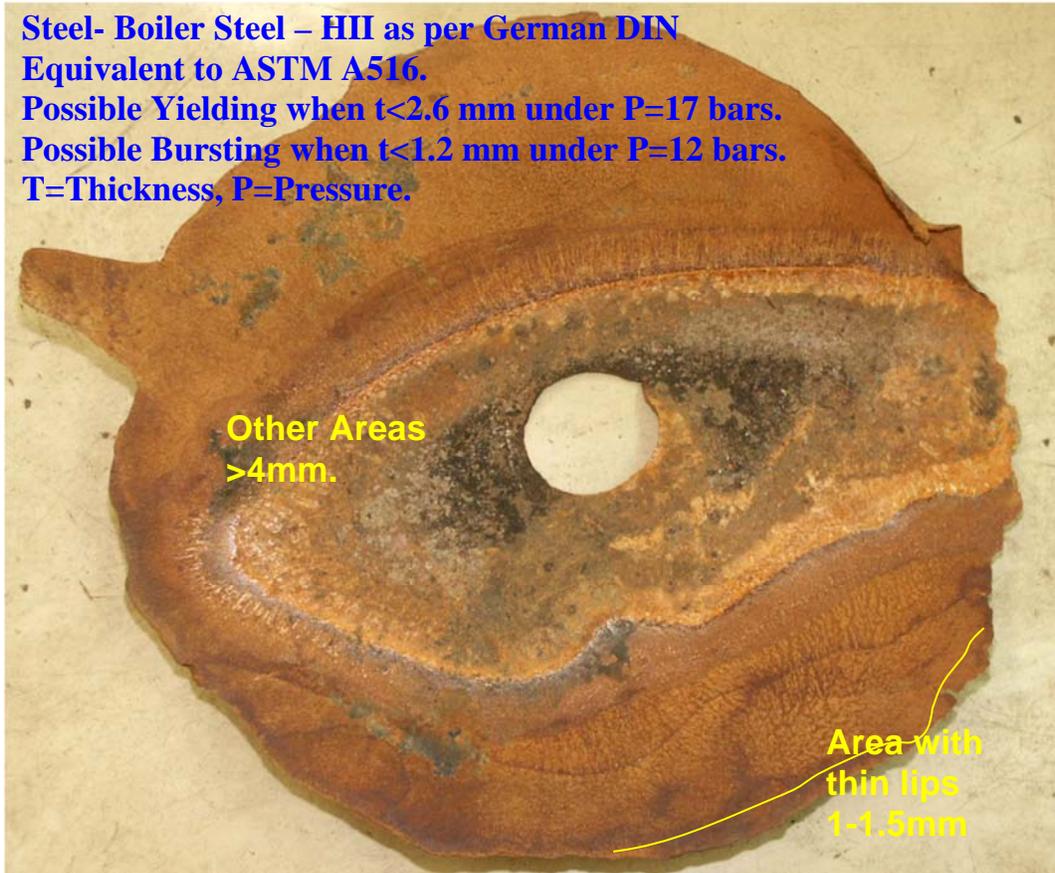
The detached lower dished head - flattened by the impact

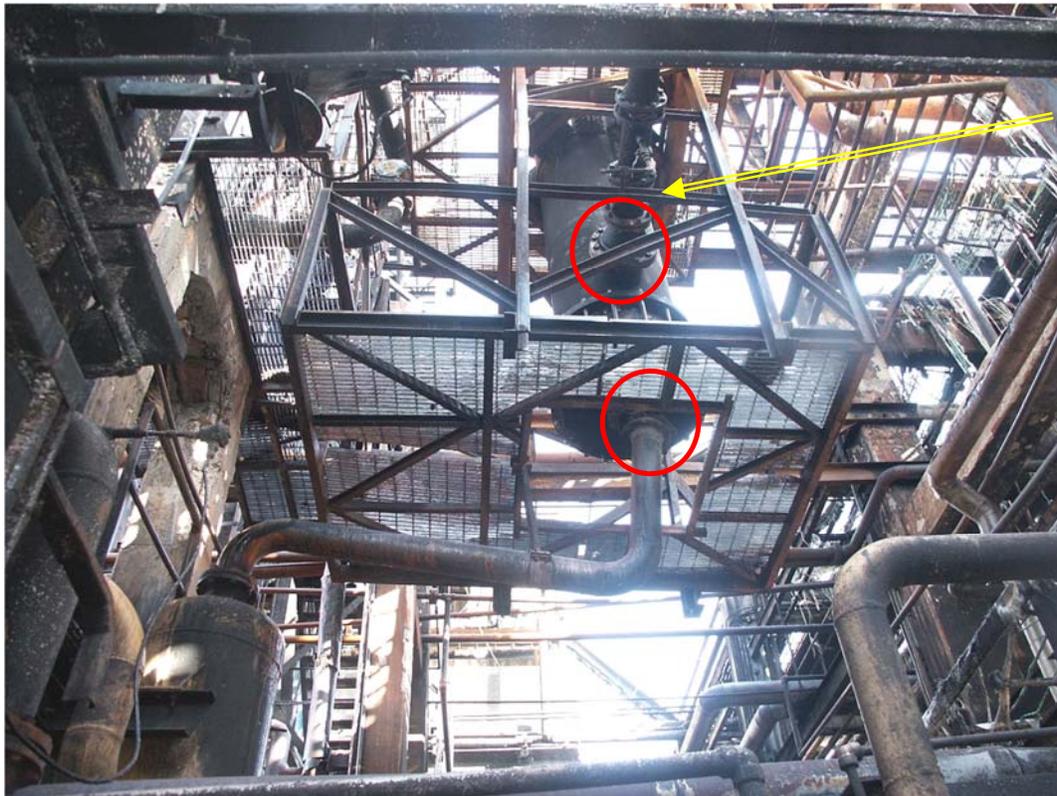
Graphite Heat exchanger – south of the 3-D-5, VCM column.

Fluid discharged through bursting bellows

Severe fire in this area.

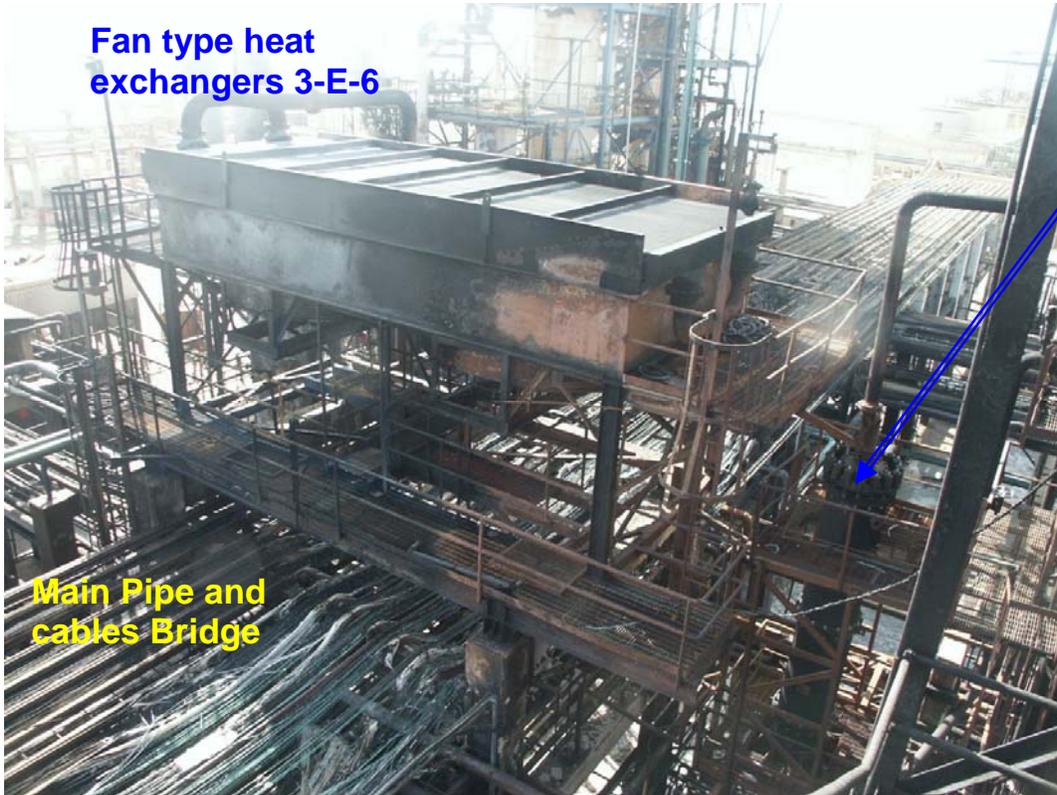
Fan type heat exchangers 3-E-6

Graphite Heat exchanger as above

Severe fire in this area.
