Date: 14/12/04  
Ref: N-Woven-131204

## ***NONWOVEN CONVERTING Concise Report***

<b>Insured:</b>	Nonwoven converting in Germany
<b>Survey on:</b>	Underwriting Information

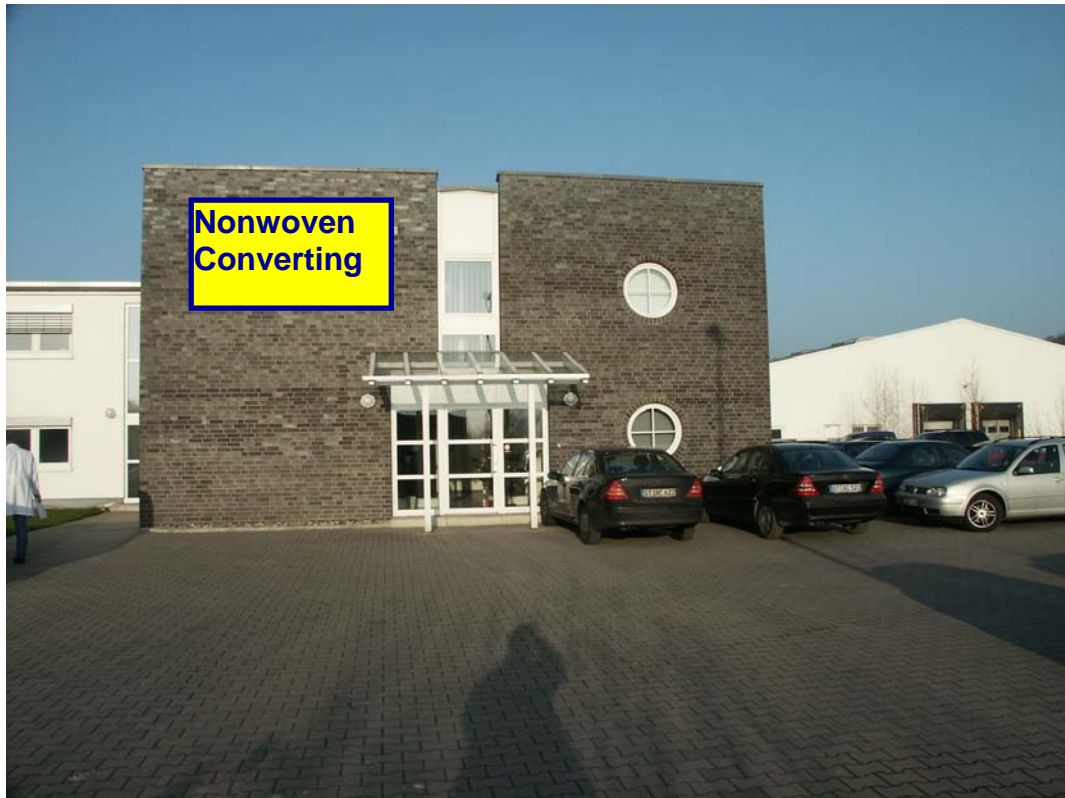
**2 floors office section of the production building.**

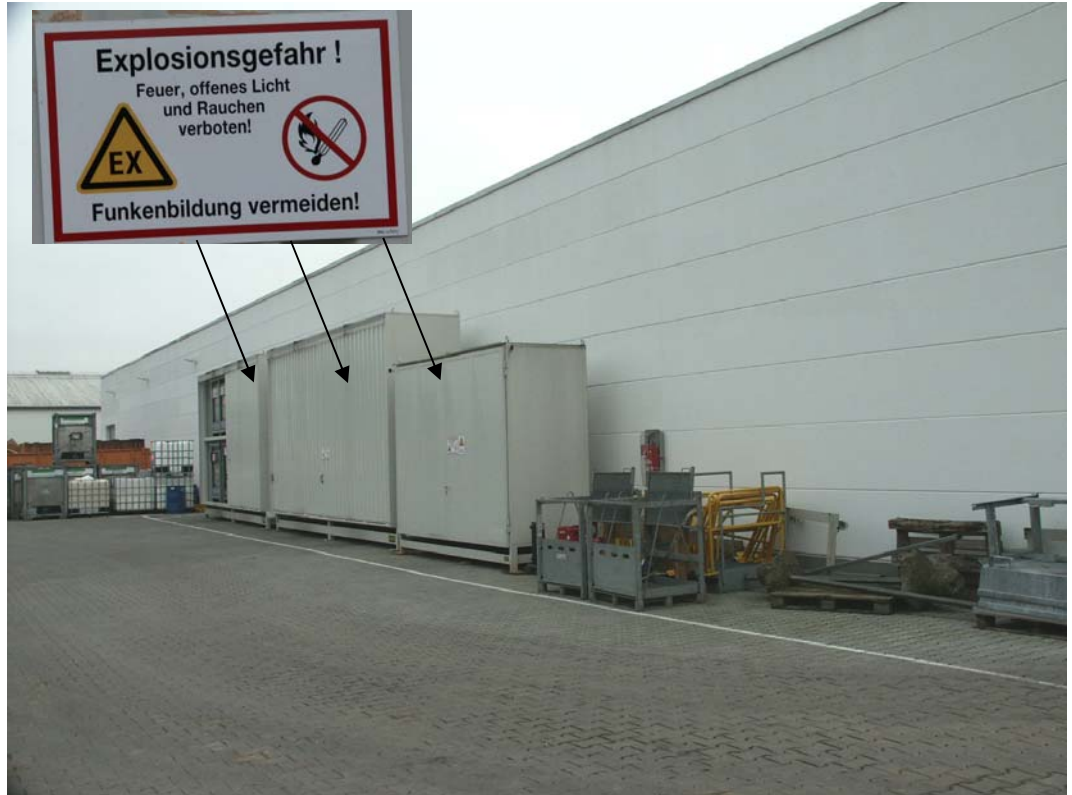
**The safety container has capacity to collect spillage.**
