Date: 21/09/03  
Ref.: Carton-210903

## ***CARTON PLANT FIRE INVESTIGATION – 20/05/03***

### ***FINAL REPORT***

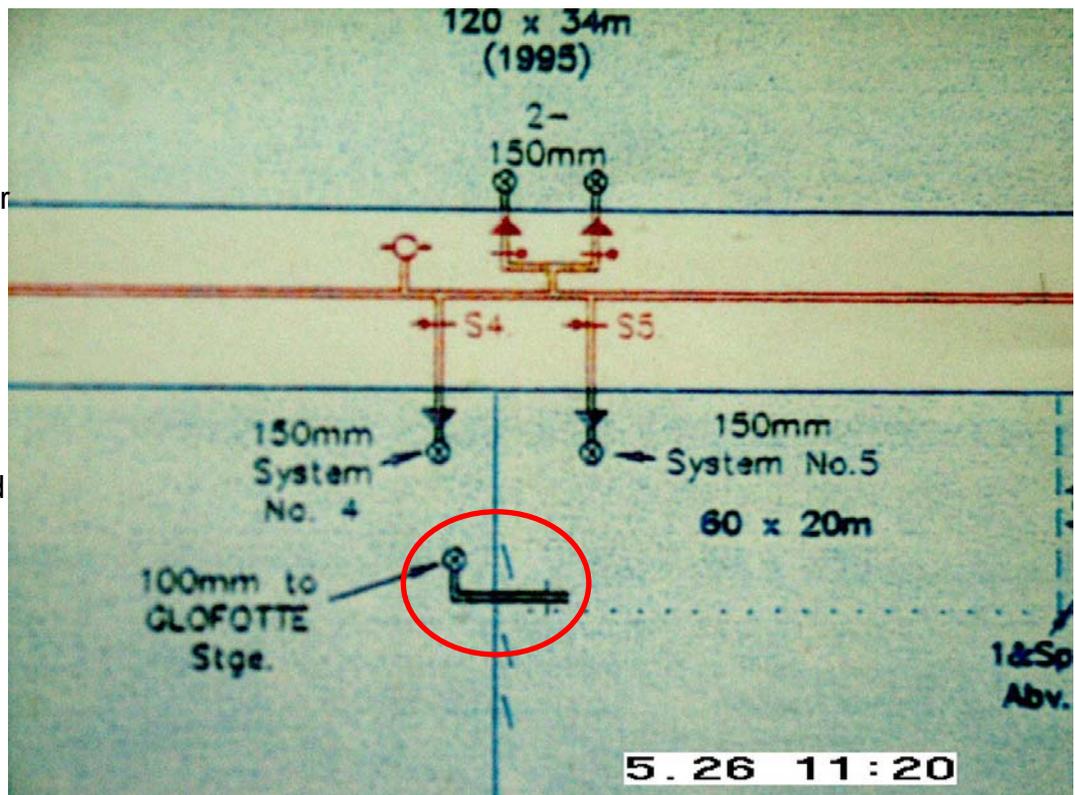
- h. The Printing Plates Storage:** This facility does not appear on the plan, although it should have been in view of the erection date and the book date. The last FM layout does note existence of a sub-system riser (see sketch next page).
- i. Changes Procedure:** This is major item is missing from the emergency procedures book. Its roll is to make certain that changes do not compromise safety. During the period of their service they did not register the erection of the storage of the printing plates and further additions made in later periods and made no studies of risks involved, the hazard classification and meaning of sub-section valves.

Part of FM sketch that show a 100mm extension for storage.

The actual extension is 80mm.

It has not been incorporated in any fire safety plan.

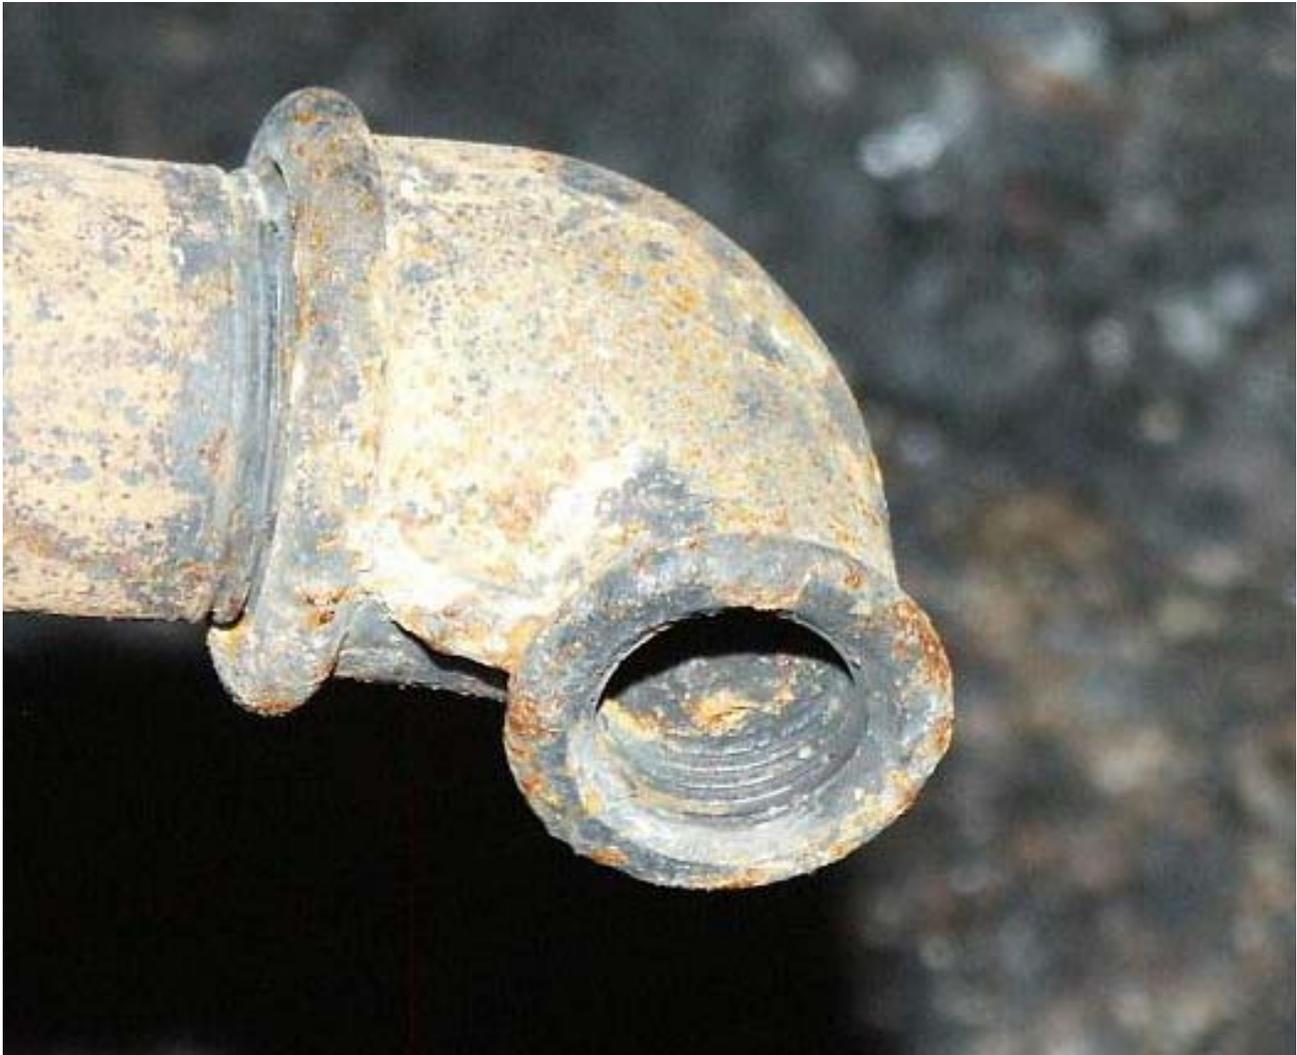
## **TEMPERATURES**

The disappearance of the sprinkler from the fittings indicates temperature exceeding 900<sup>0</sup>C.
