PLENUM FIRE IN A MULTI- TENANTS BUILDING

PRODUCT LIABILITY CASE

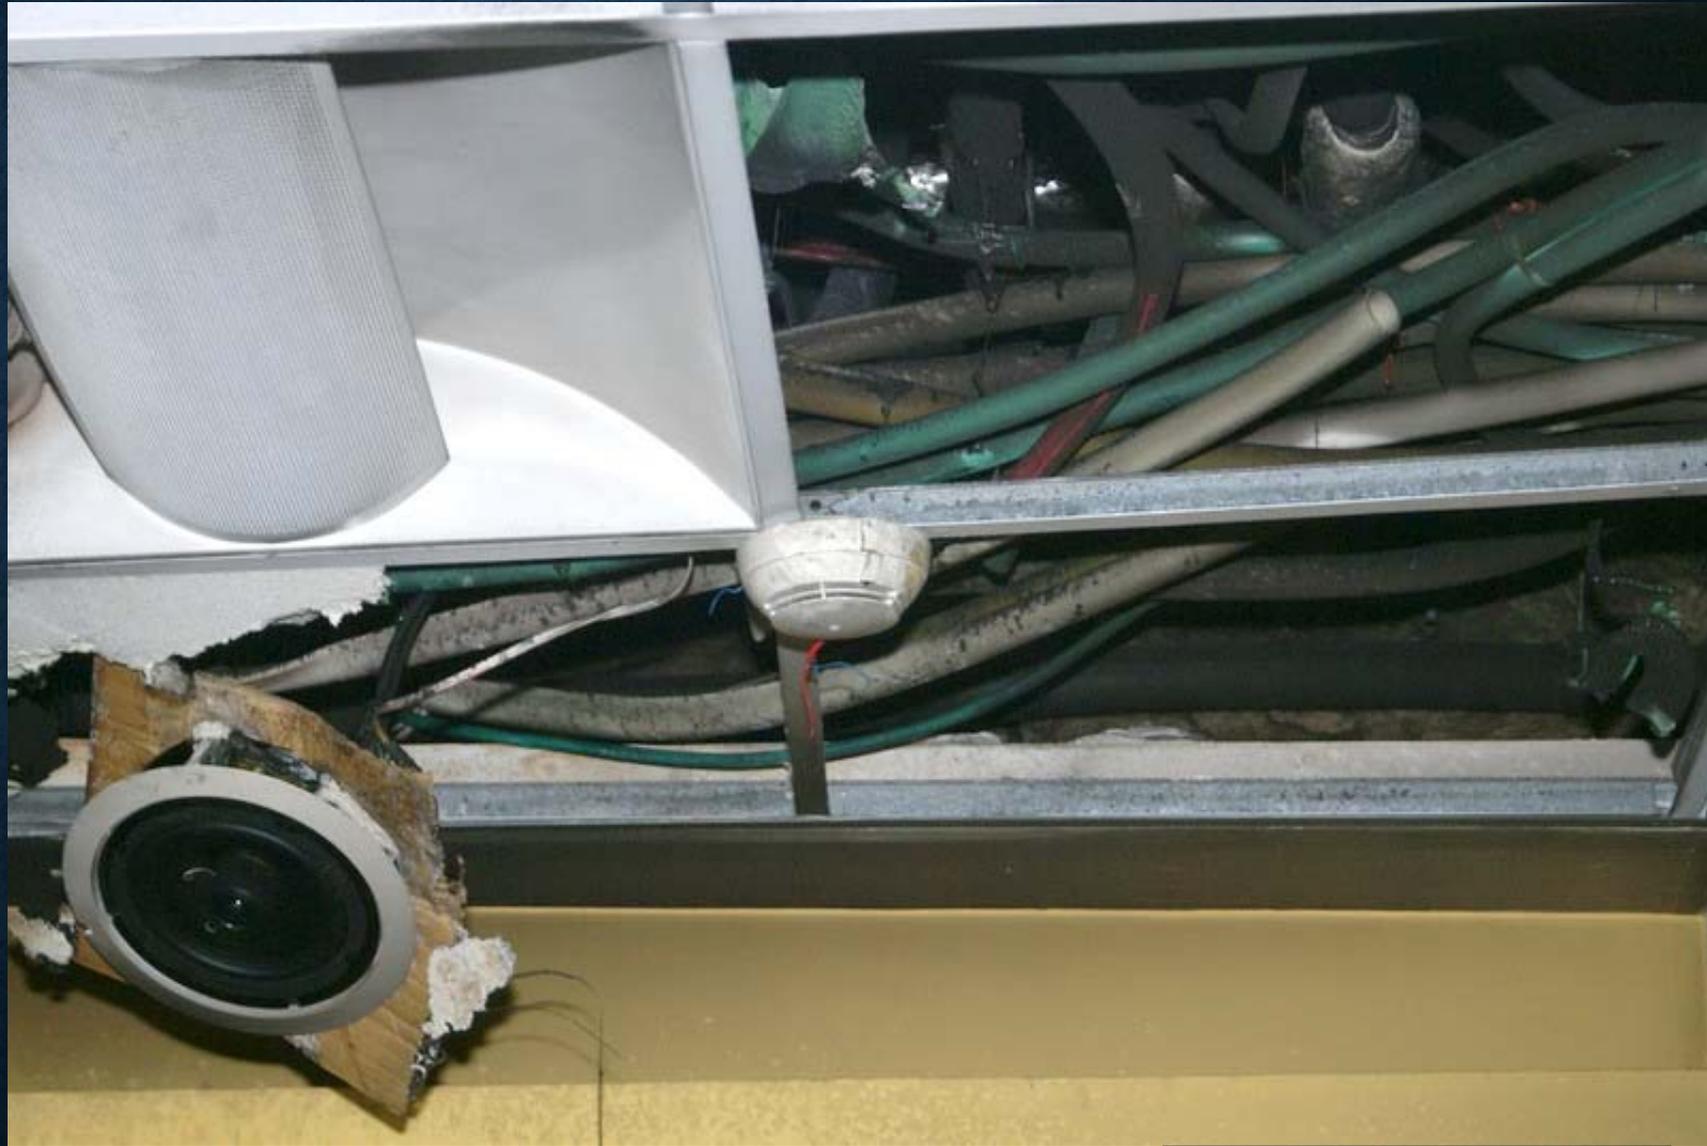
- 1. The installation of the Lighting Fixture by the electrical contractor without a cover that left the electrical devices within, exposed.**
- 2. The mess of electrical cables within the plenum with cables resting right on the Fixture.**

**Mess of
Cables on
the
suspending
ceiling and
lighting
fixtures**

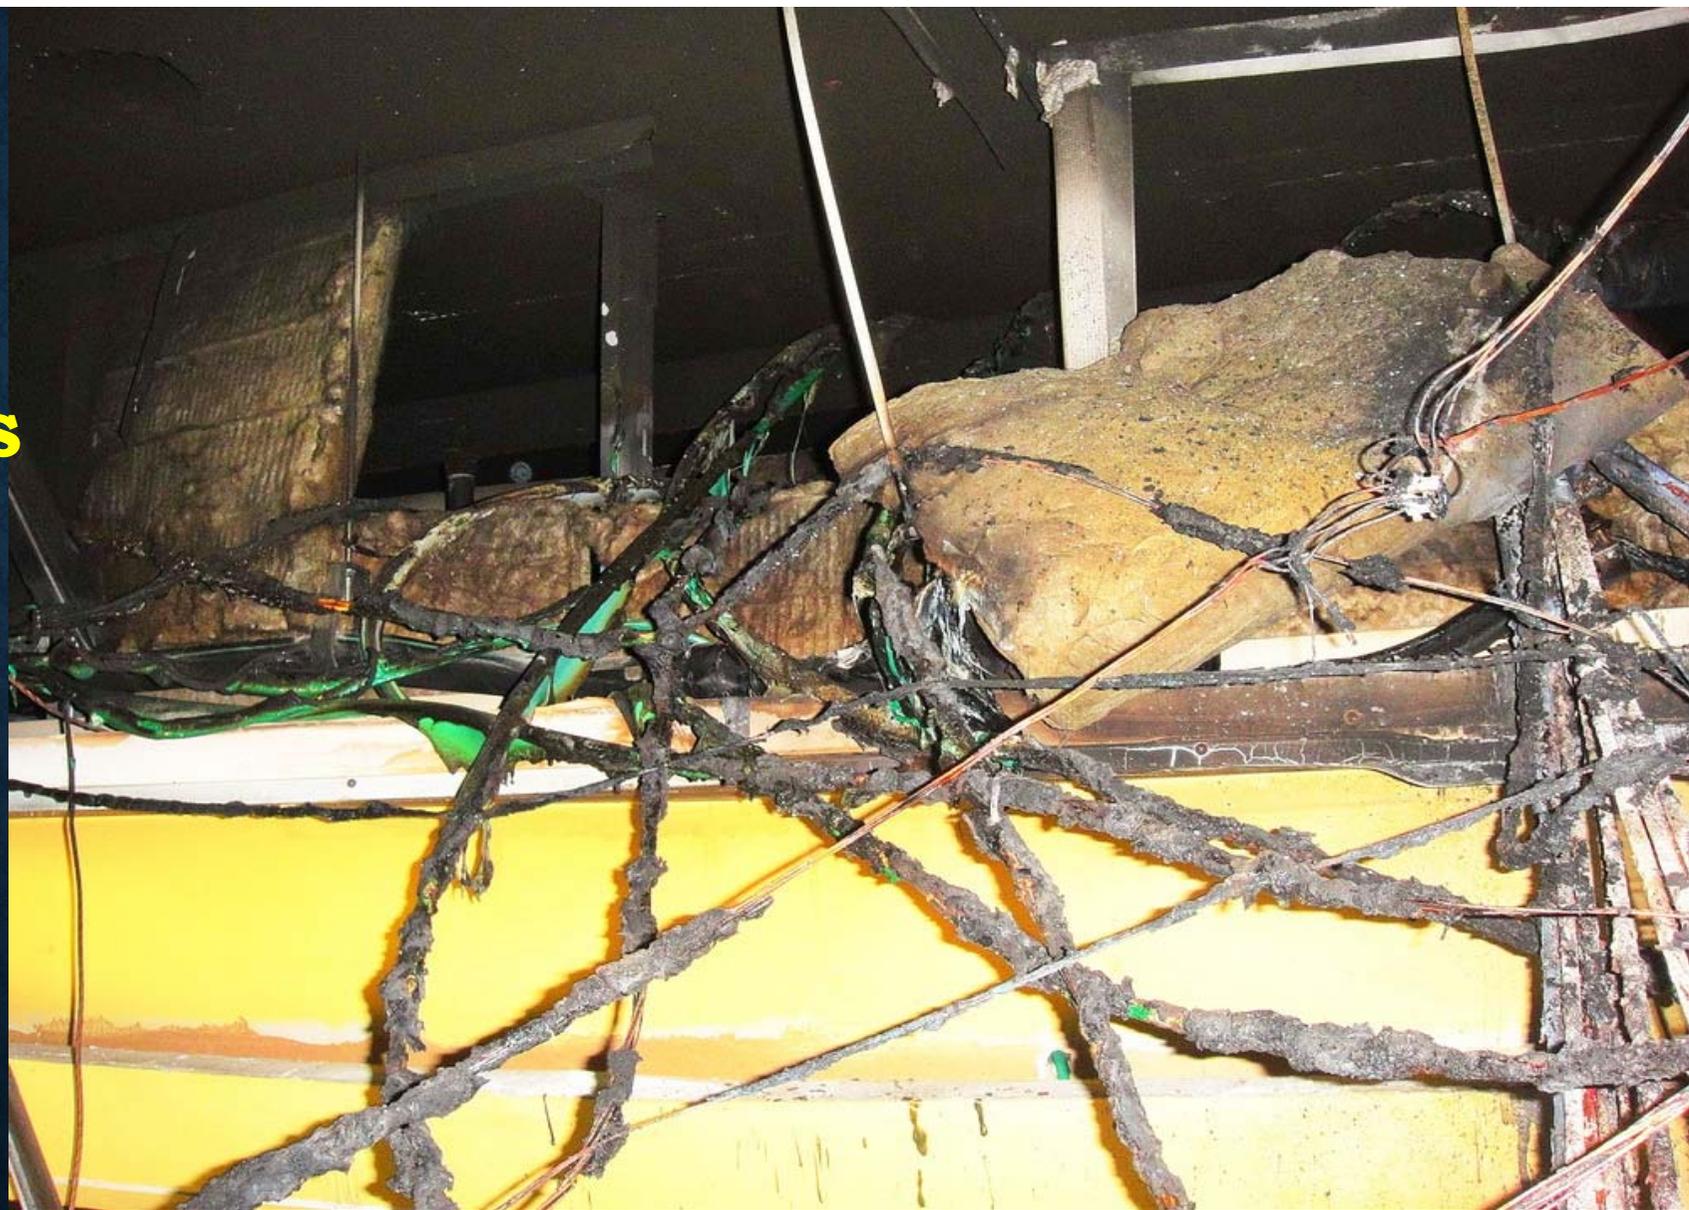
The cables penetrated the so-called “fire partitions” in an “unorganized manner”. Thus they could not be defined as “Fire Partitions”

**Failed Fire
Partitions,
flimsy cable
penetrations**

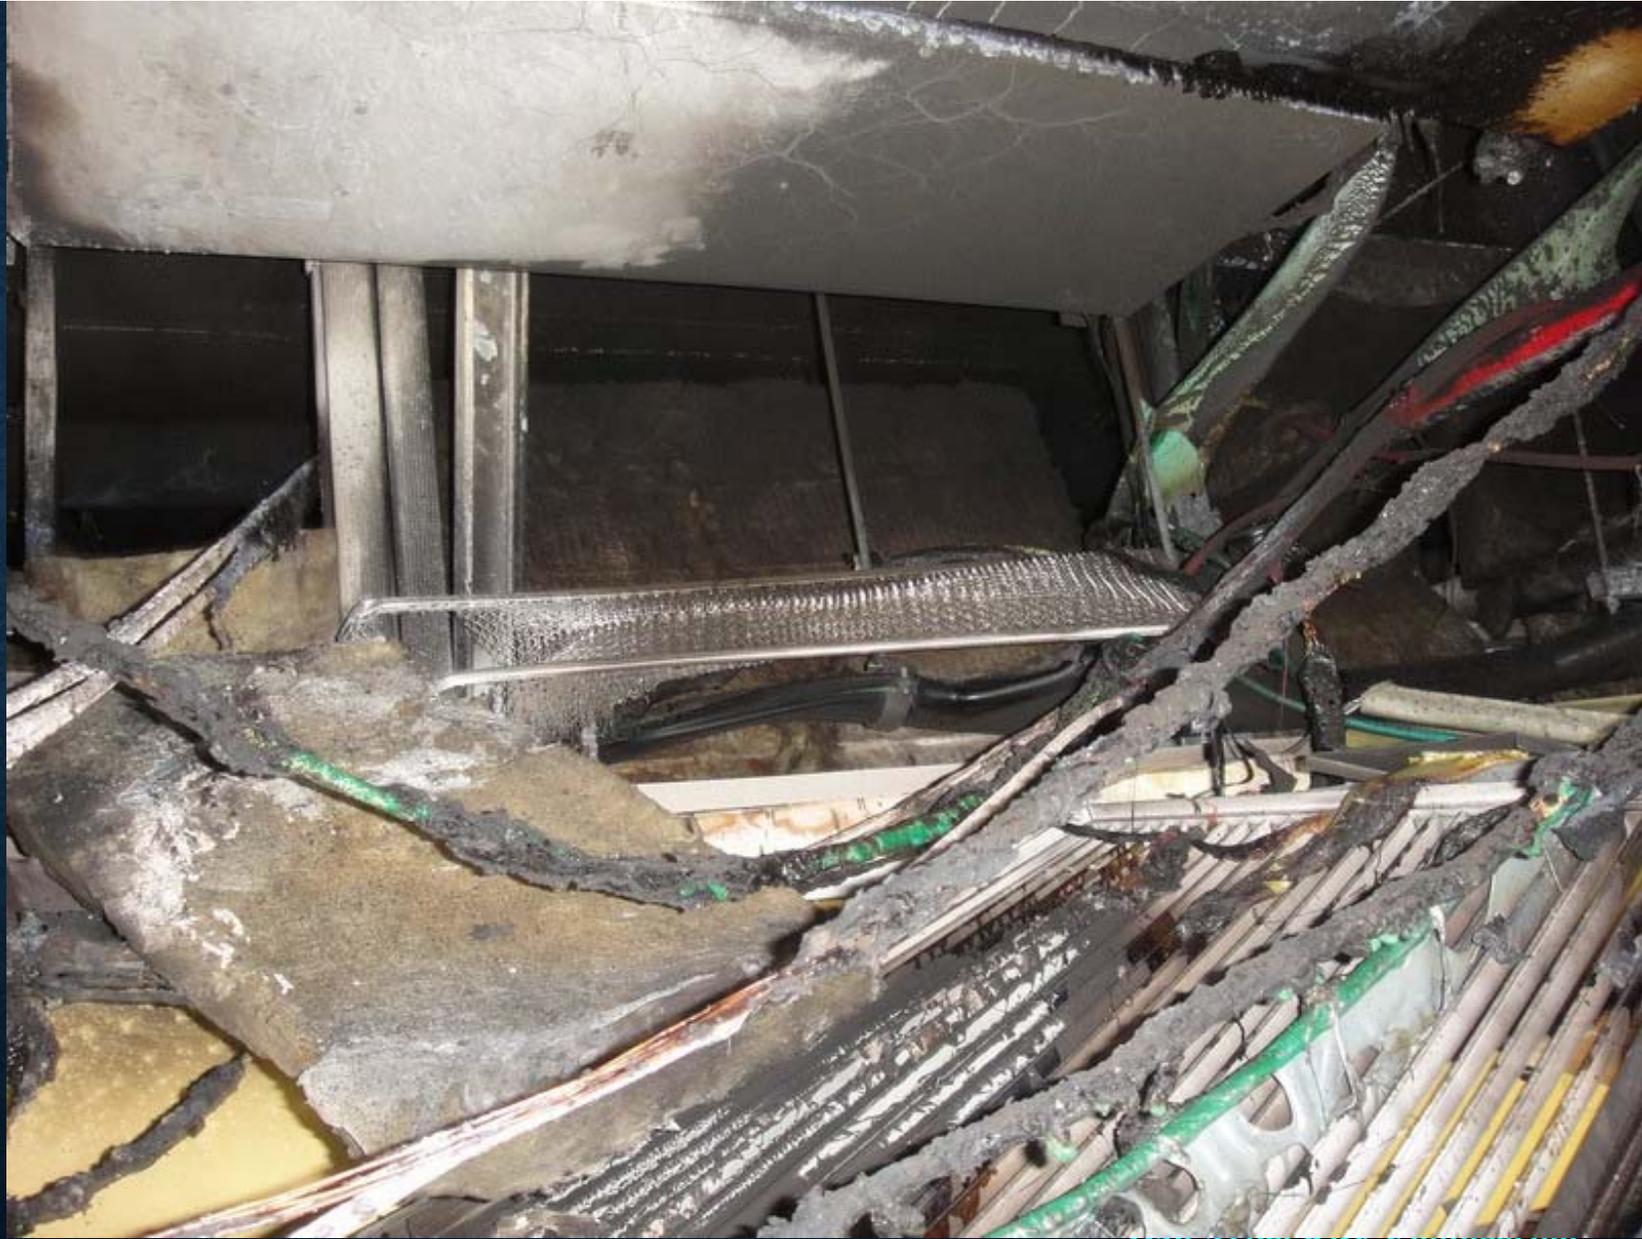
Cables on top of the suspended ceiling and failed fire partition between the room and the lobby

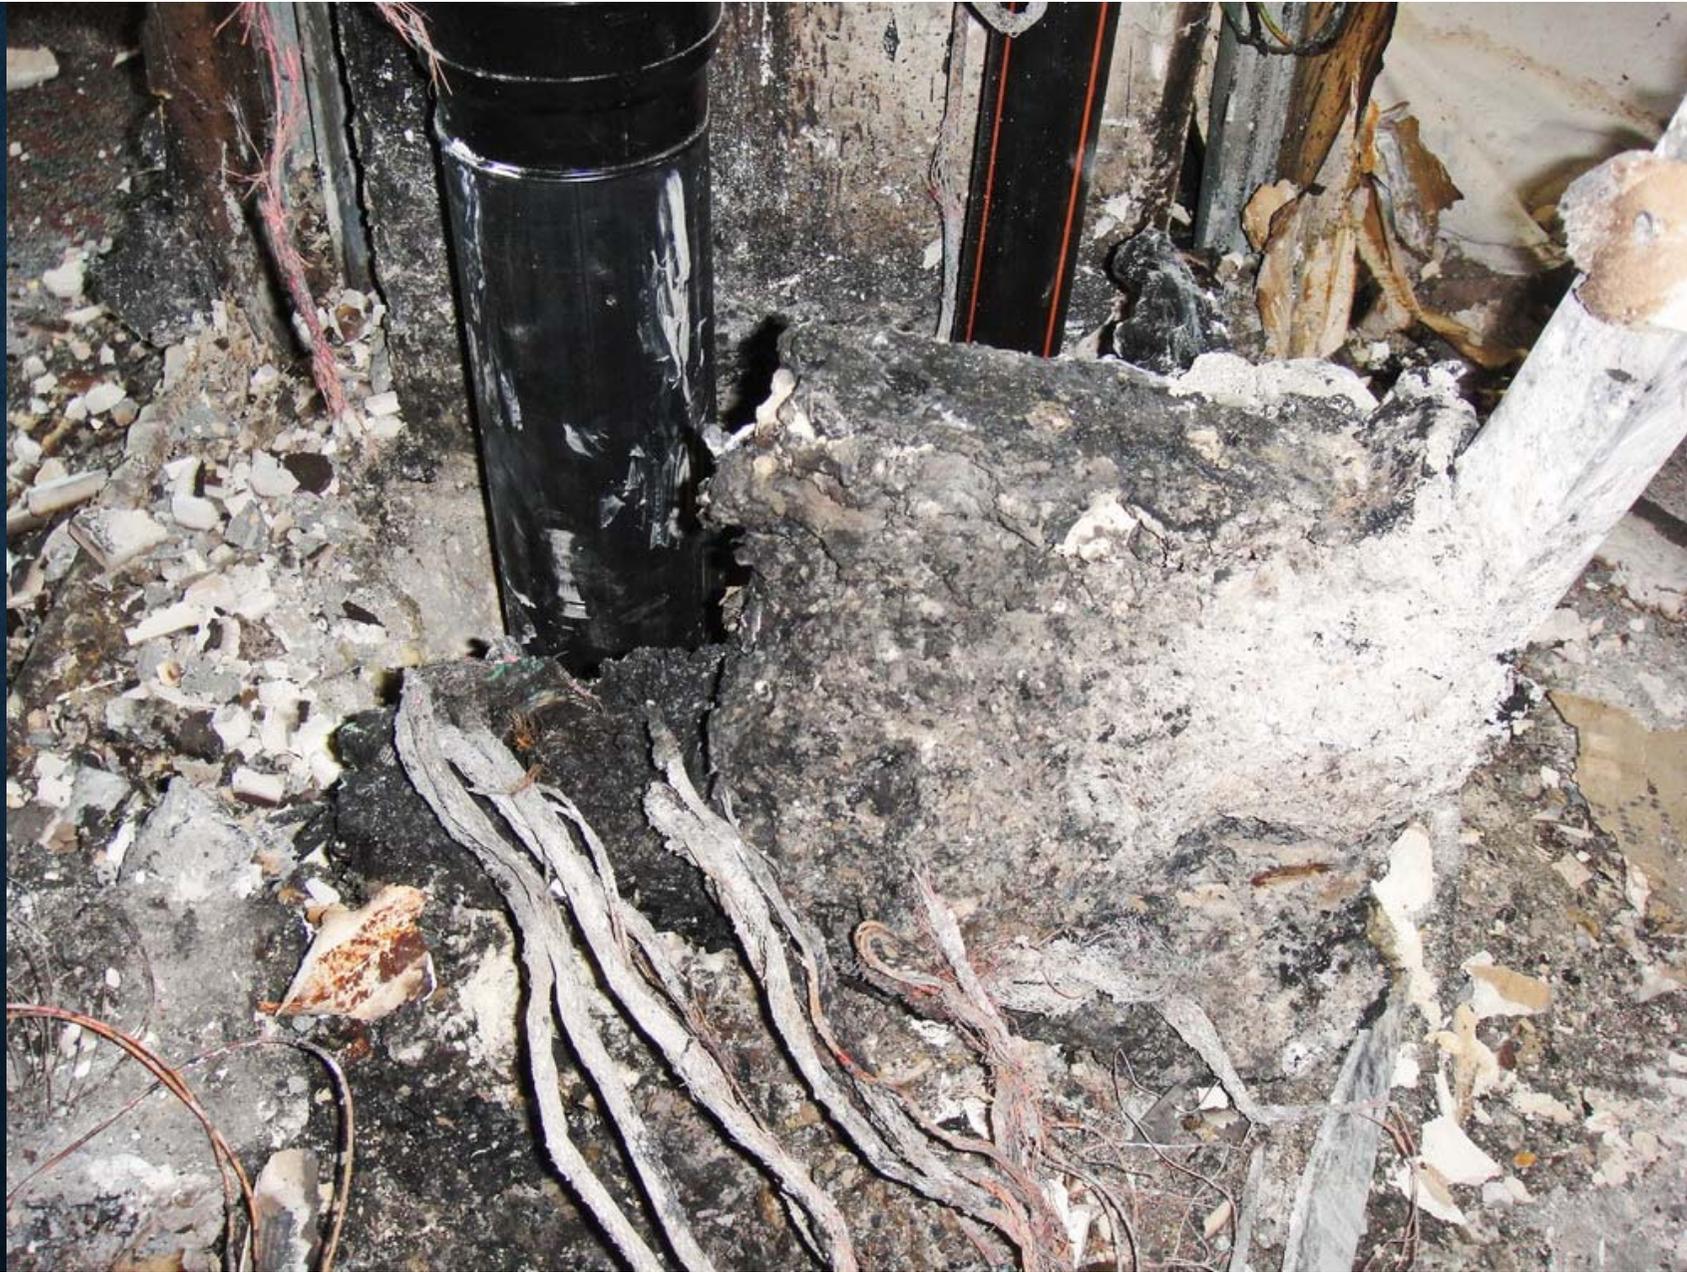
Passing through the room was a vertical shaft containing electrical cables and plastic drainage piping.

The shaft was constructed with gypsum boards that failed allowing fire fighting water flooding the floors below through a floor barrier that was not water sealed.

**Shaft
containing
Burnt
Cable and
newly
installed
plastic
drainage
pipes
replacing
the burnt
ones.**

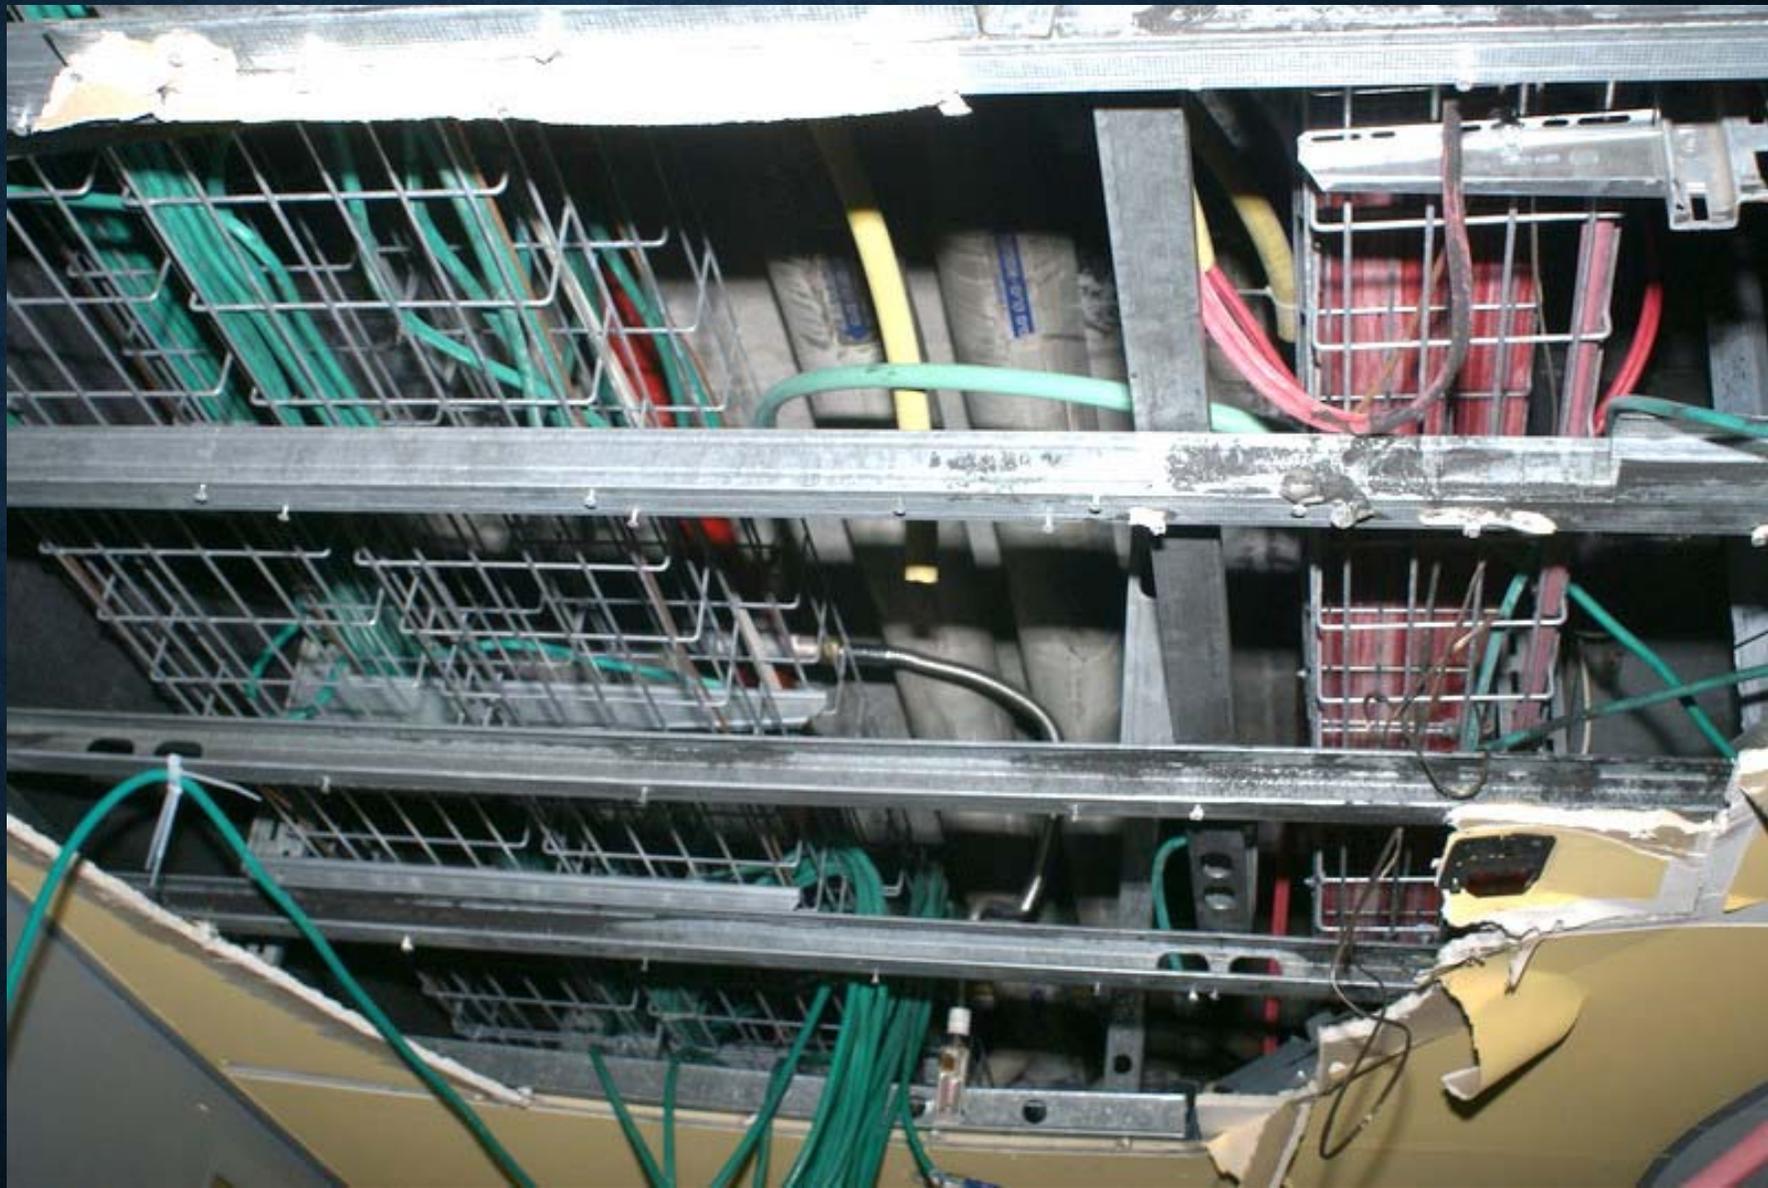
**Organized
Cables on
Trays in
the
Corridor
/ Lobby
side**

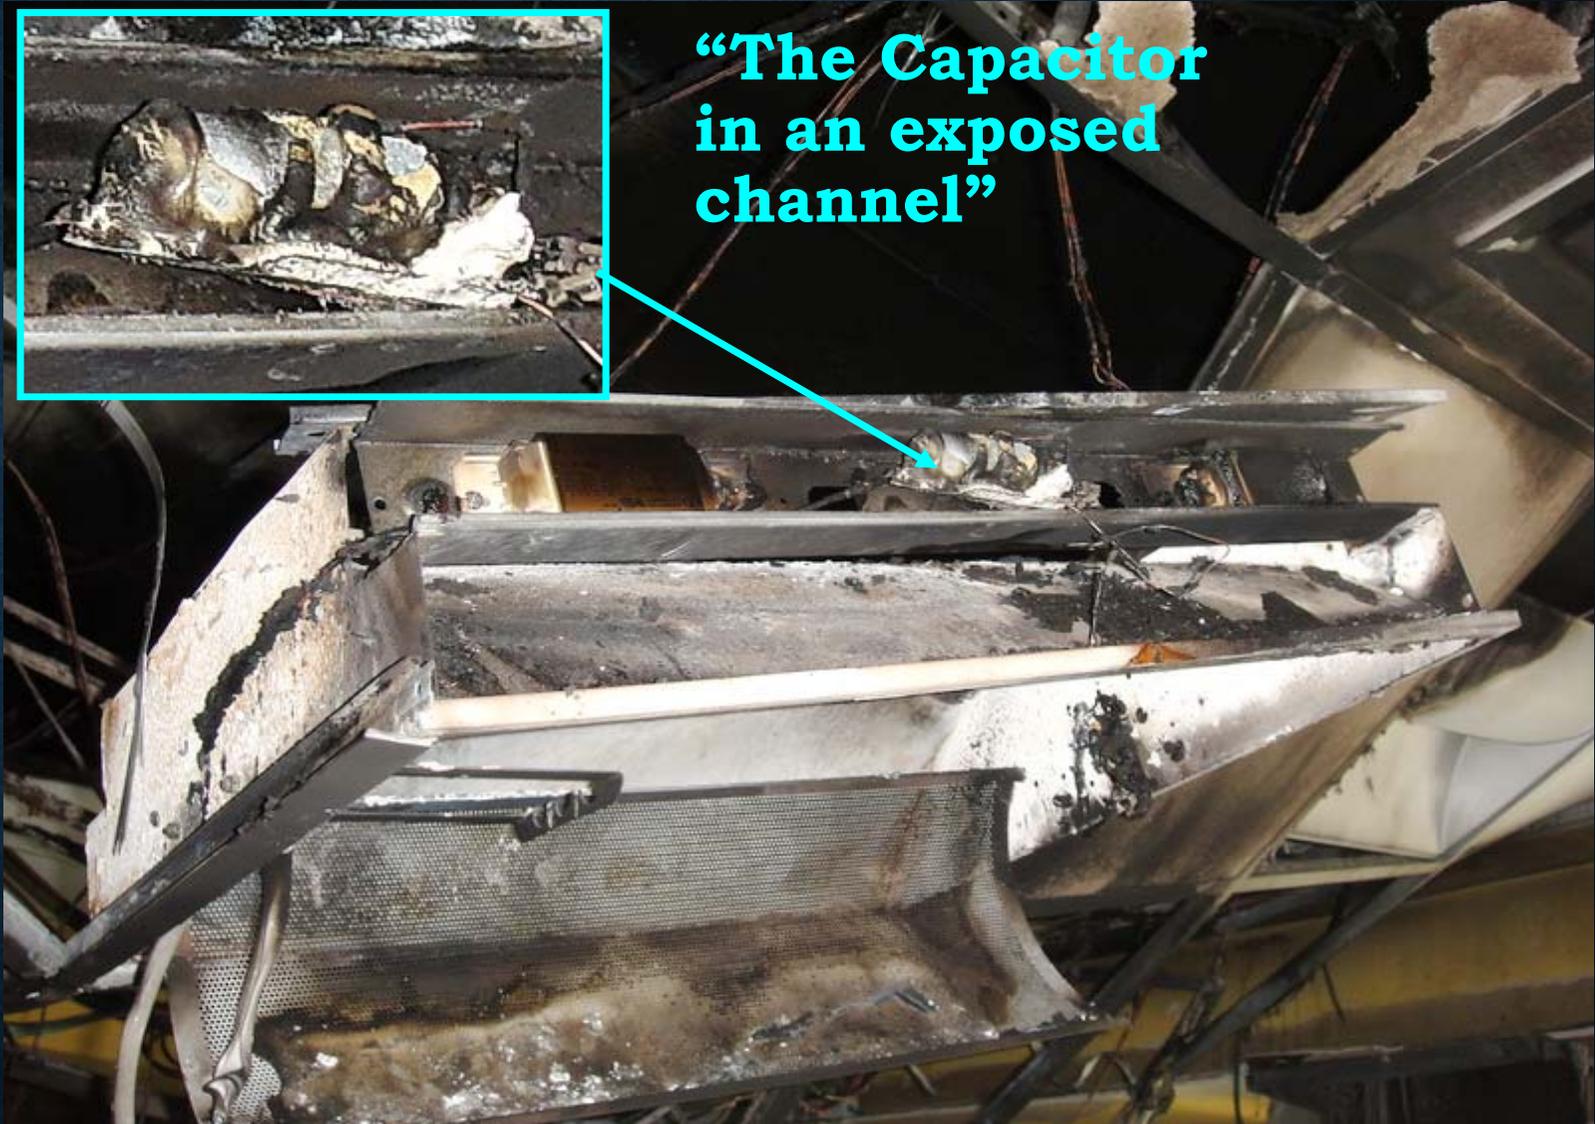
**A lighting
Fixture
next to the
one
designated
as the
“fire
origin”**

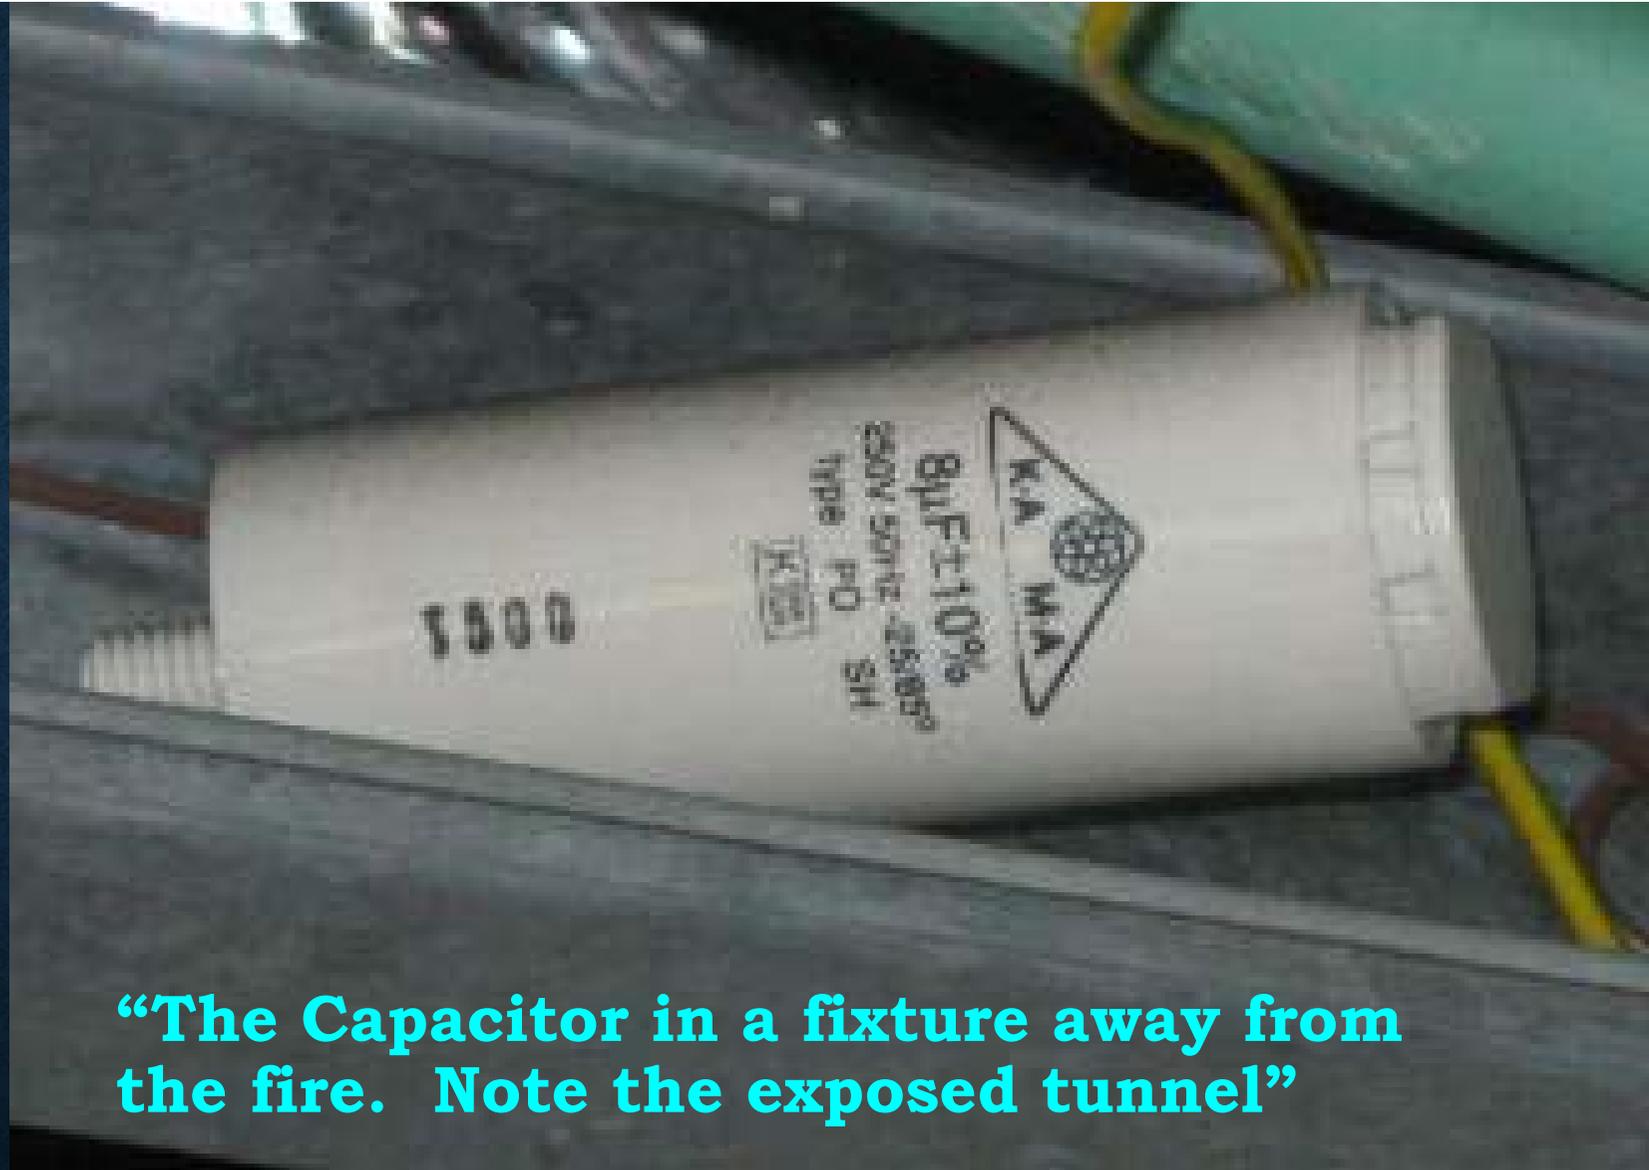
**“The Capacitor
in an exposed
channel”**

**Exposed,
uncovered
equipment
tunnel**

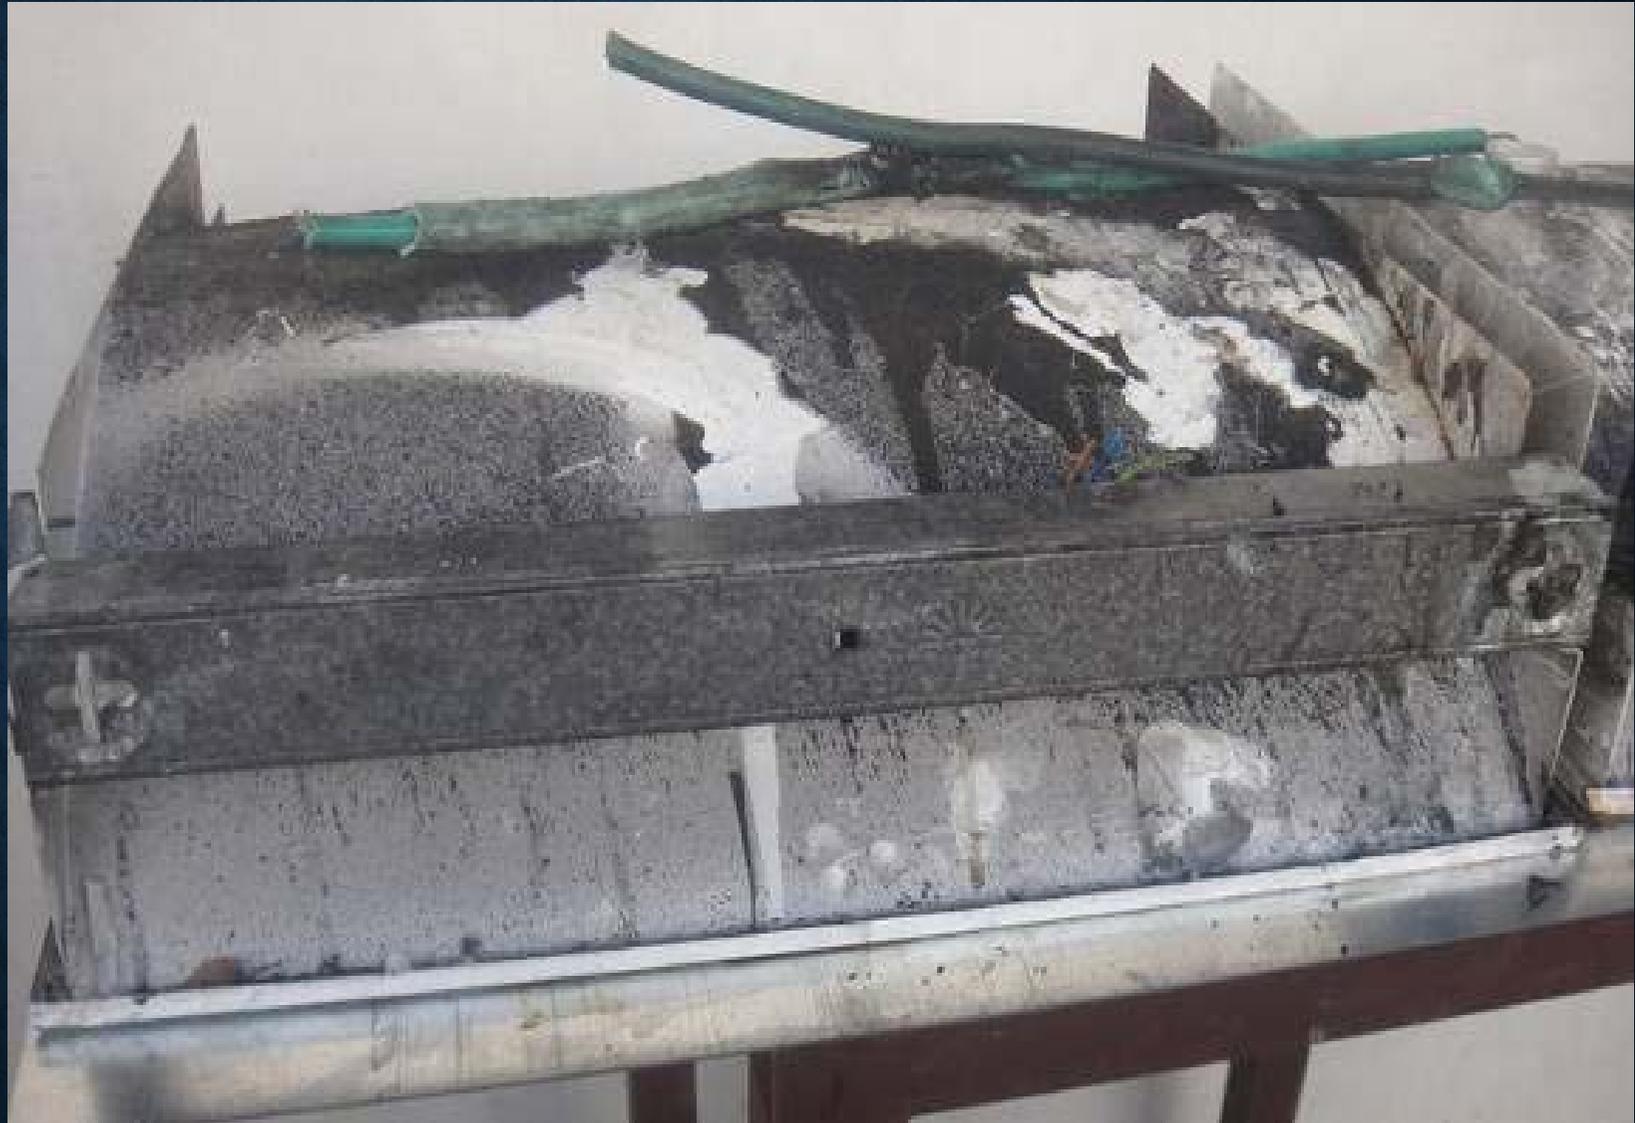
**“The Capacitor in a fixture away from
the fire. Note the exposed tunnel”**

**A fixture
from the
site with
the
equipment
tunnel
with a
closed
cover as
supplied
by the
Mfg.**

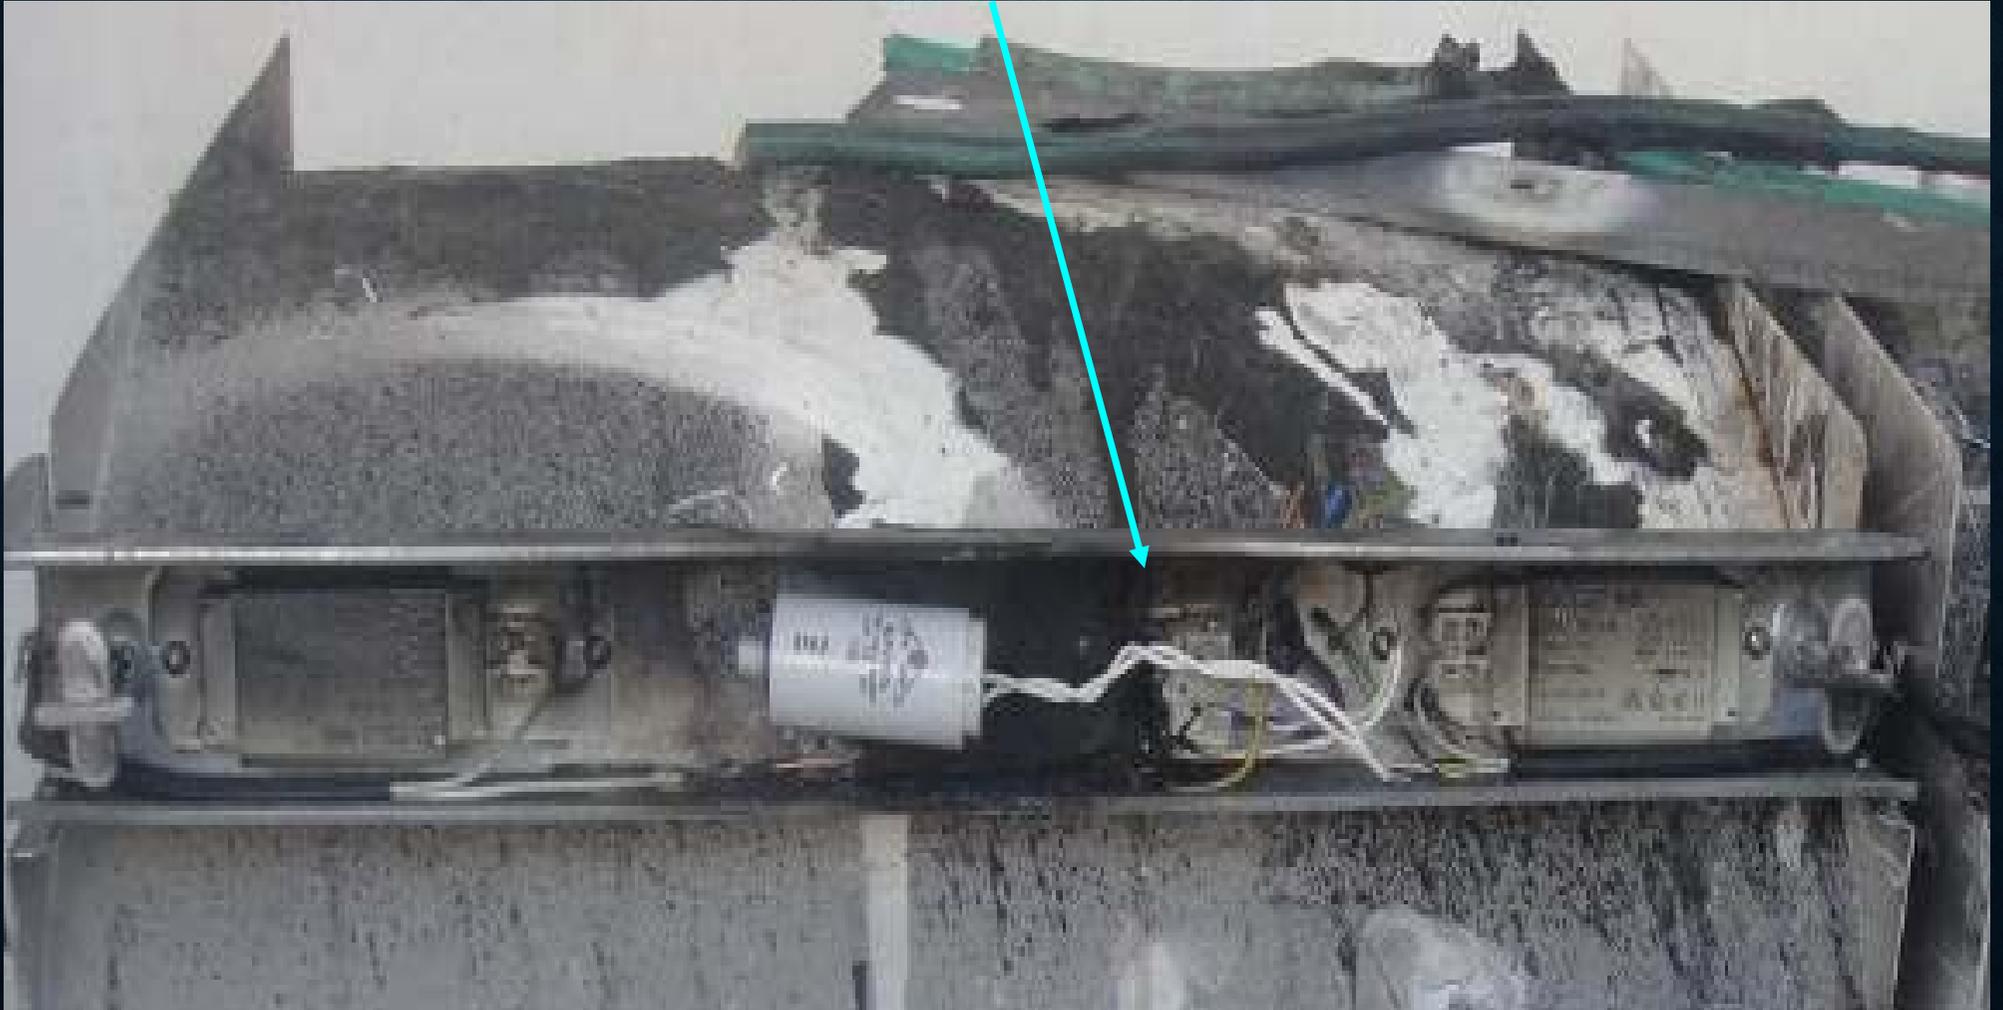
A fixture from the site with equipment tunnel exposed with a cover removed.

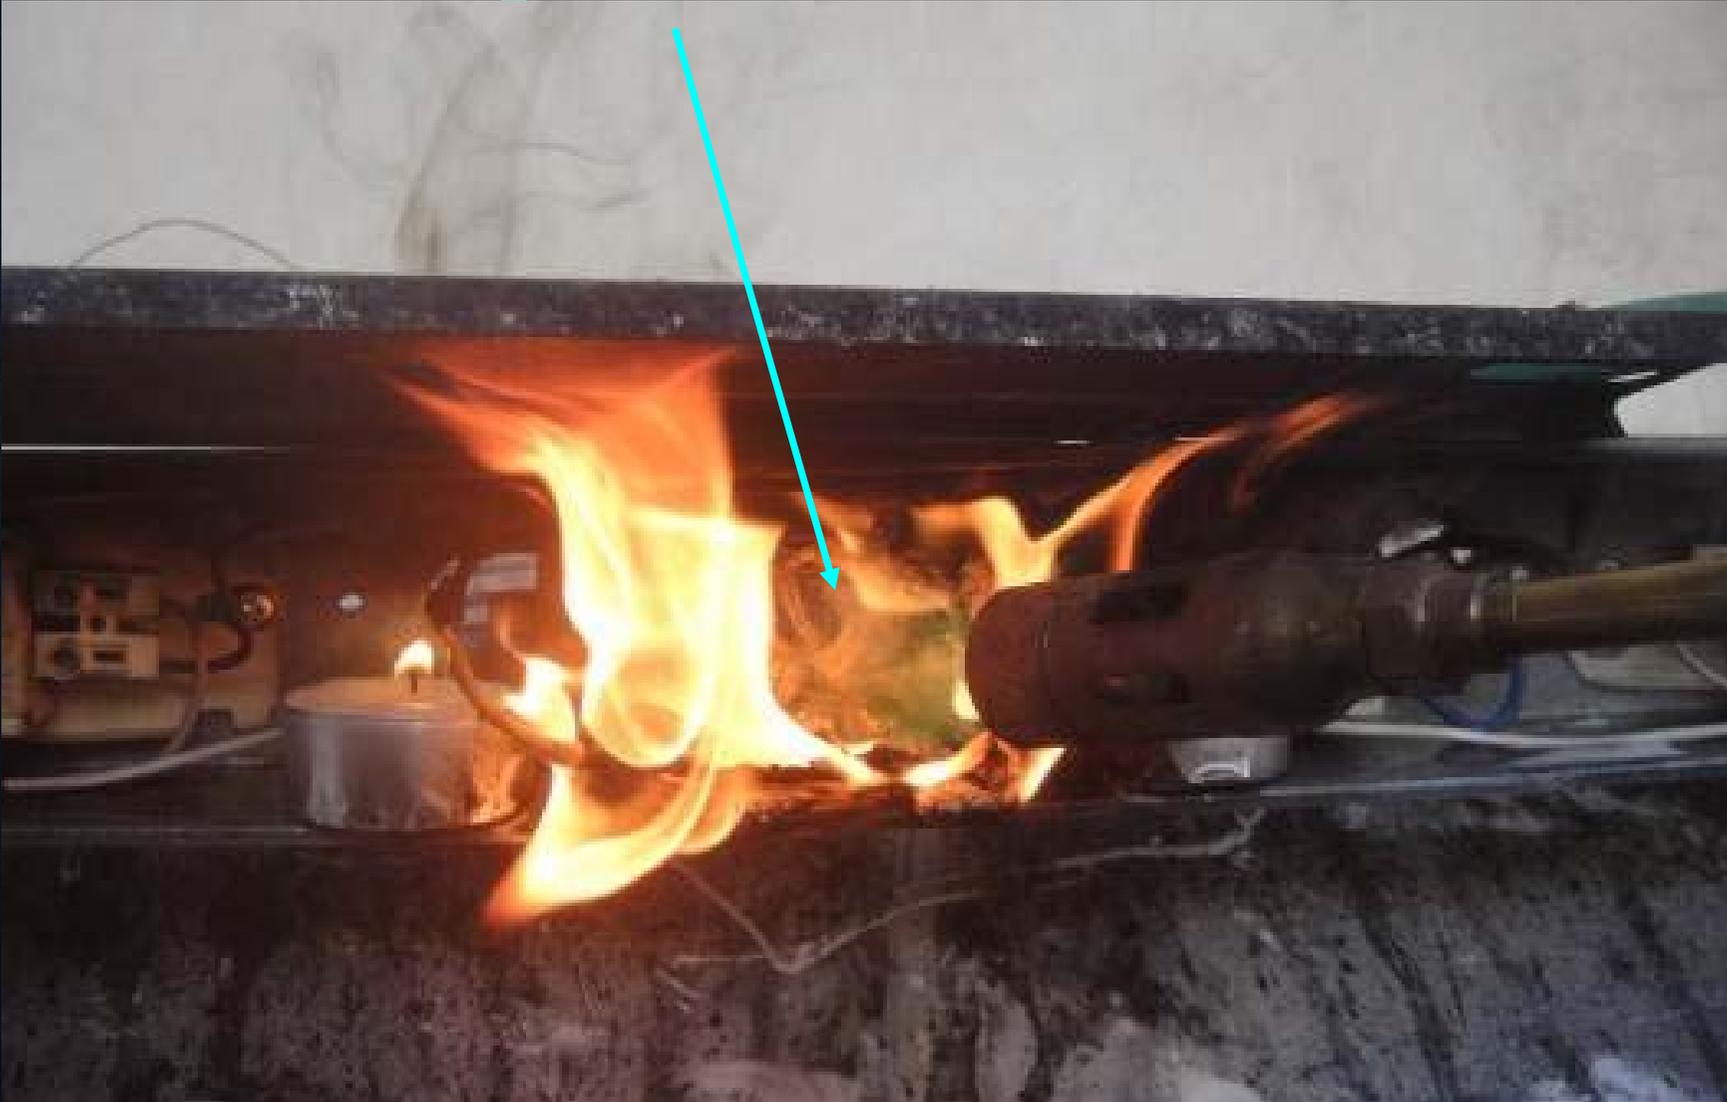
We Burn the capacitor to research the effect.

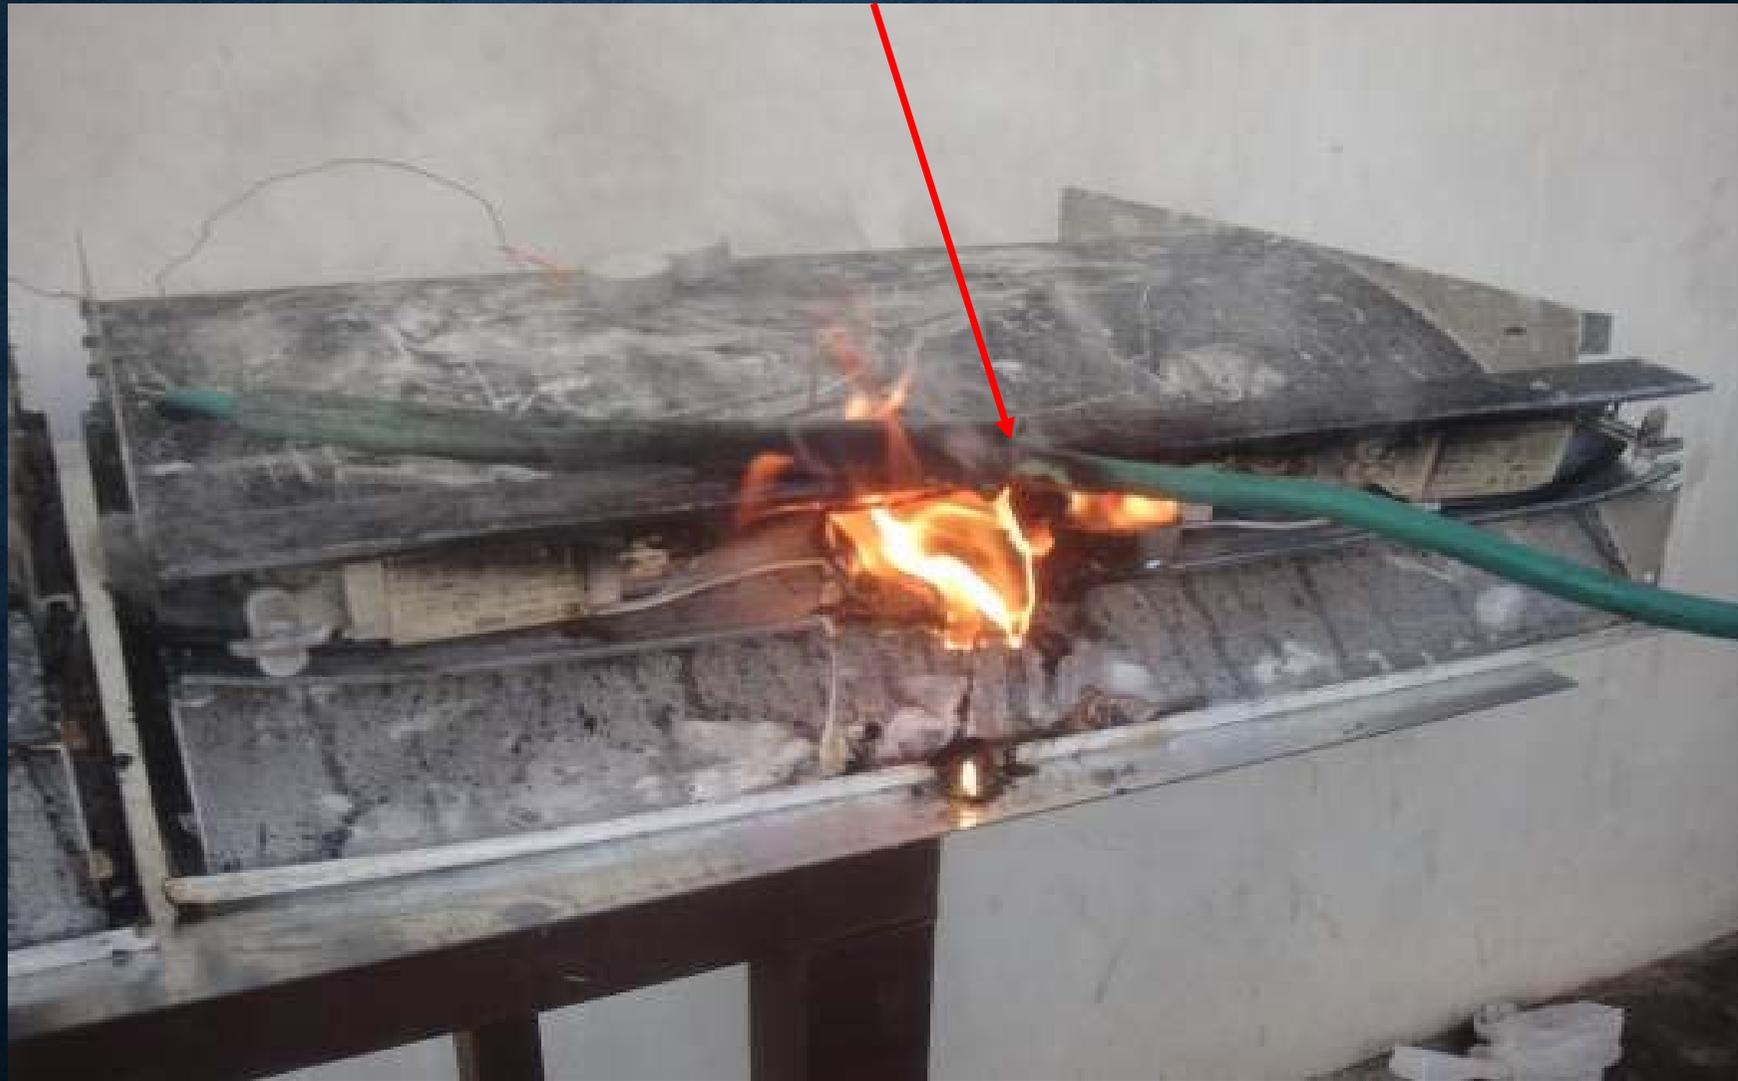
**No cover.
The cable
catch fire
if is
directly
exposed
to the
capacitor
flames.**

The Capacitor is burning
