PLENUM FIRE IN A MULTI- TENANTS BUILDING

PRODUCT LIABILITY CASE

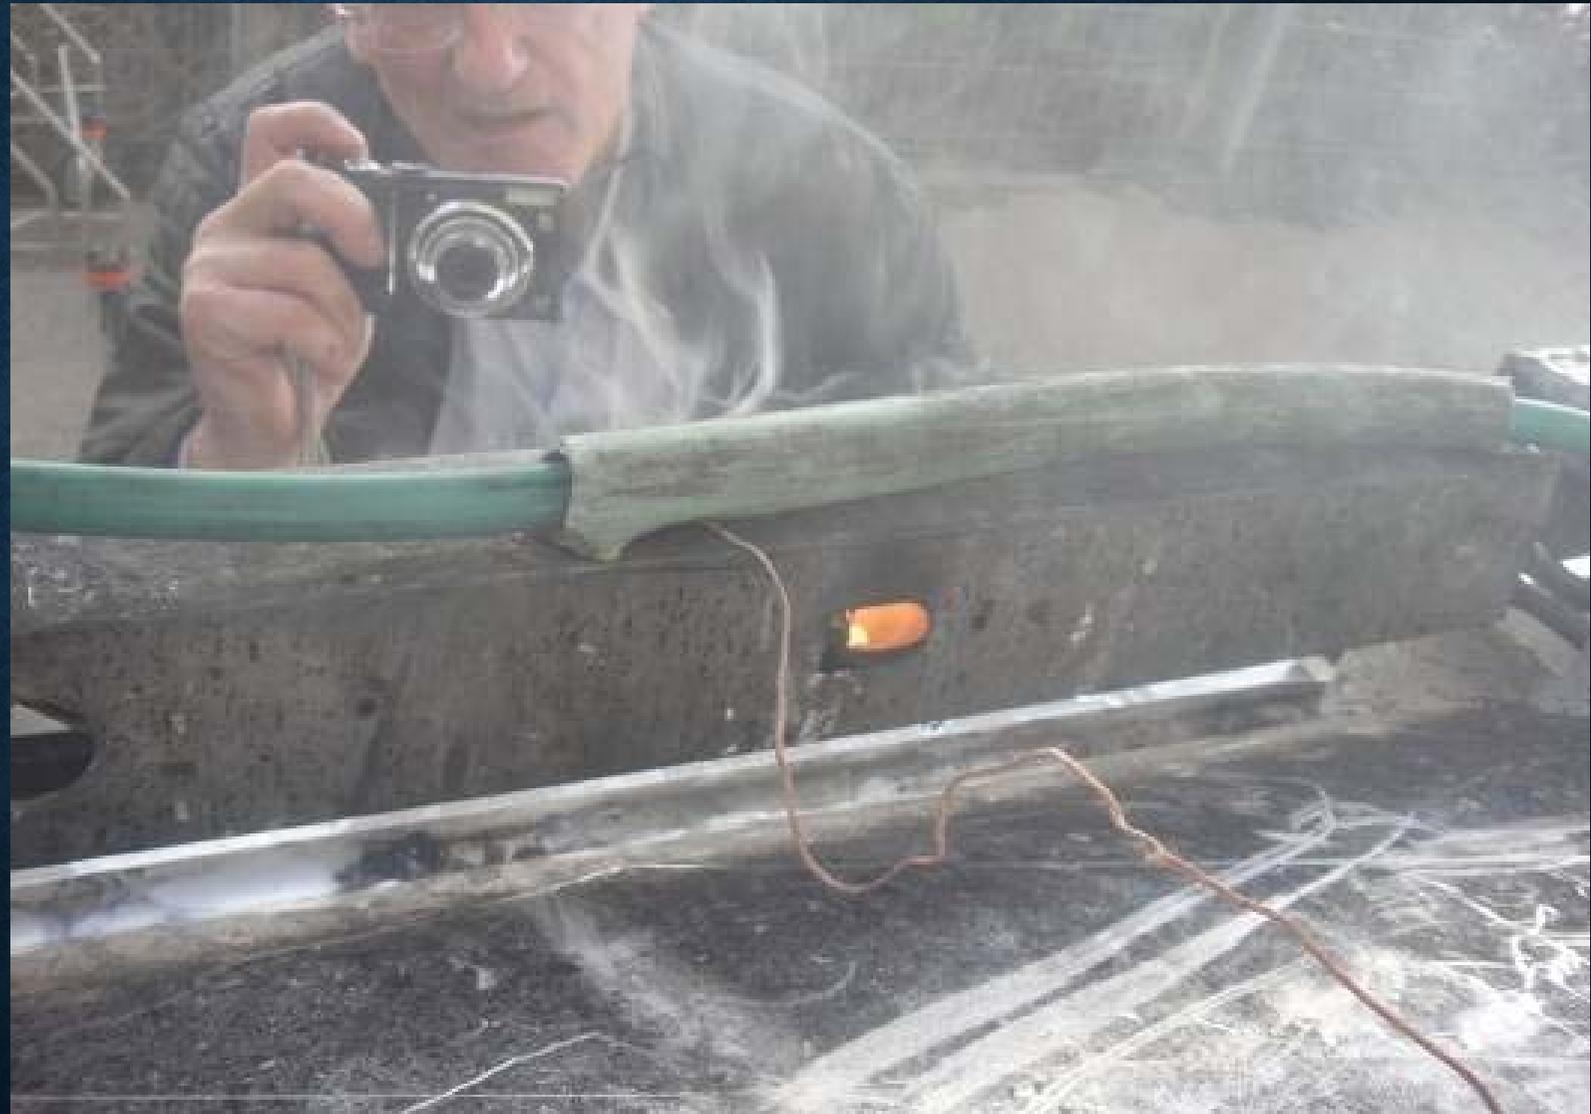
The Capacitor is burning inside

With a cover.
The cable cannot catch fire.
Not enough air within the tunnel
