דן ארבל הנדסת סיכונים ושמאות בע"מ

חקירת אירוע התפוצצות 13/10/2003

Date: 24/10/03
Ref.: PVC - Loss 2003

Explosion and Fire – 13-Oct-2003 Insurance Claim

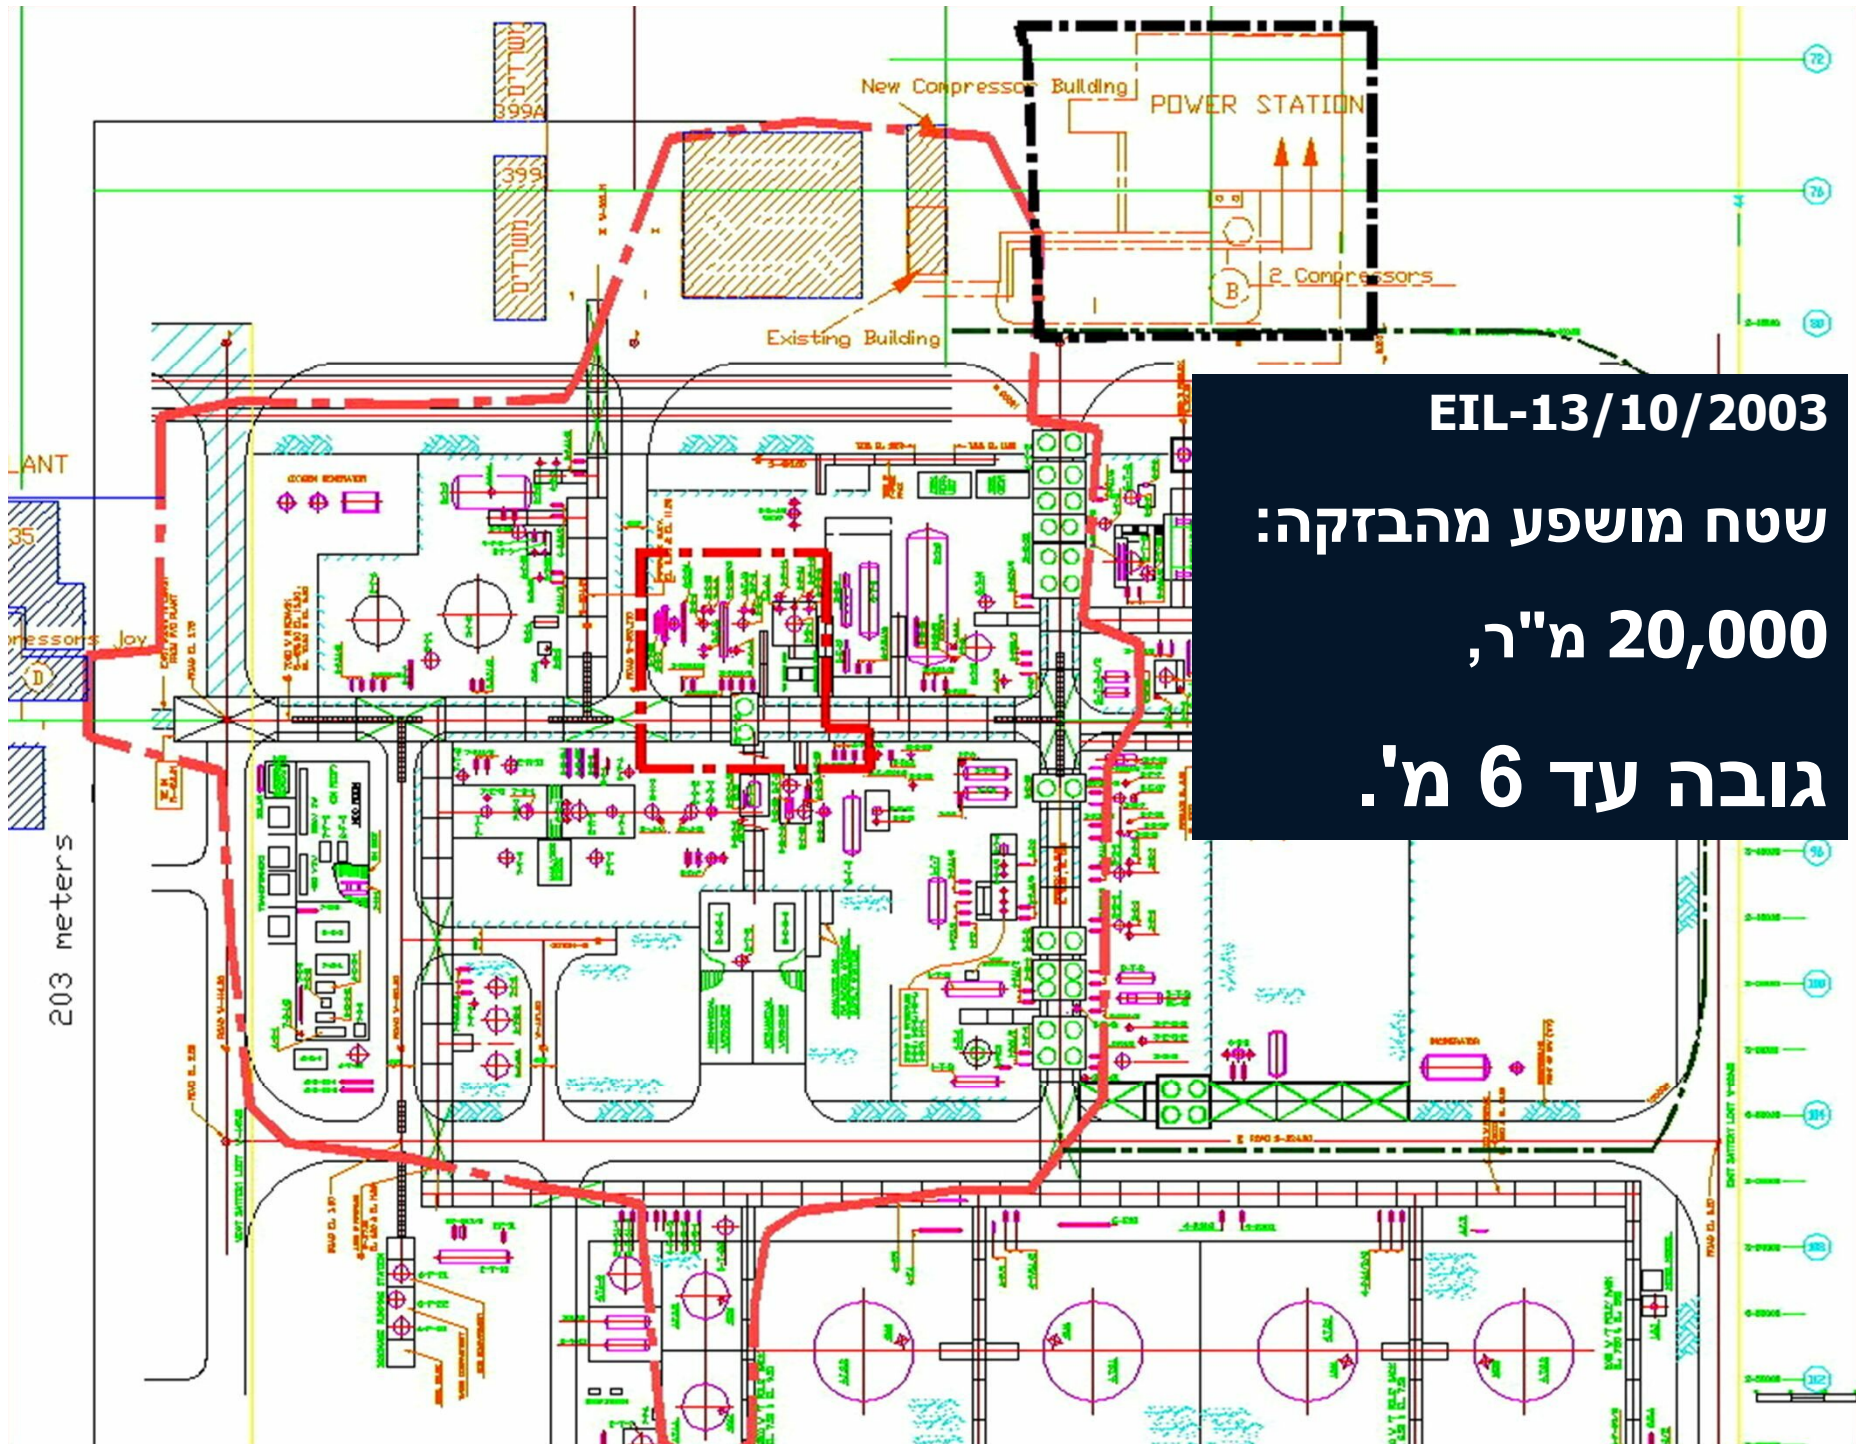
EIL-13/10/2003
שטח מושפע מהבזקה:
20,000 מ"ר,
גובה עד 6 מ'.

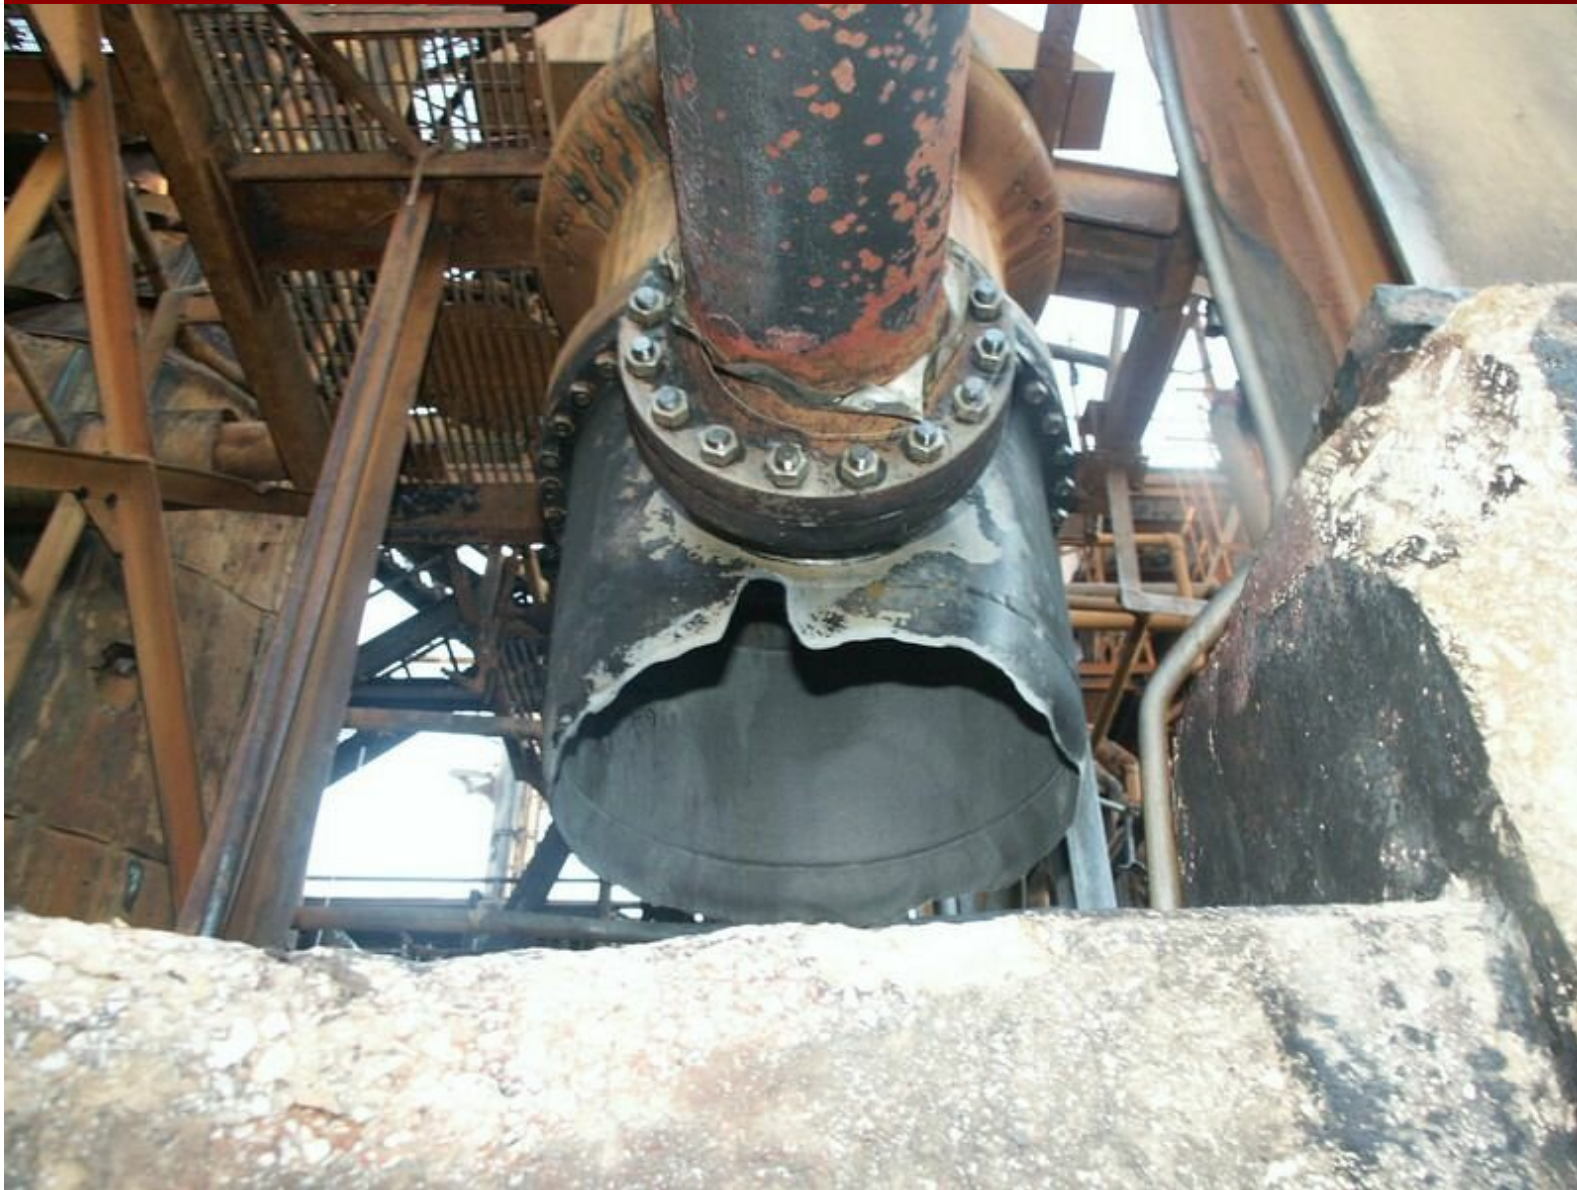
המיכל הזה
התפוצץ.

תחתיתו
נפרדה, חבטה
בקונסטרוקציה
והגיעה בסוף
לקרקע.

בעת האירוע
המיכל היה
פתוח
למערכת, אבל
לא בפעולה.

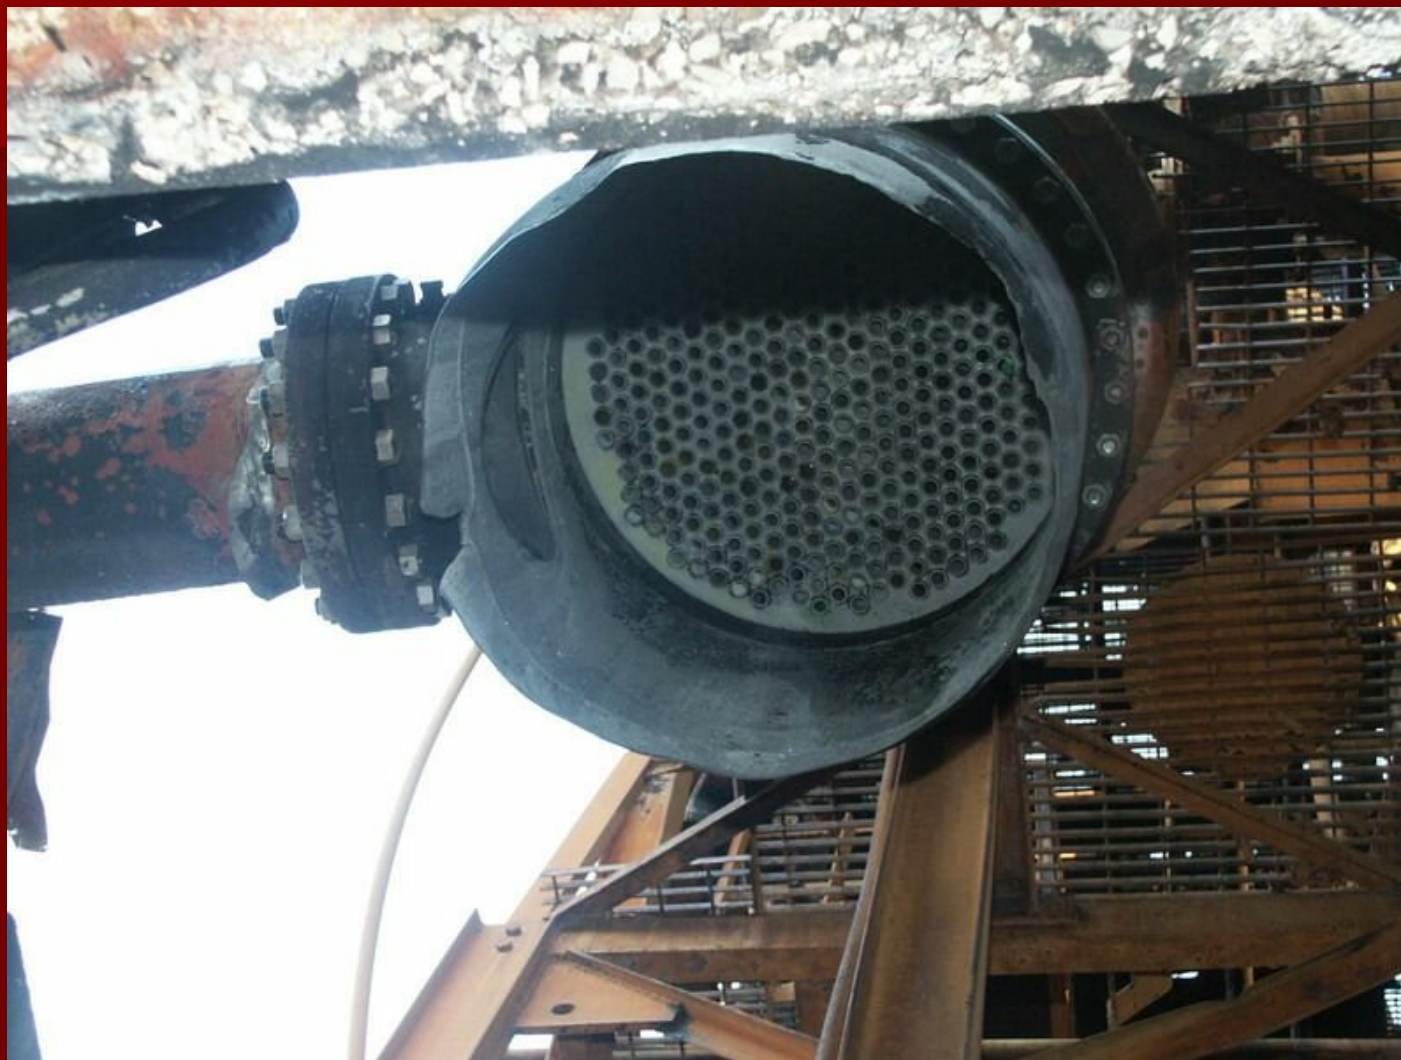
**המיכל
שהתפוצץ.**

**זה מחליף חום
כאשר הגזים
בתחתית
עוברים מלמטה
למעלה דרך
הצינורות, כאשר
קיטור מועבר
במעטפת. בעת
האירוע הזנת
הקיטור הייתה
מנותקת**

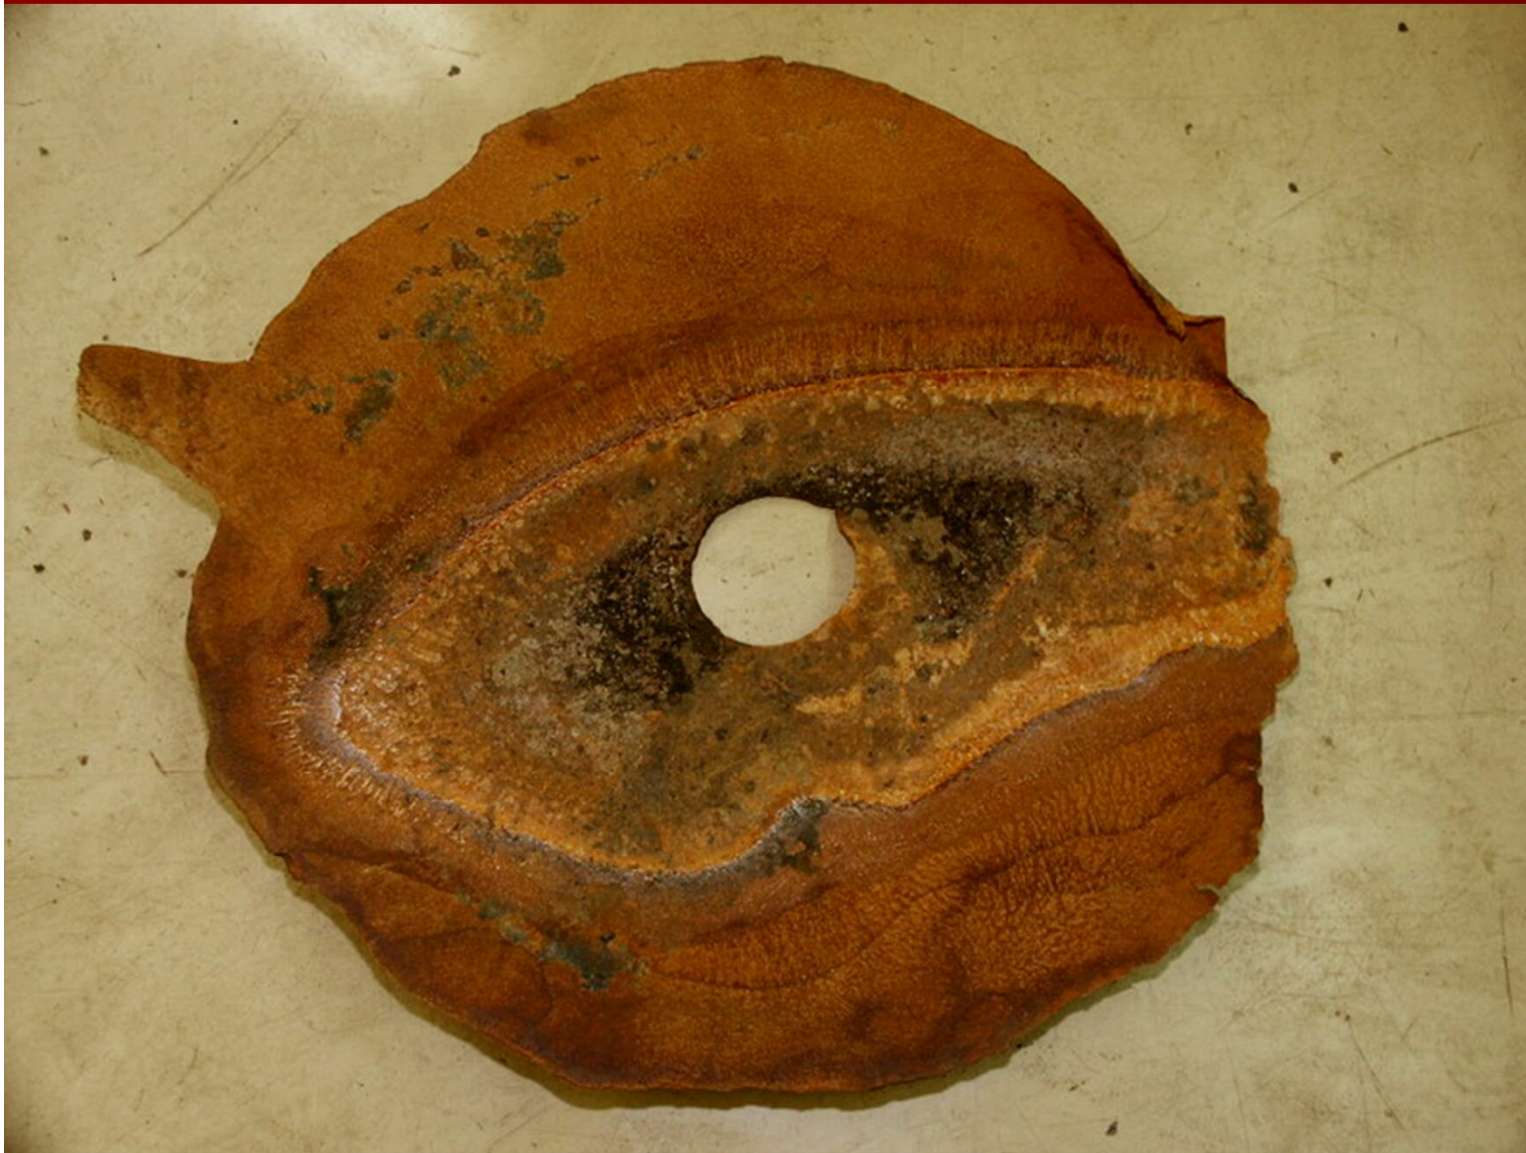
התחתית
הגיעה
לקרקע.

מה שהייה
חצי כדורי-
נעשה
שטוח
לגמרי על
הקרקע!!

זה נבע
מעוצמת
הפיצוץ

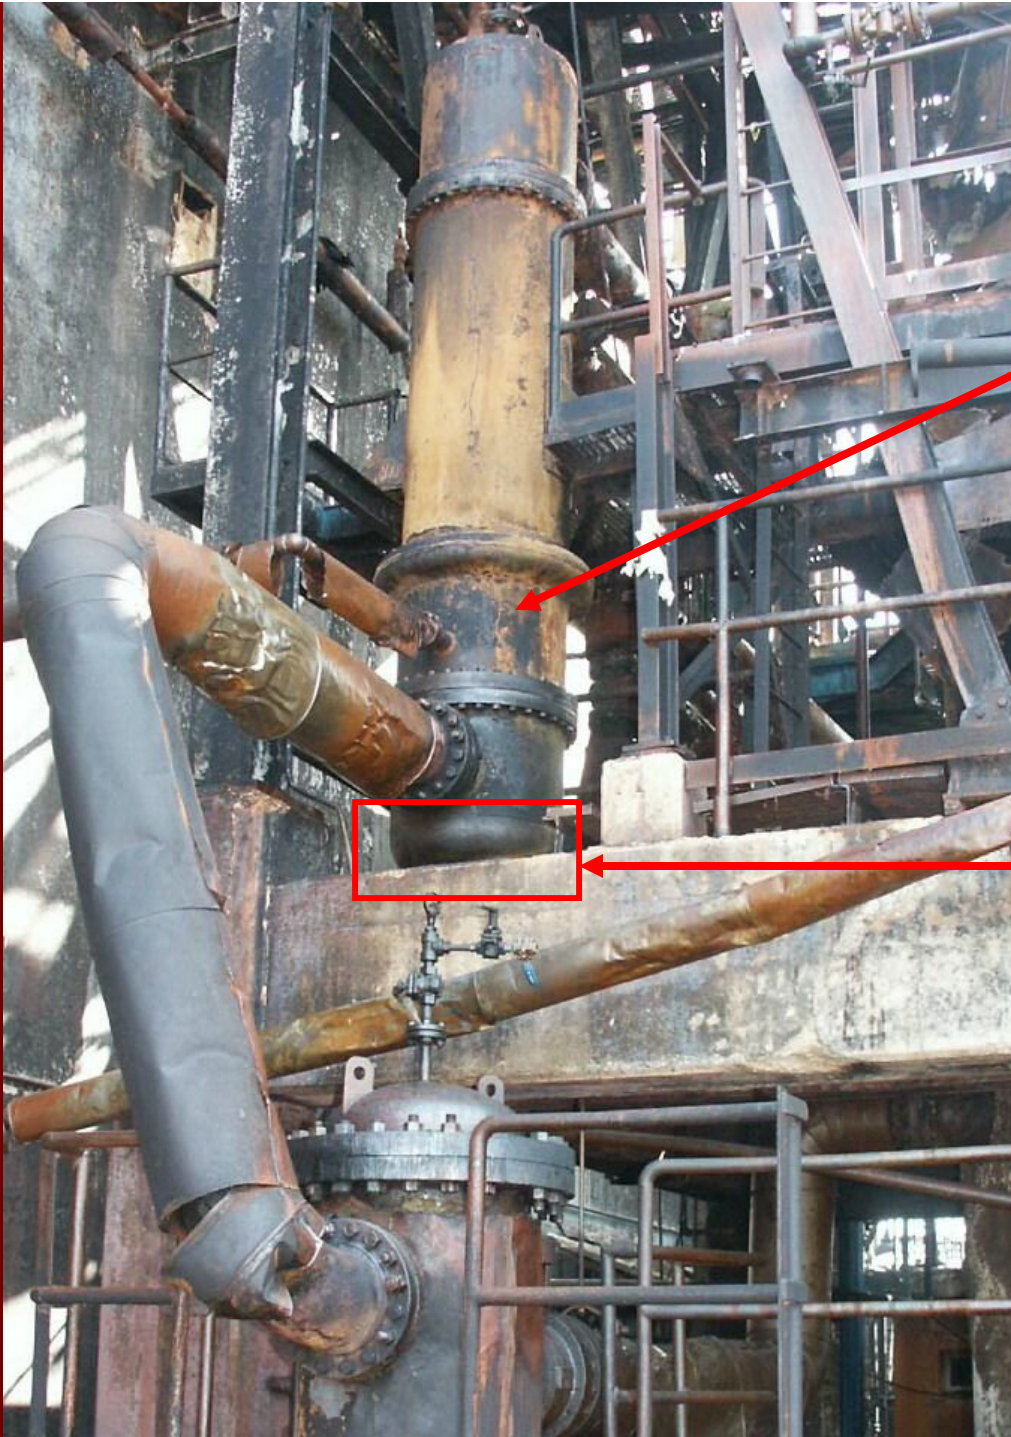
המיכל
התאום לזה
שהתפוצץ,
היה בתהליך
בעת הפיצוץ.

התחתית הזו
הוא הקטע
שנפרד
בהתפוצצות
מהמיכל
המקביל.

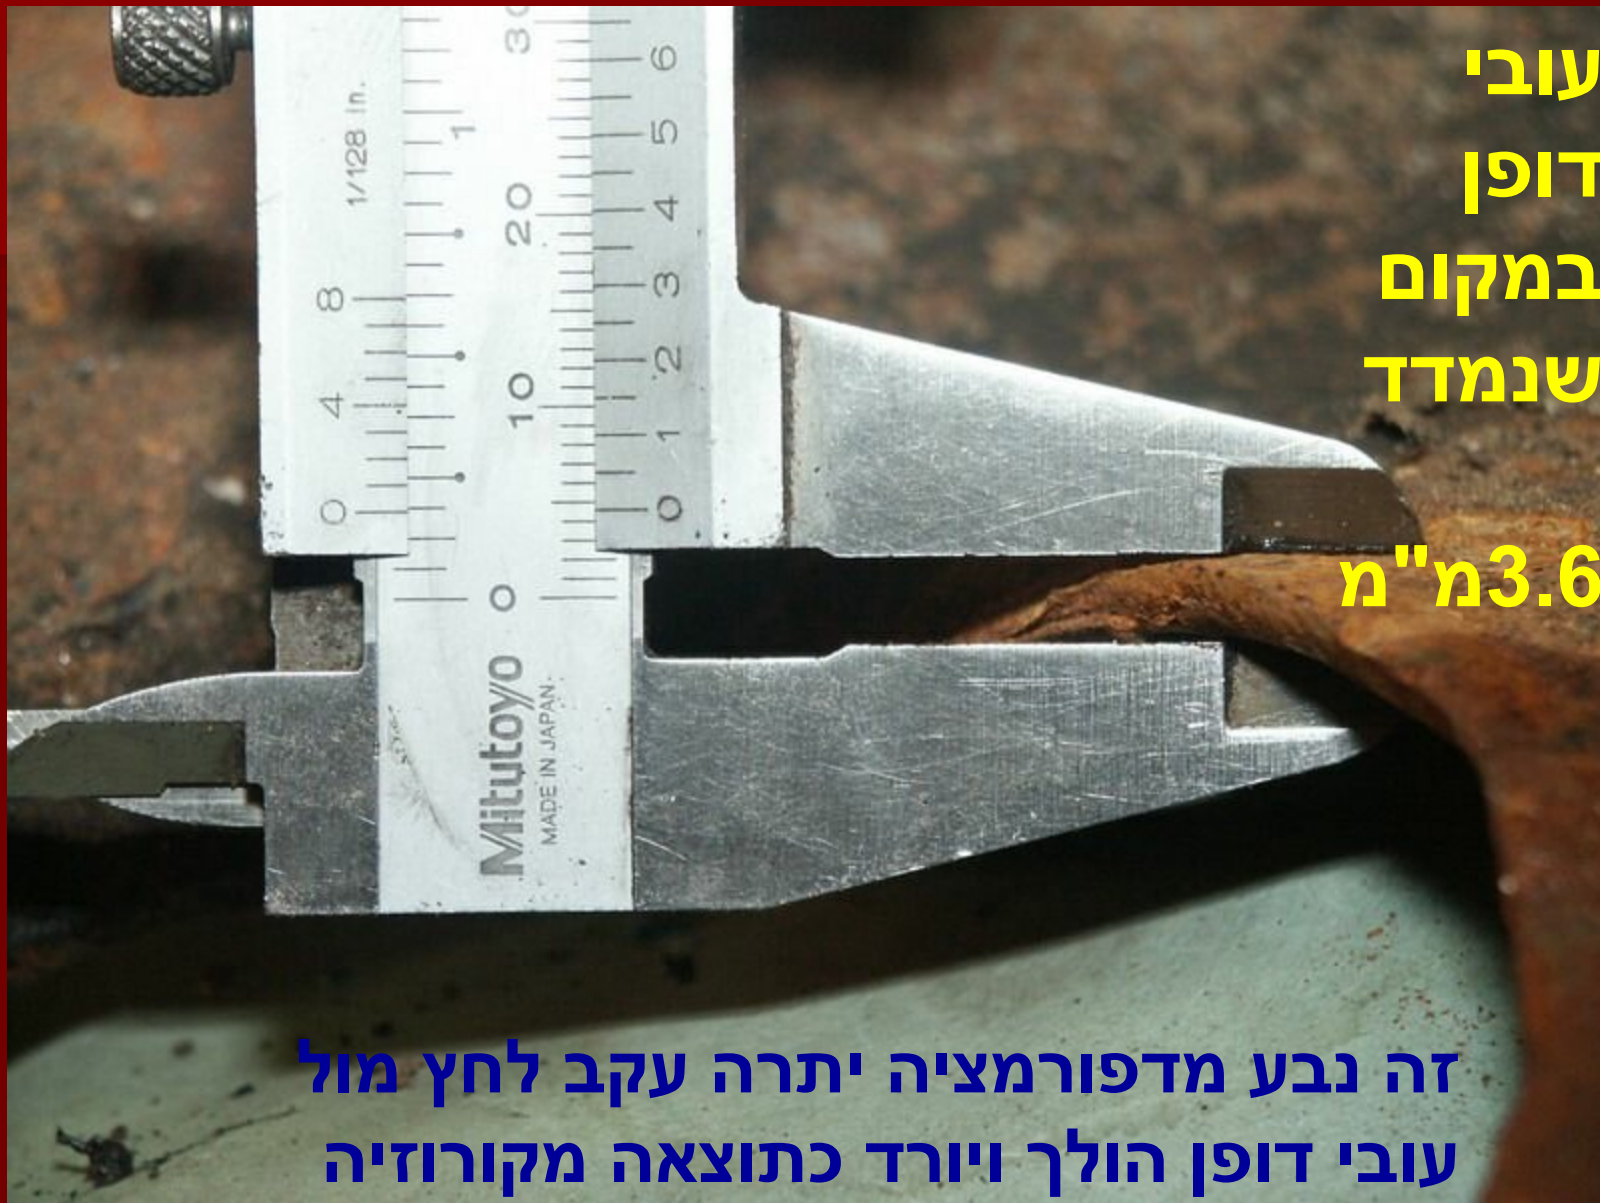
עובי
דופן
במקום
שנמדד
3.6 מ"מ

זה נבע מדפורמציה יתרה עקב לחץ מול
עובי דופן הולך ויורד כתוצאה מקורוזיה

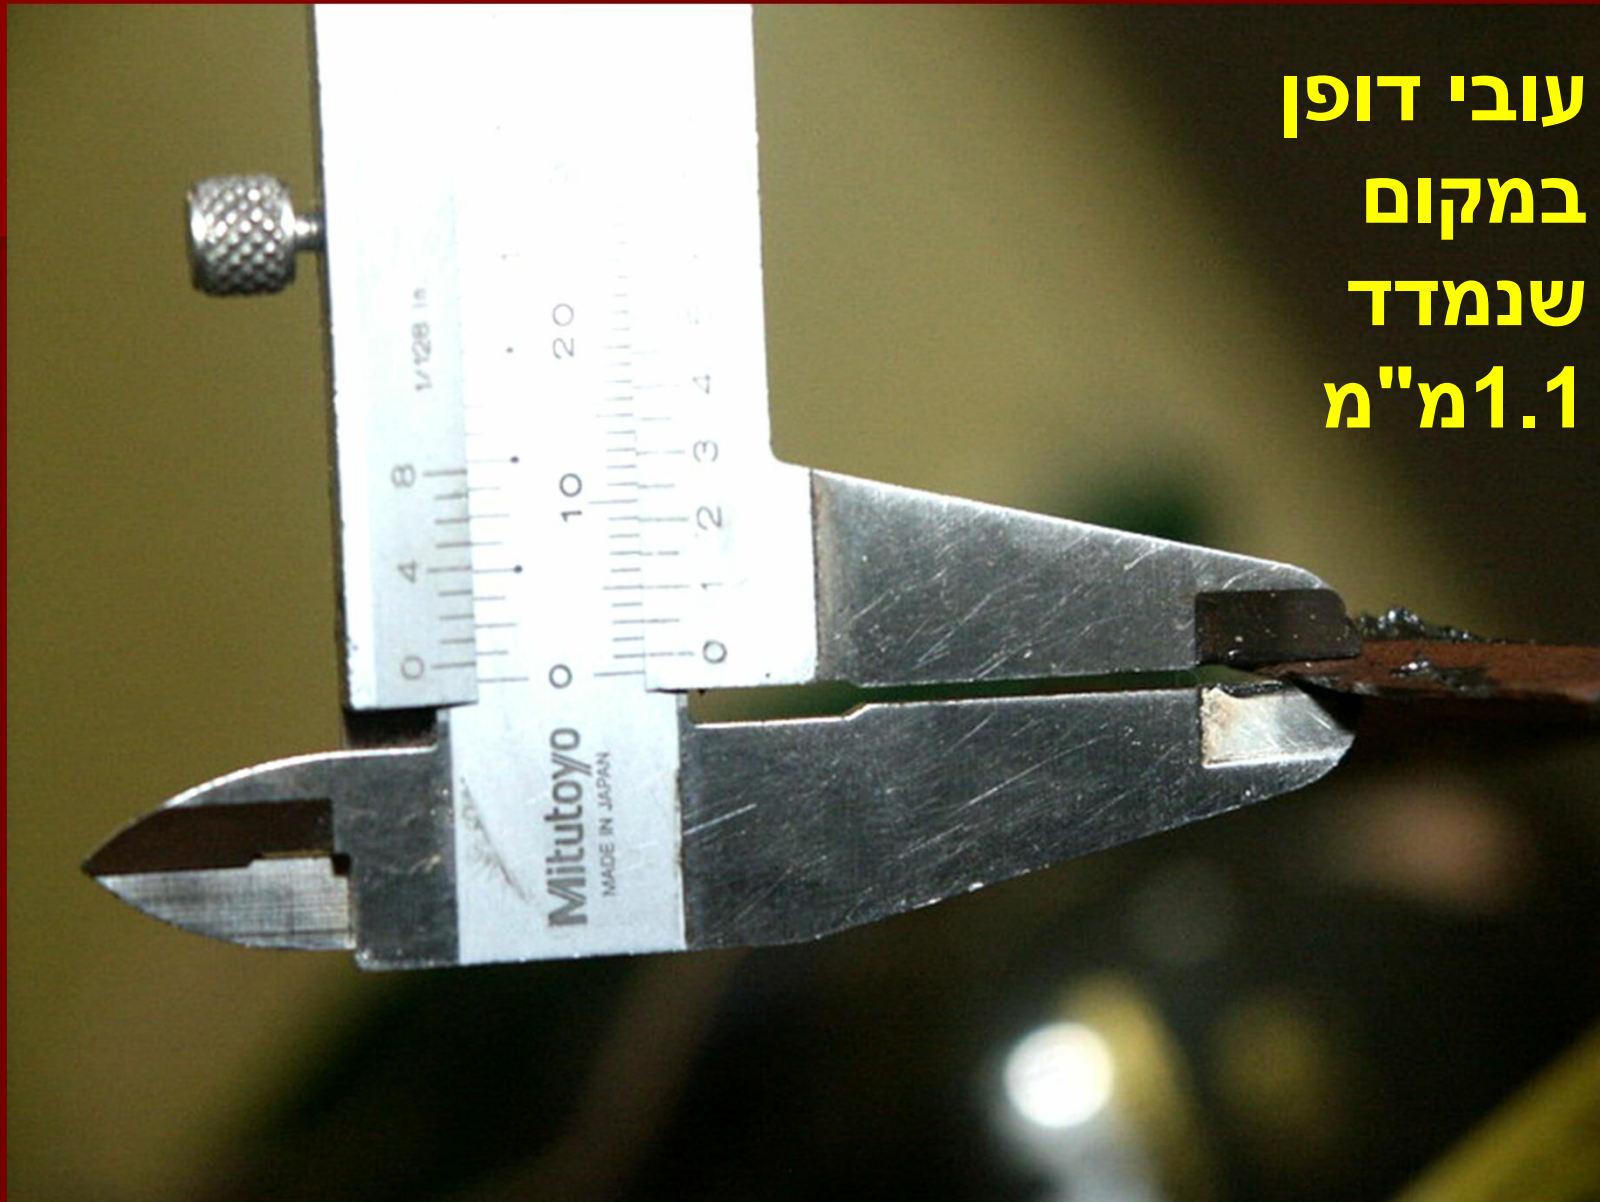
עובי דופן
במקום
שנמדד
1.1 מ"מ

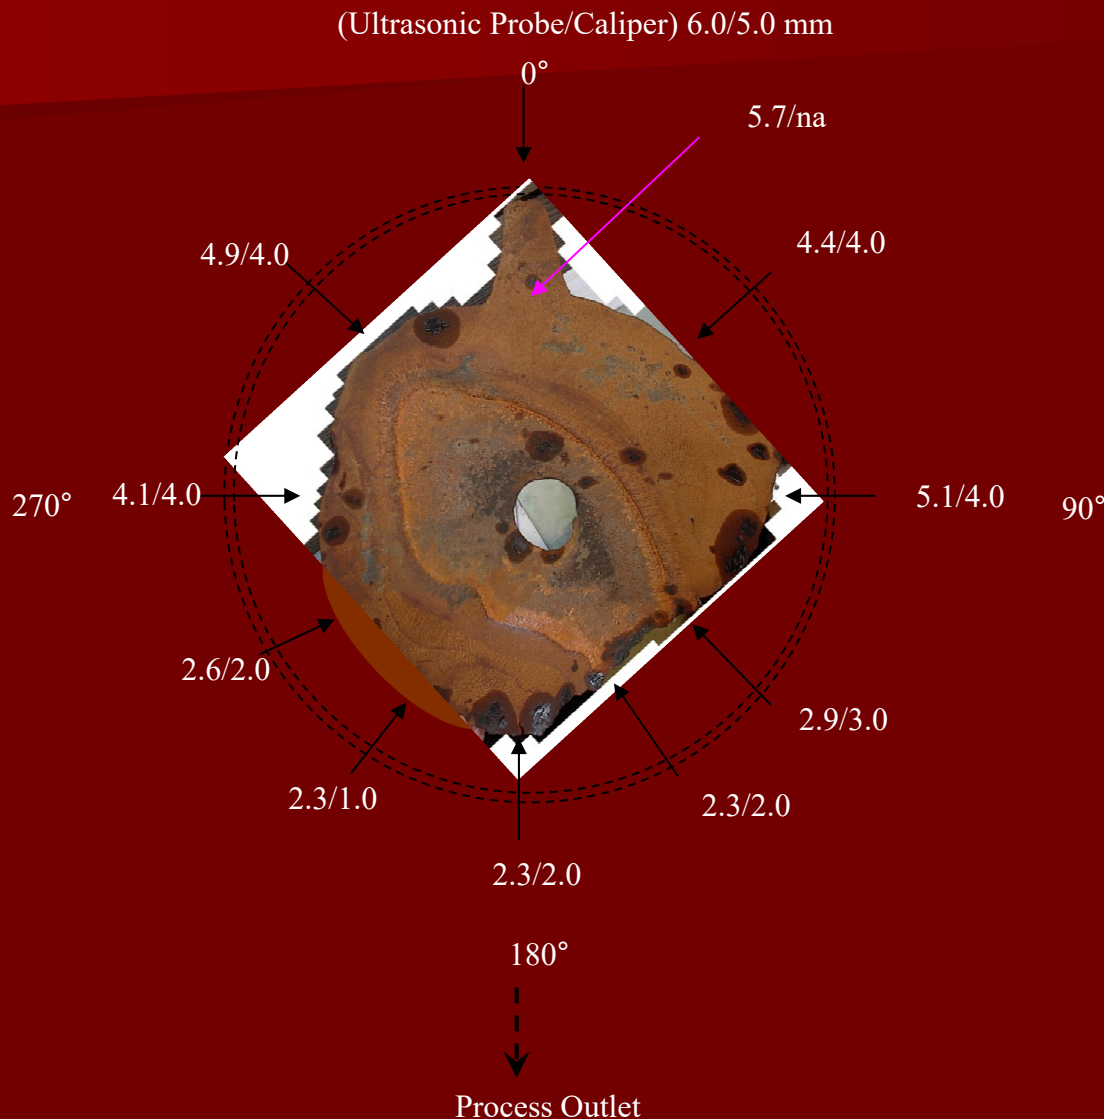
3-E-8 #1 (West) Bottom Shell
Head Process Inlet

פלדת HII לפי DIN-

17155

כניעה מחושבת של

החומר בעובי 2.6

מ"מ בלחץ 17 בר.

שבירה של החומר

בלחץ 12 בר, כאשר

העובי יורד ל-

1.2 מ"מ.

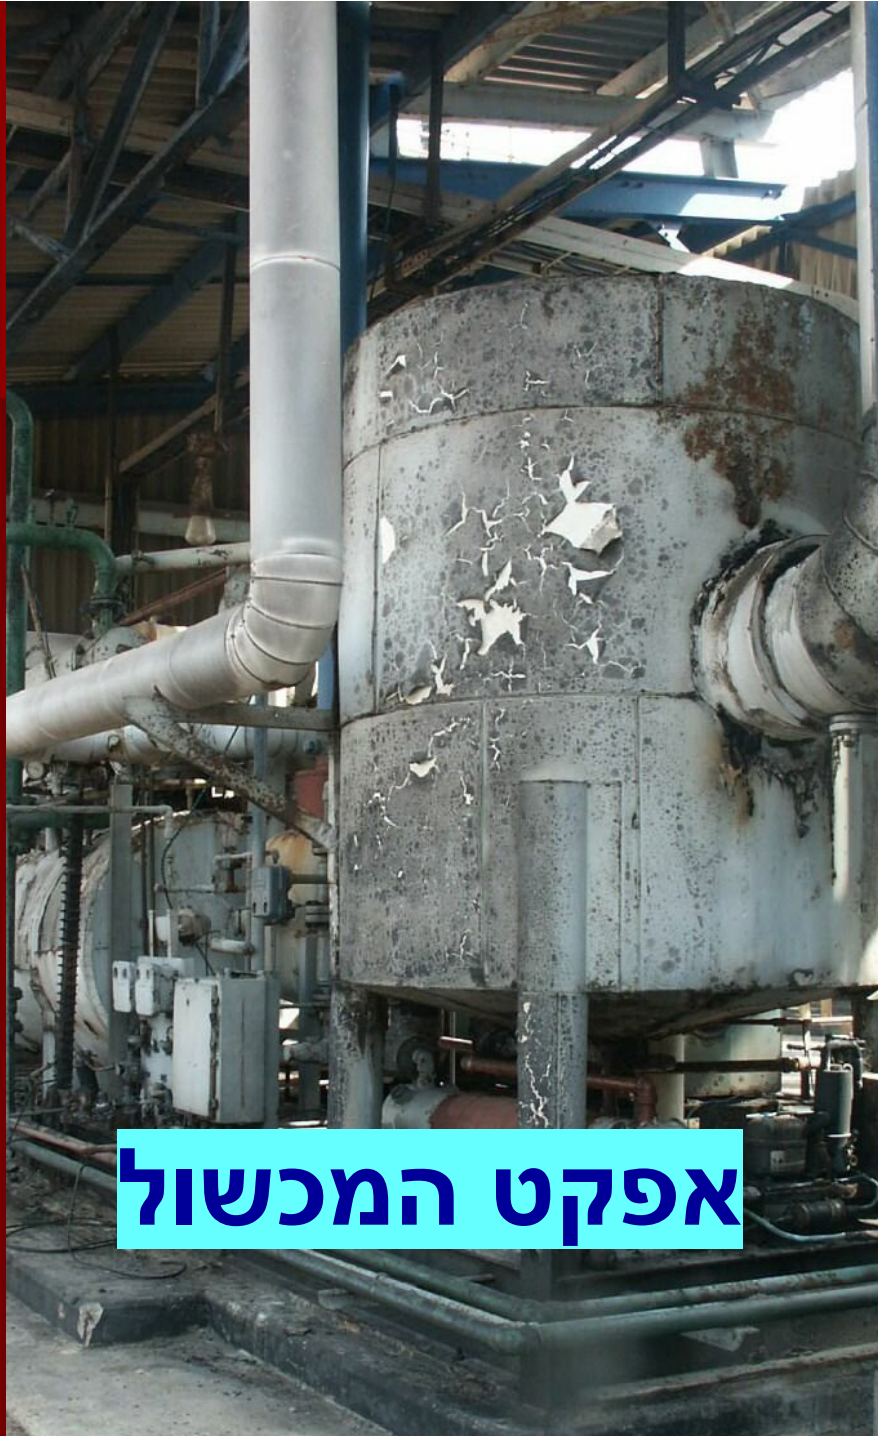
מיכל שצבעו נחרך
אשר נמצא מאחורי
מבנה כבד שהגן
עליו.

הענן הבוער פשוט
בצע מעקפים והגיע
למיכל מהצד ההפוך

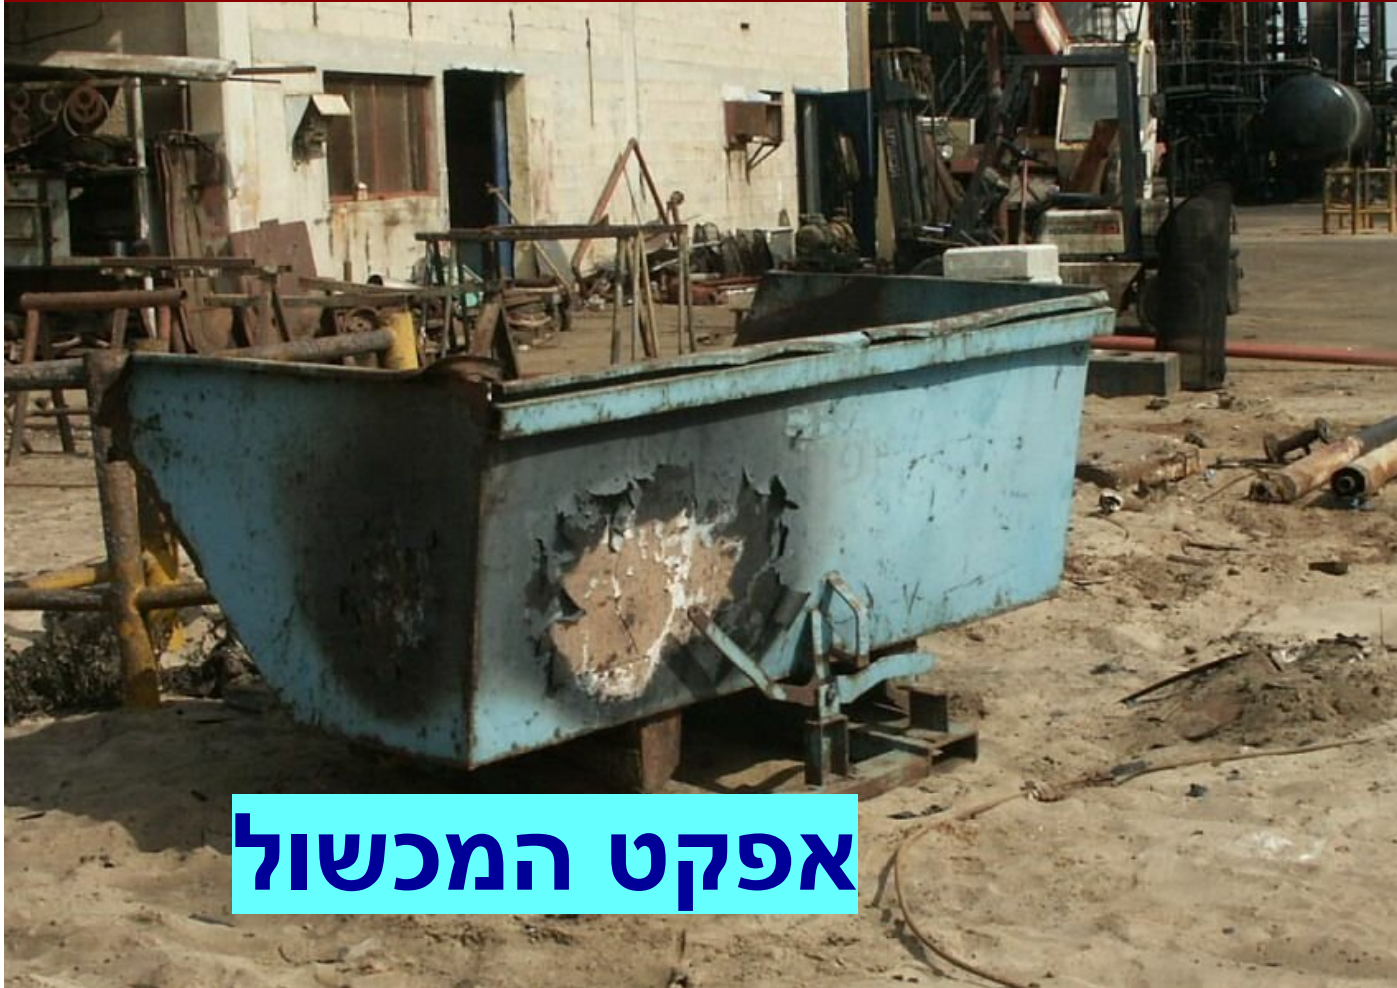
פח אשפה, עם
סימני חריכה
חיצוניים בלבד,
משני צידי הפינה
ההפוכה מהכיוון
ממנו הגיע הענן
שנדלק.

הסיבה: הערבול
שיצר המכשול על
זרם הגז גרם
לבעירה שיצרה
את החריכות

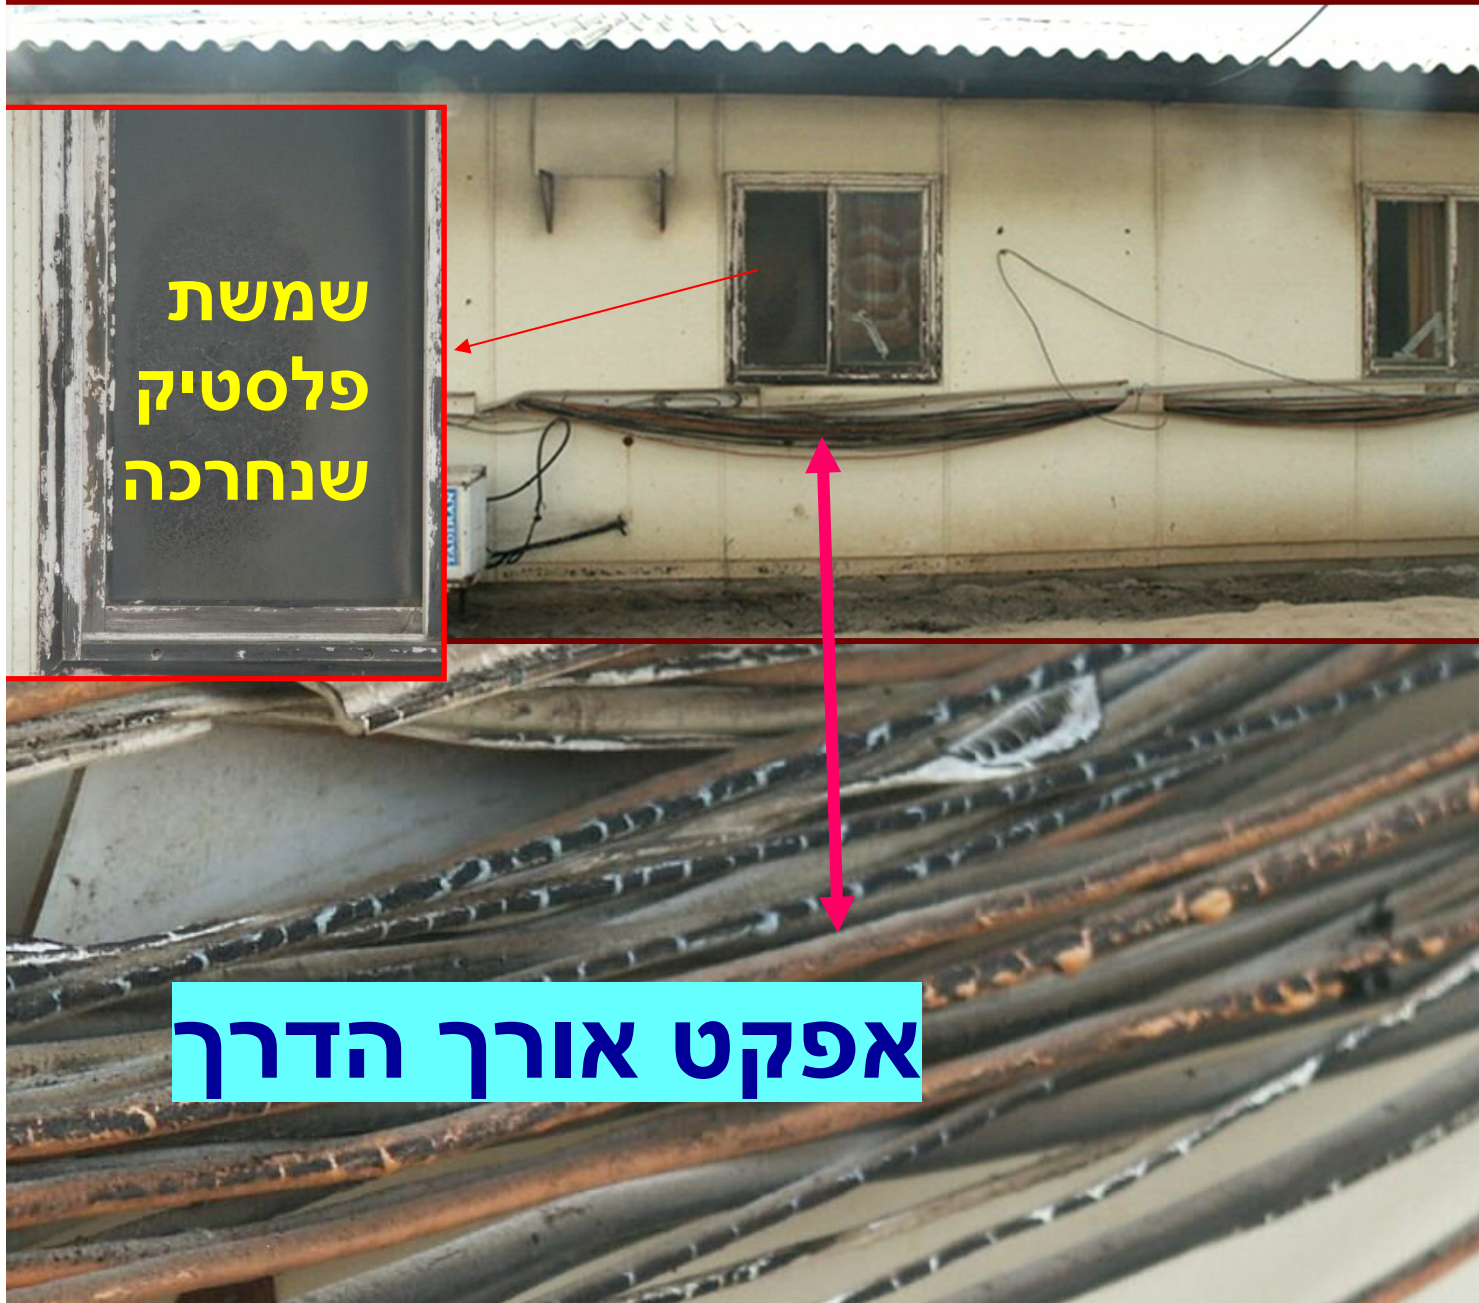
כבלים
מתחת
לחלון של
מבנה כ-
120 מ'
מהמוקד.
נא לשים לב
לחלון.
החלונות
משני
הצדדים לא
נפגעו!!

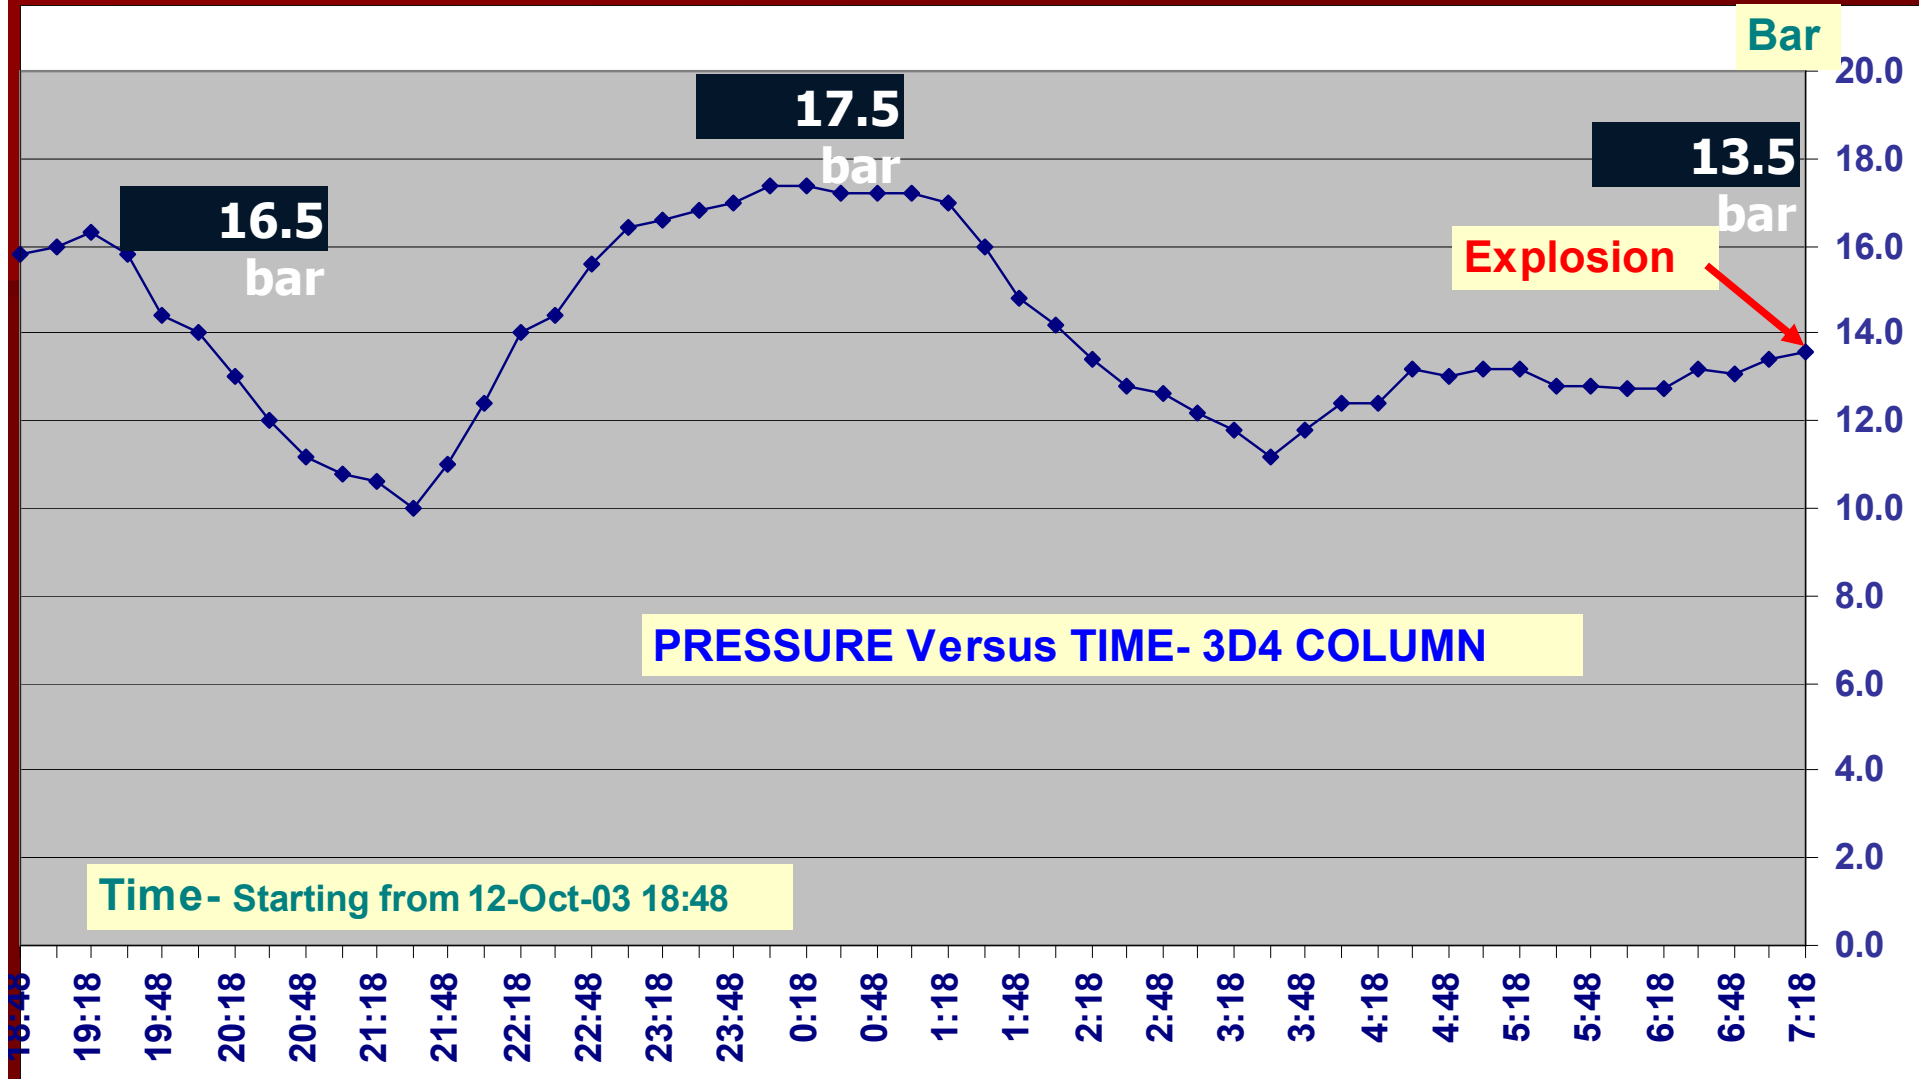
במשך הלילה, המיכל ביקר פעמיים בלחצים גבוהים משמעותית מהלחץ שבו התפוצץ לבסוף. בשתי הפעמים הקודמים היו עובדים בסביבת המתקן.

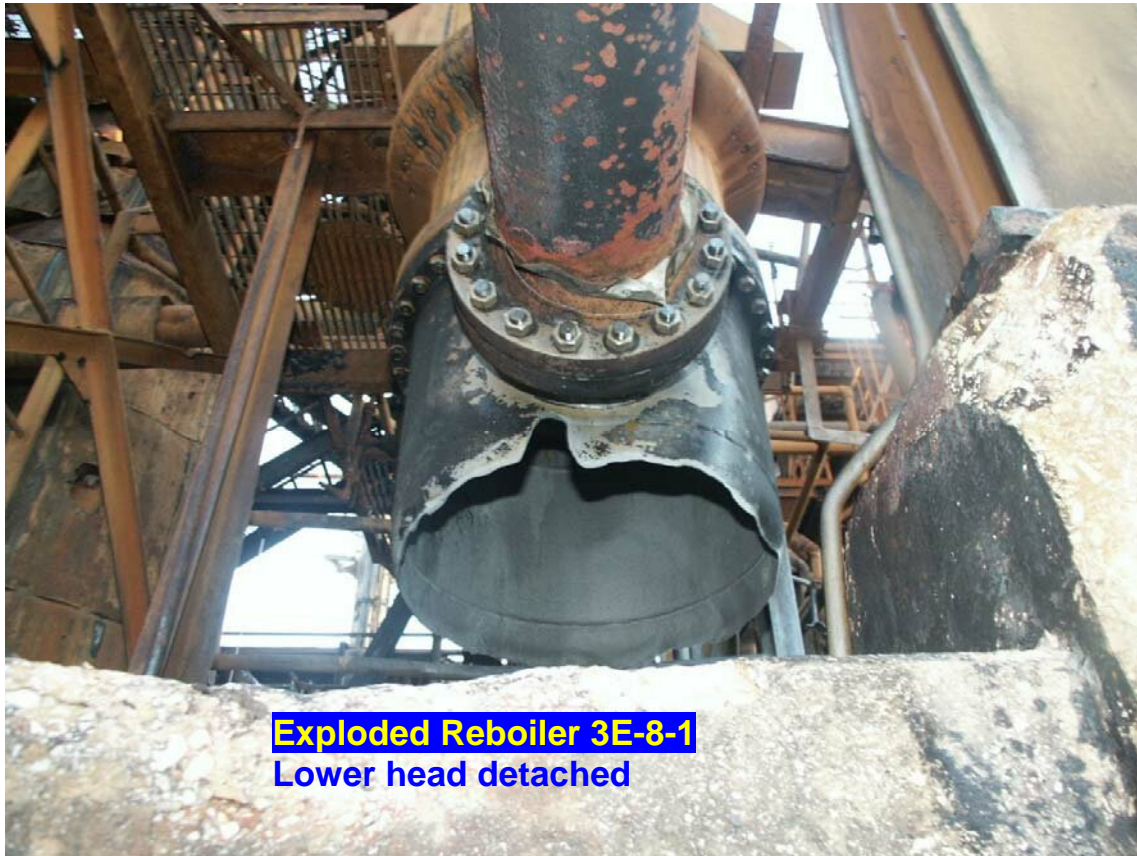
Exploded Reboiler 3E-8-1
Lower head detached

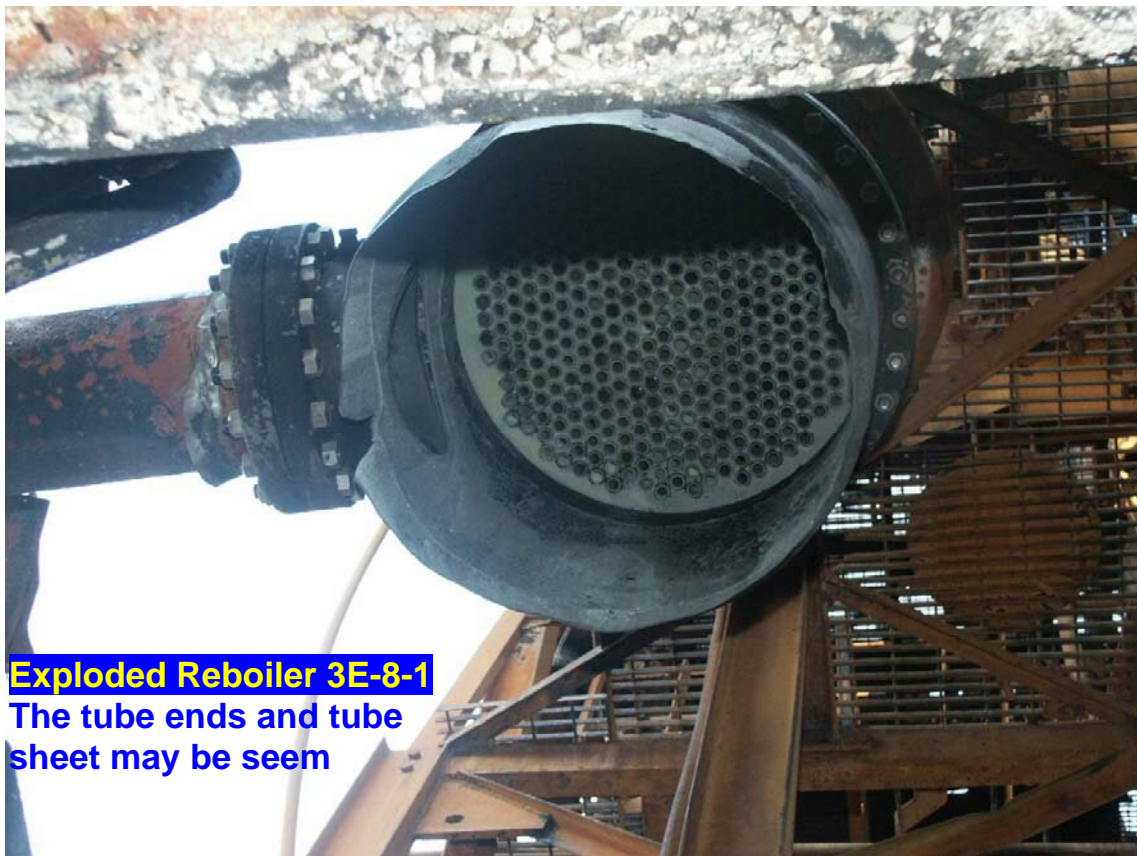
Exploded Reboiler 3E-8-1
The tube ends and tube sheet may be seen
