דן ארבל הנדסת סיכונים ושמאות בע"מ

חקירת אירוע התפוצצות 13/10/2003

Date: 24/10/03
Ref.: PVC - Loss 2003

Explosion and Fire – 13-Oct-2003 Insurance Claim

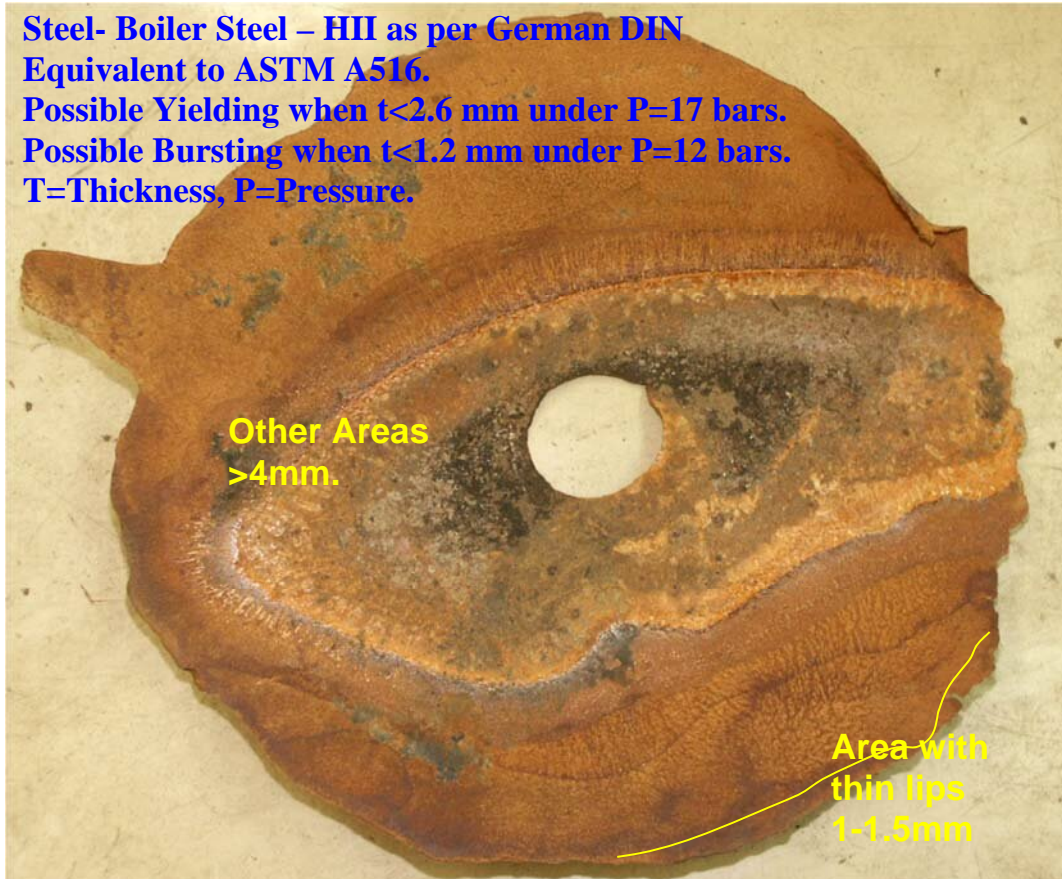
The detached lower dished head - flattened by the impact

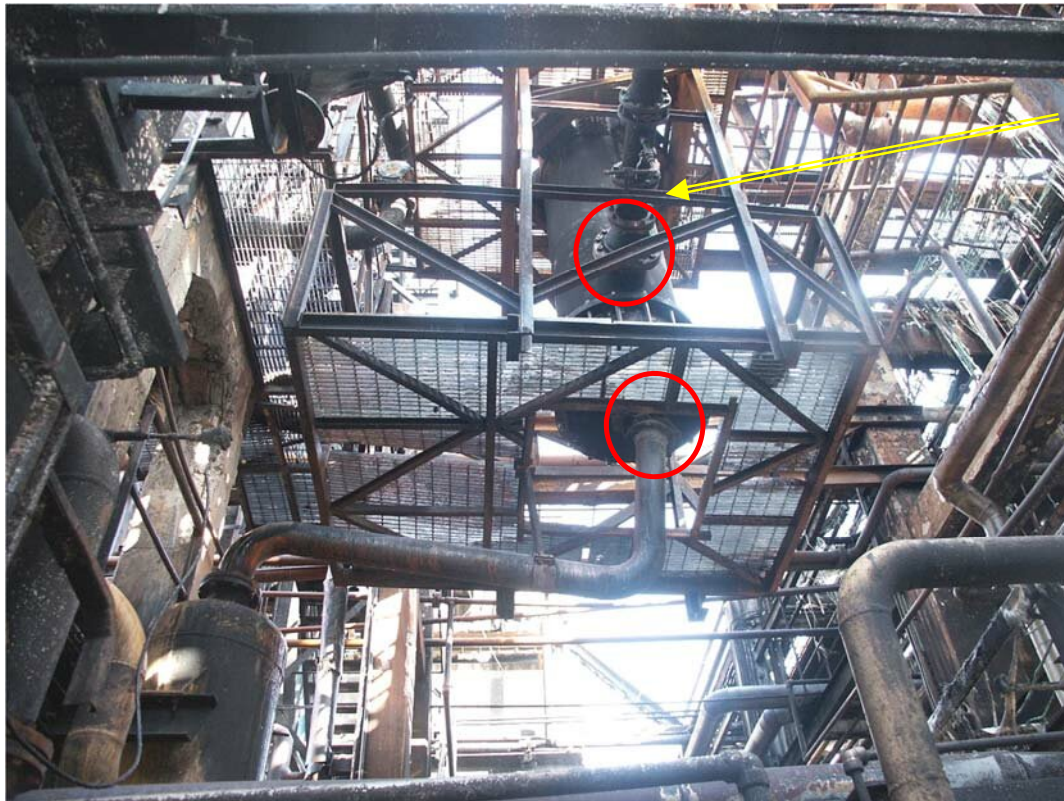
Graphite Heat exchanger – south of the 3-D-5, VCM column.

Fluid discharged through bursting bellows

Severe fire in this area.

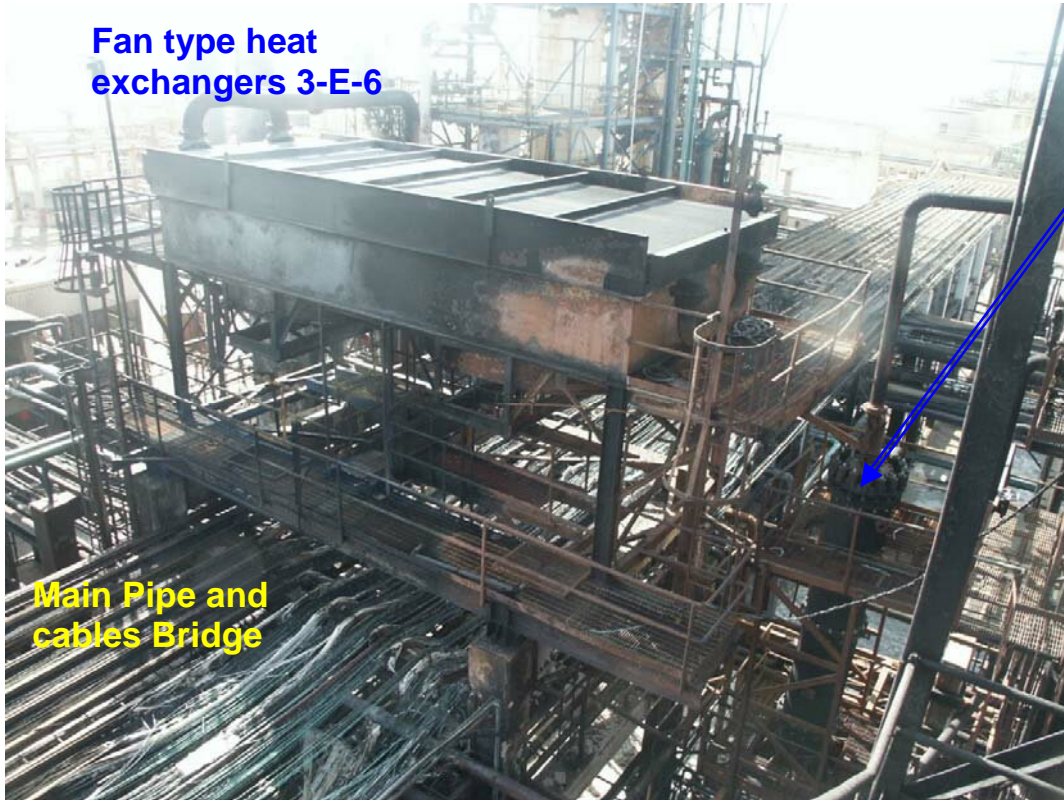
Fan type heat exchangers 3-E-6

Graphite Heat exchanger as above

Severe fire in this area.
