Date: 24/10/03
Ref.: PVC - Loss 2003

PVC INSURANCE CLAIM

Explosion and Fire – 13-Oct-2003 Insurance Claim

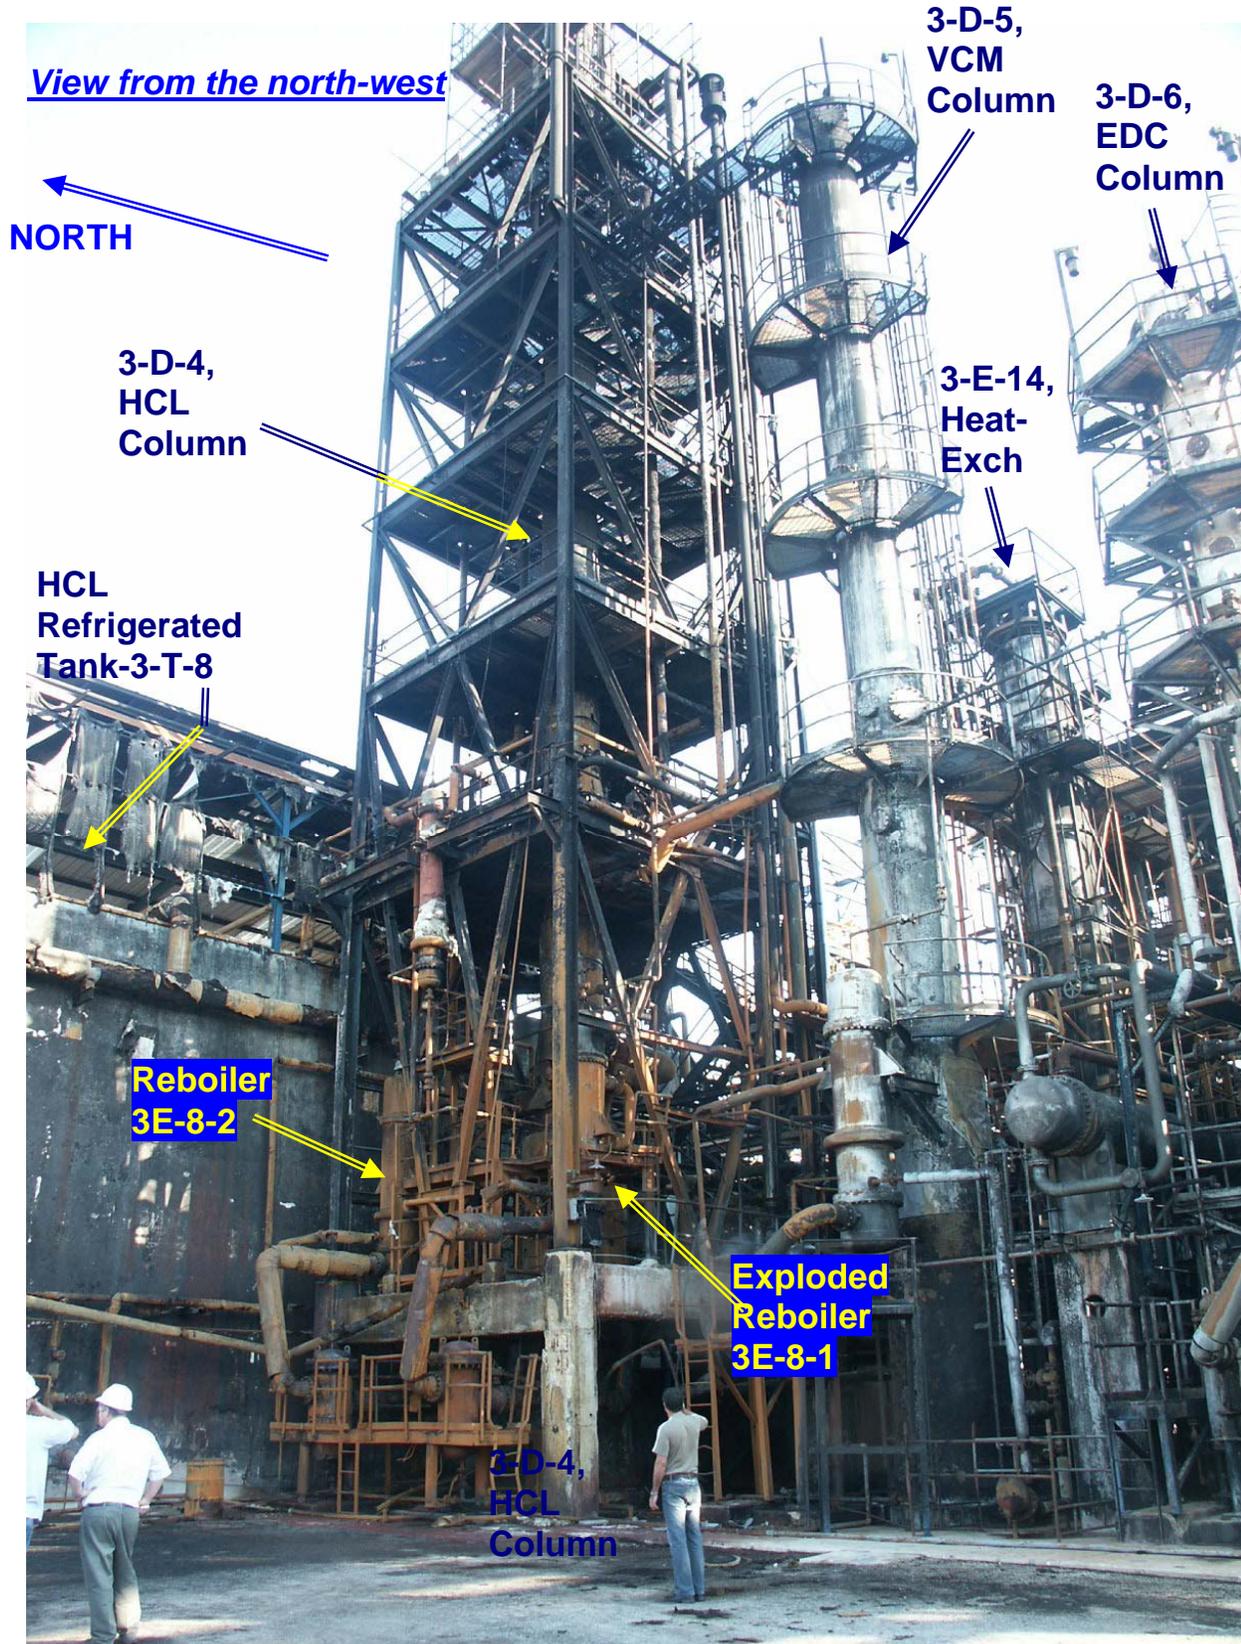
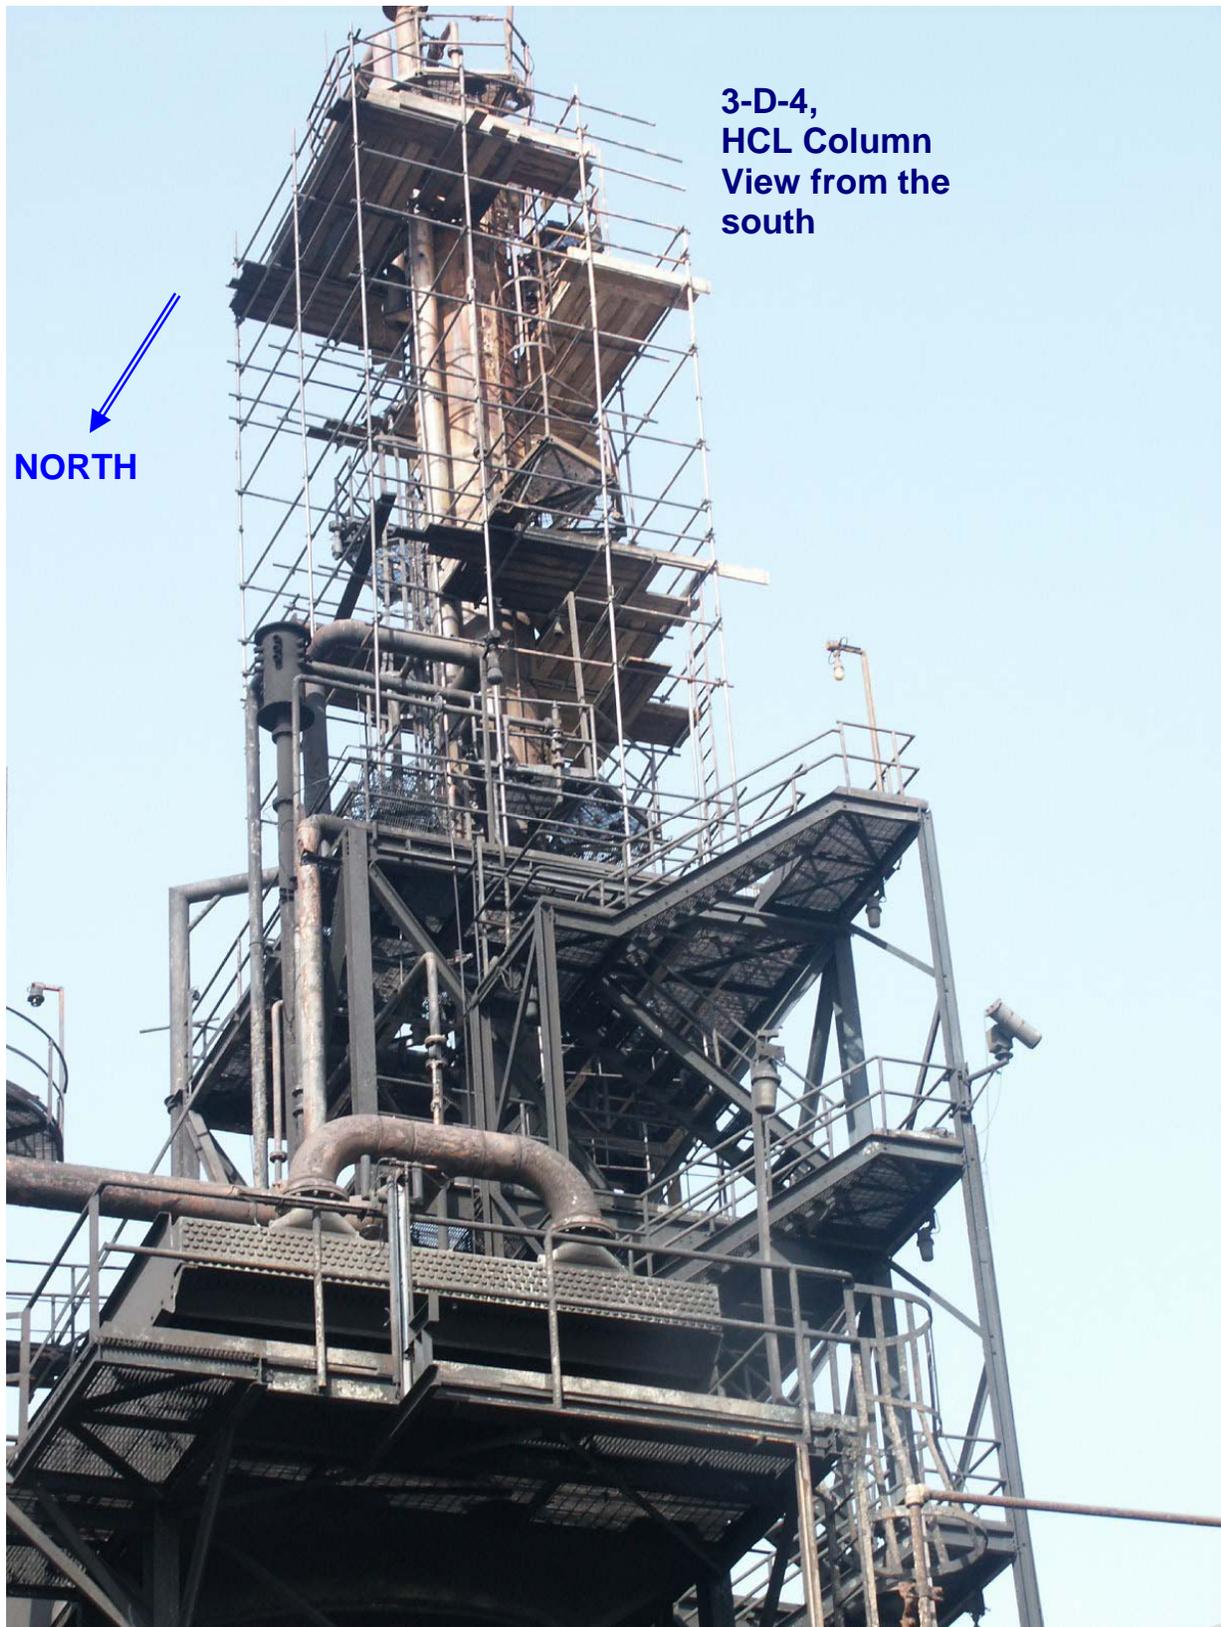
- (1) Thinning of a part of the area of the Reboiler lower dished head to below 1.5mm is extraordinary.
- (2) The parallel Reboiler and an additional spare unit had their thicknesses measured after the occurrence and found in the range of 5.5-6.5 mm.
- (3) The reboilers are exchanged between them periodically, so that there is no question of one unit serving more than another.
- (4) There was an extensive thickness measurements taking place in the column and piping in last April.
- (5) The unit was cleaned and tested in July 2003 and reinstalled in August-2003.

Exploded Reboiler 3E-8-1
Lower head detached

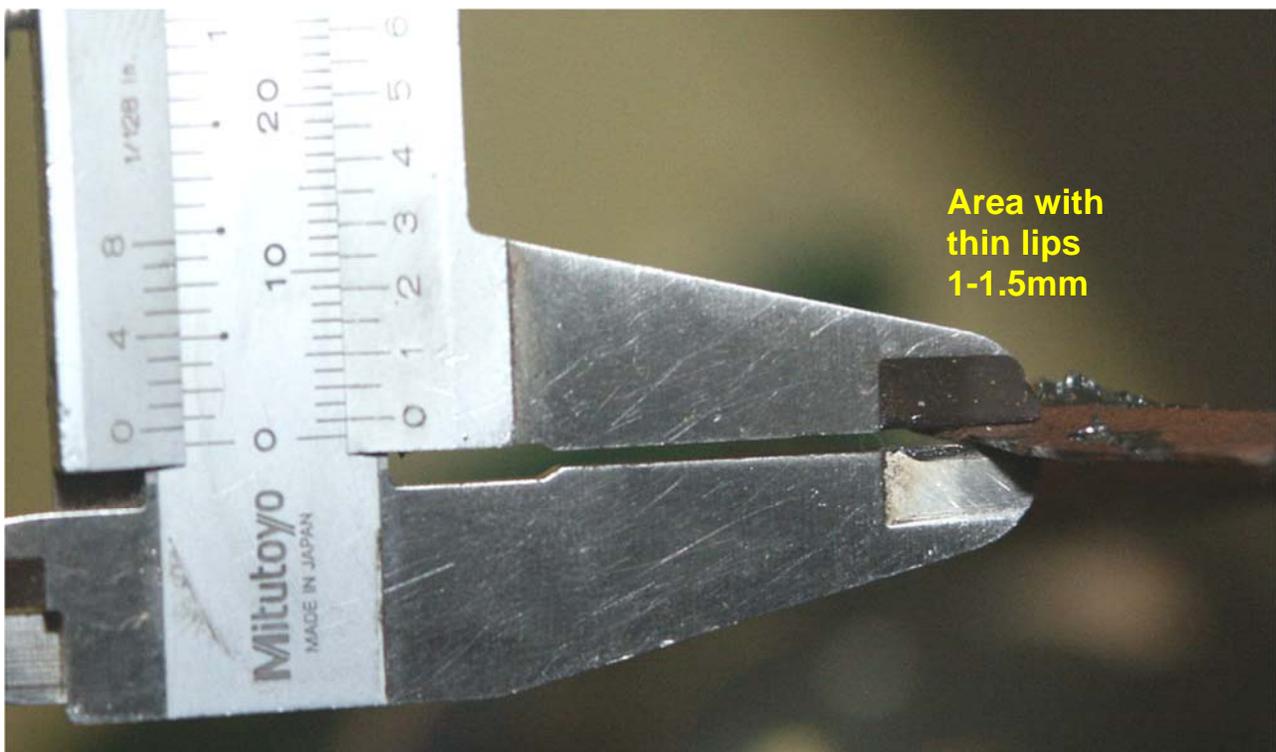
The detached lower dished head - flattened by the impact

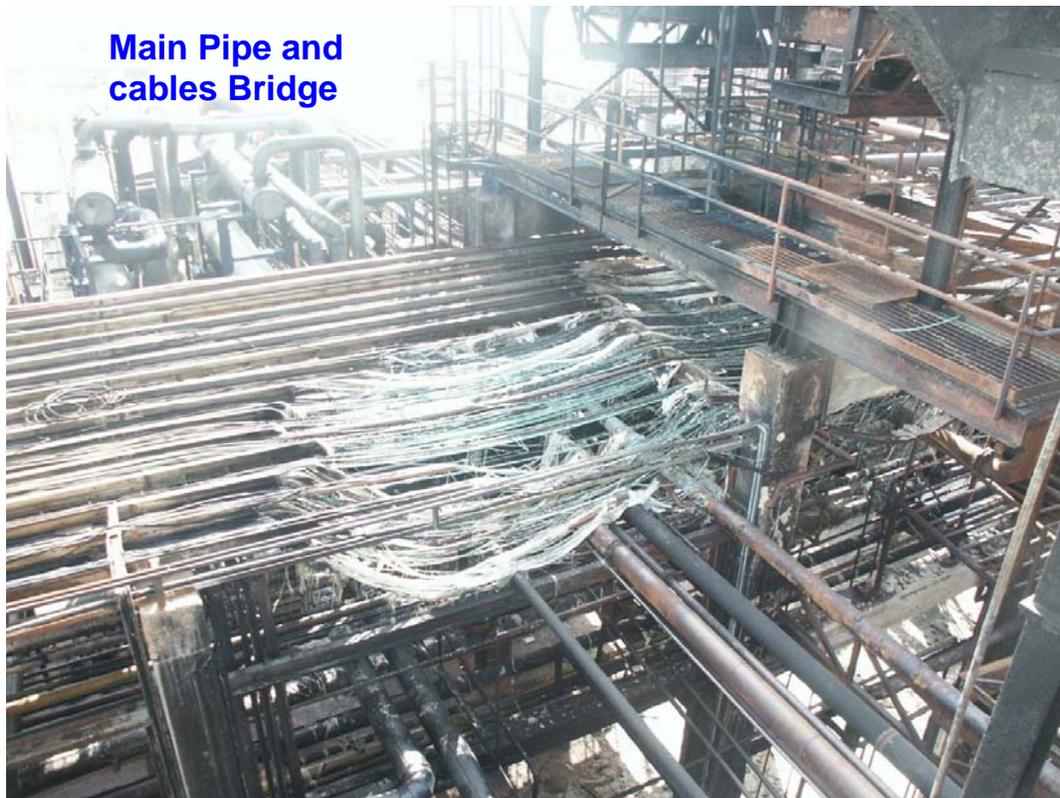
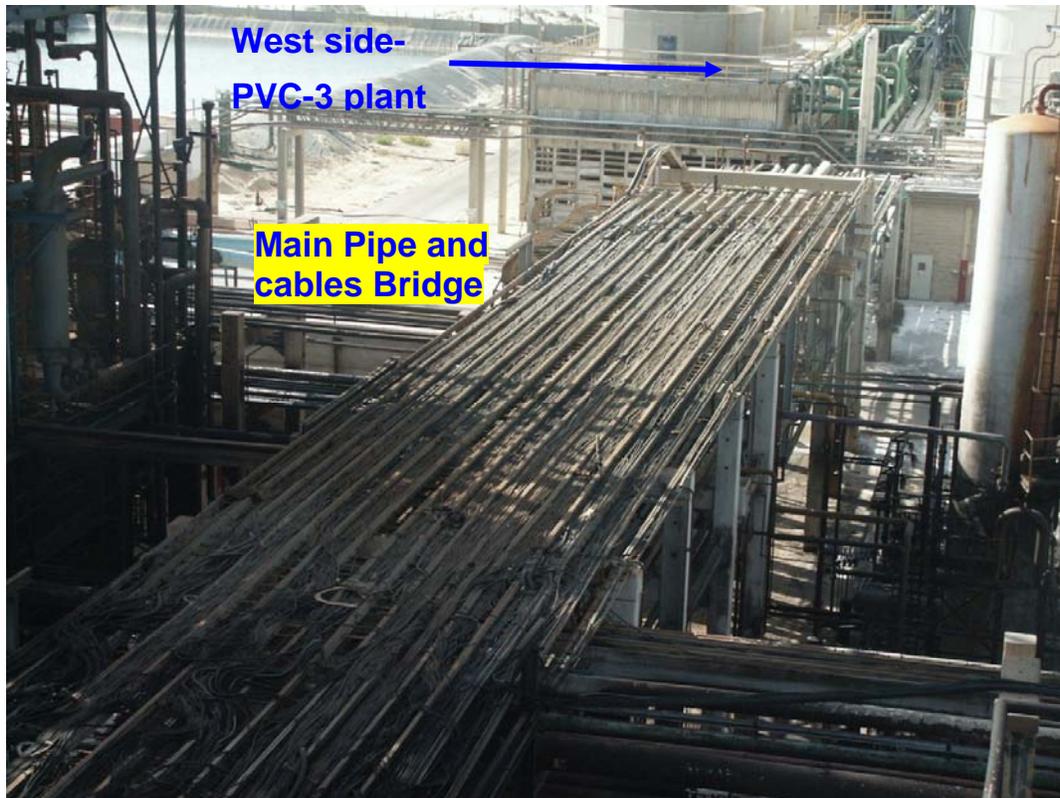
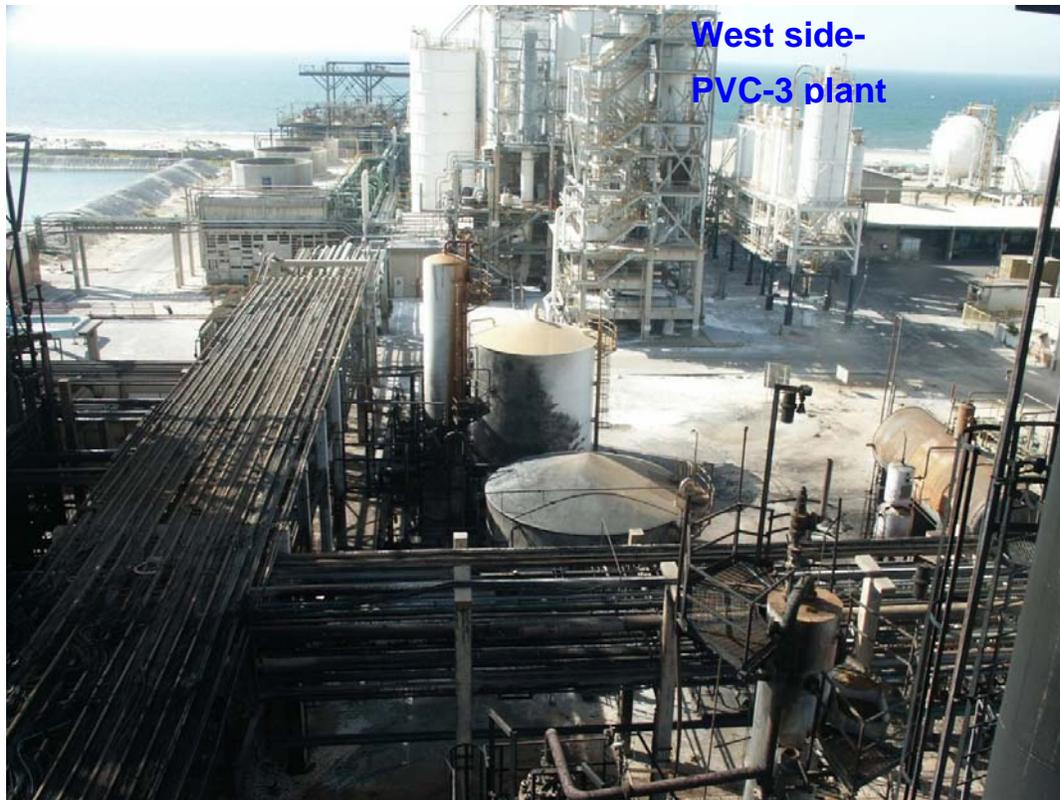
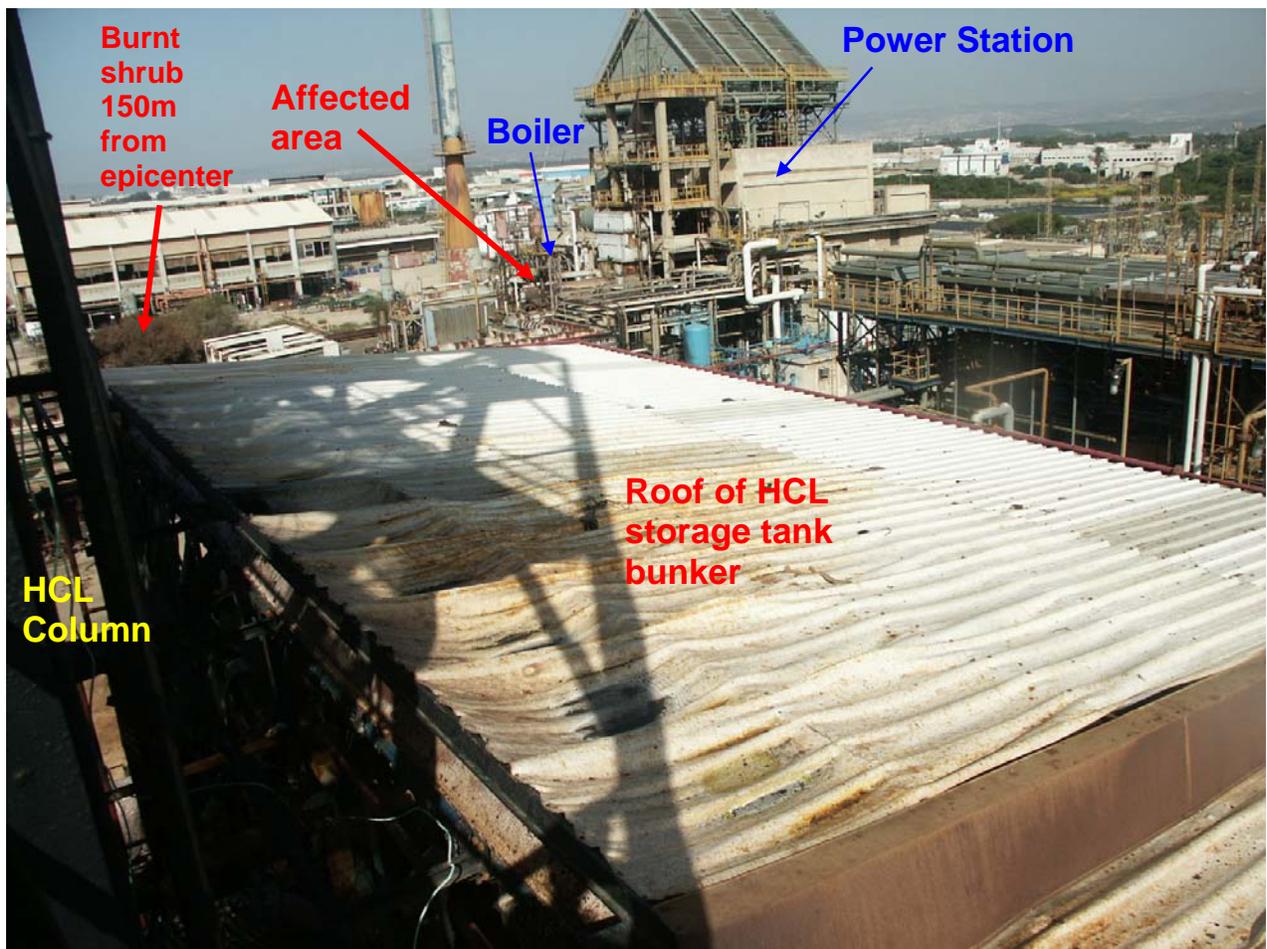
Main Pipe and cables Bridge

Severe fire in this area.

4.	Damage to Power and Communication cables	Scorching throughout the heat affected zone and actual burning in the area of the Purification process unit, adjacent main bridge and various locations throughout the heat affected zone.
