Date: 14/12/04  
Ref: N-Woven-131204

## ***NONWOVEN CONVERTING Concise Report***

<b>Insured:</b>	Nonwoven converting in Germany
<b>Survey on:</b>	Underwriting Information

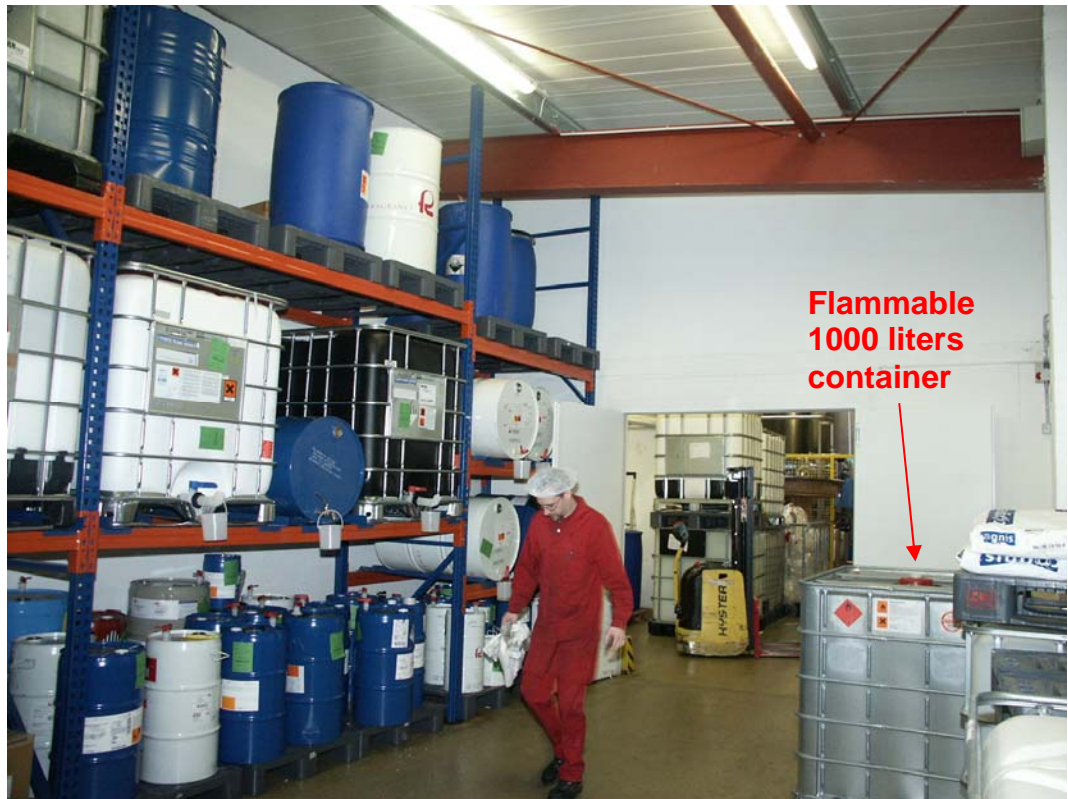
**One 1000 liters alcohol is present.**

**Between the other chemicals there are combustible chemicals having flash point between 100C to 400C**
